CRAZY WOMAN WATERSHED PROJECT - LEVEL II

PHASE I
REHABILITATION PLAN
AND
PHASE II
CONCEPTUAL DESIGN AND COST ESTIMATES
FINAL REPORT

HKM ASSOCIATES
1842 Sugarland Drive, Suite 103
Sheridan, Wyoming 82801
307-672-9006

November 6, 1991

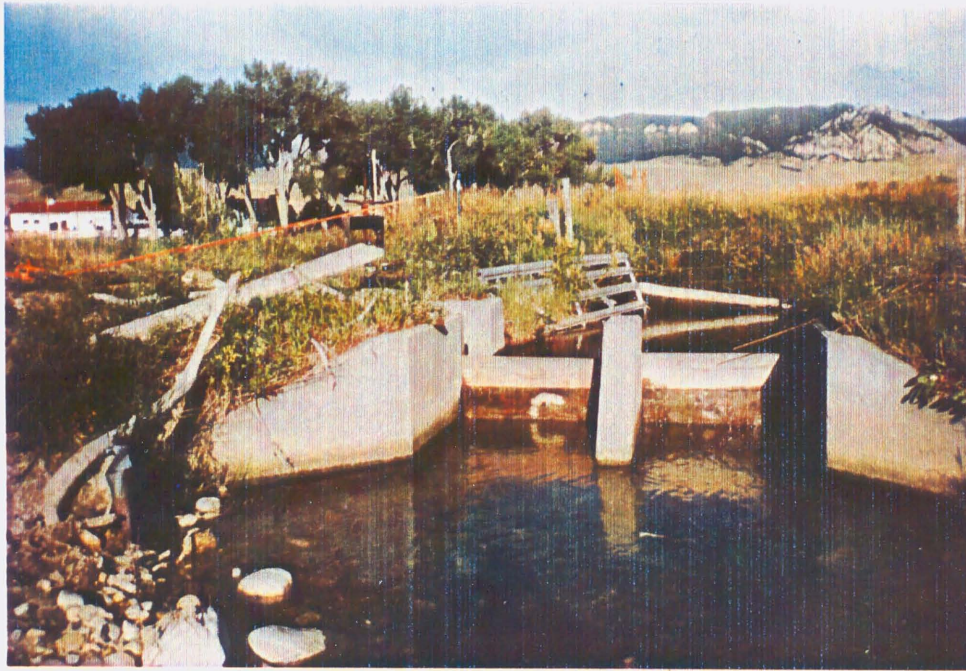
The headgate at station 0+00 on Figure No. 2 which diverts from the Cook Ditch is a concrete structure which is in good condition (Refer to the Photograph C-1 in Appendix C). From Station 0+00 to Station 37+00 the ditch is in good condition and does not need repair work. Headgates and culverts along this 3700 foot section are in good, usable condition.

WEIR: ROGERS-ESPY-FRALEY-BENSON DITCH
PROJECT NO.1 - STA 0+00

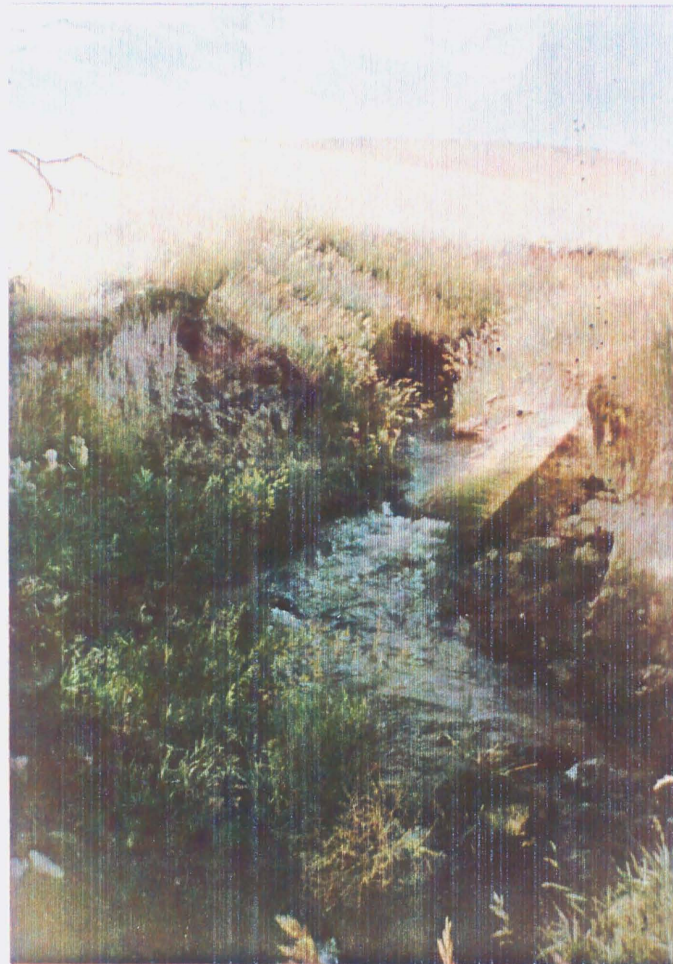
EROSION: ROGERS-ESPY-FRALEY-BENSON DITCH
PROJECT NO. 1 - STA 45+12

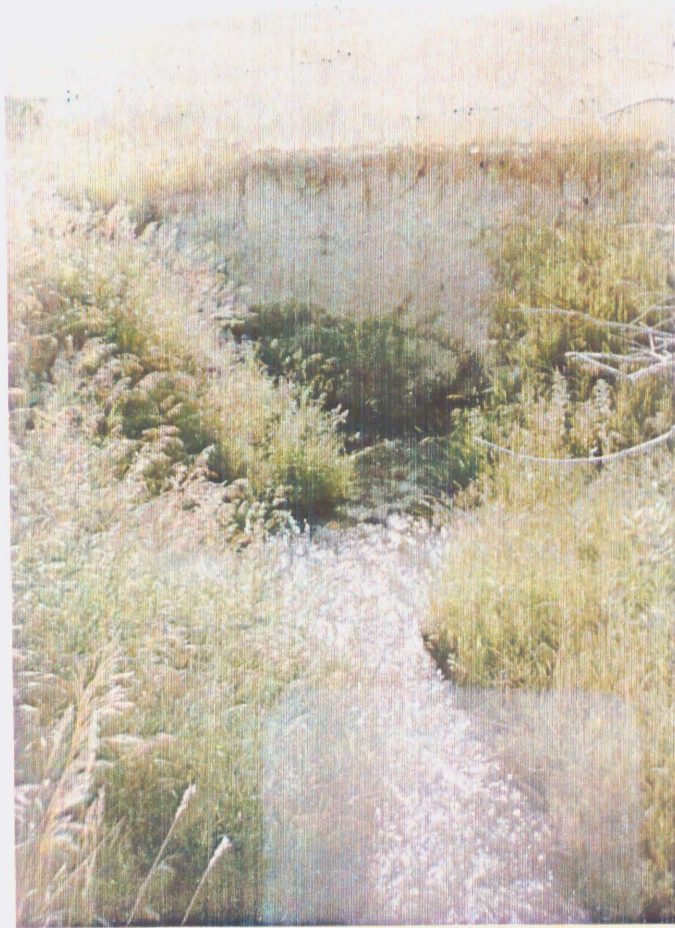
EROSION: ROGERS-ESPY-FRALEY-BENSON DITCH
PROJECT NO. 1 - STA 45+12

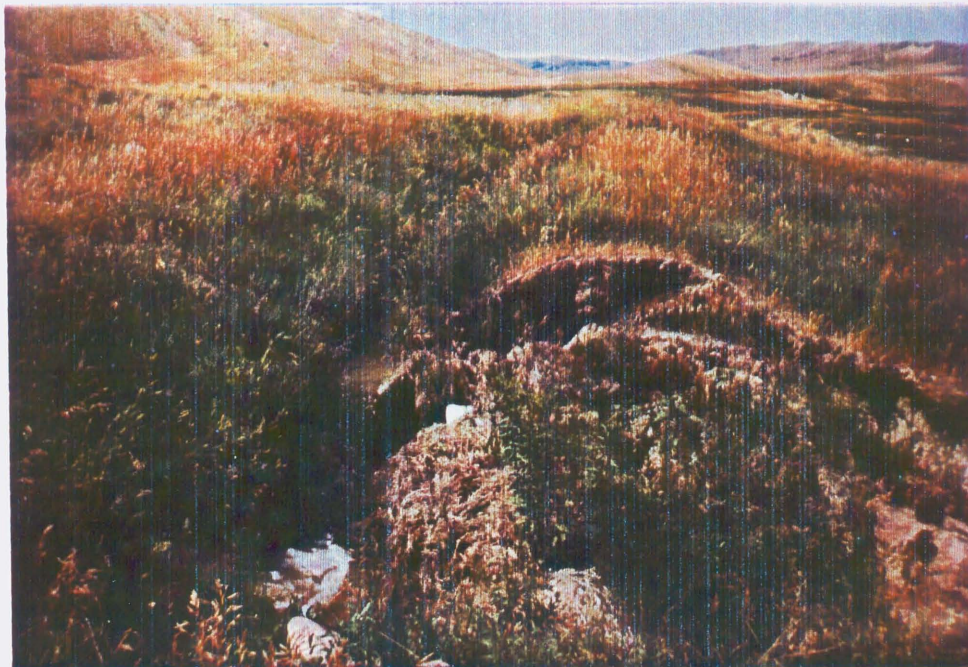
This facility is also known as the Watkins Lateral of the Cook Ditch. The headgate in the Cook Ditch is in good condition and the first 1463 feet of ditch is in good condition. The next 1200 feet of ditch is eroding severely. The ditch stabilizes for about 2700 feet and then experiences severe erosion for another 300 feet. The next 3100 feet of ditch is stable with erosion again occurring in the final 5650 feet. A total of 7150 feet of ditch is experiencing moderate to severe erosion. (See Figure 2.) Erosion is shown in Appendix C on Photograph C-4, C-5, and C-6.

EROSION: HEADGATE WASHED OUT ON
NIMICK-FRALEY 41 RANCH
PROJECT NO. 4 - STA 101+07

During Phase I, a rehabilitation plan was prepared for the plan proposed by the CWWID. The plan was to replace an eroding Watkins Ditch with pipeline starting at the point of diversion in the Cook Ditch. The plan included:

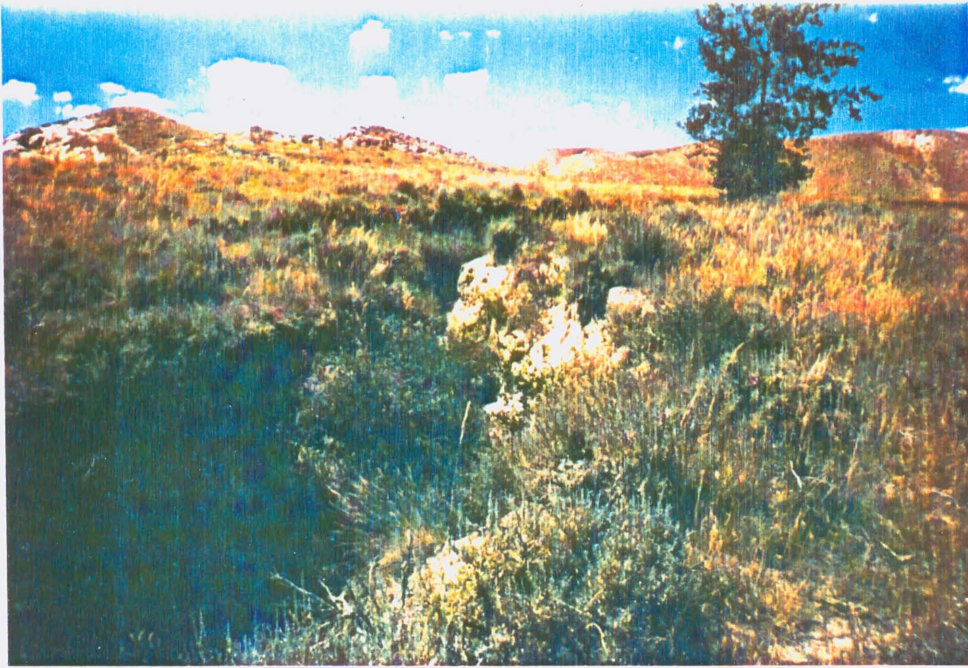
EROSION: NIMICK-FRALEY 41 RANCH
PROJECT NO. 4 - STA 103+66

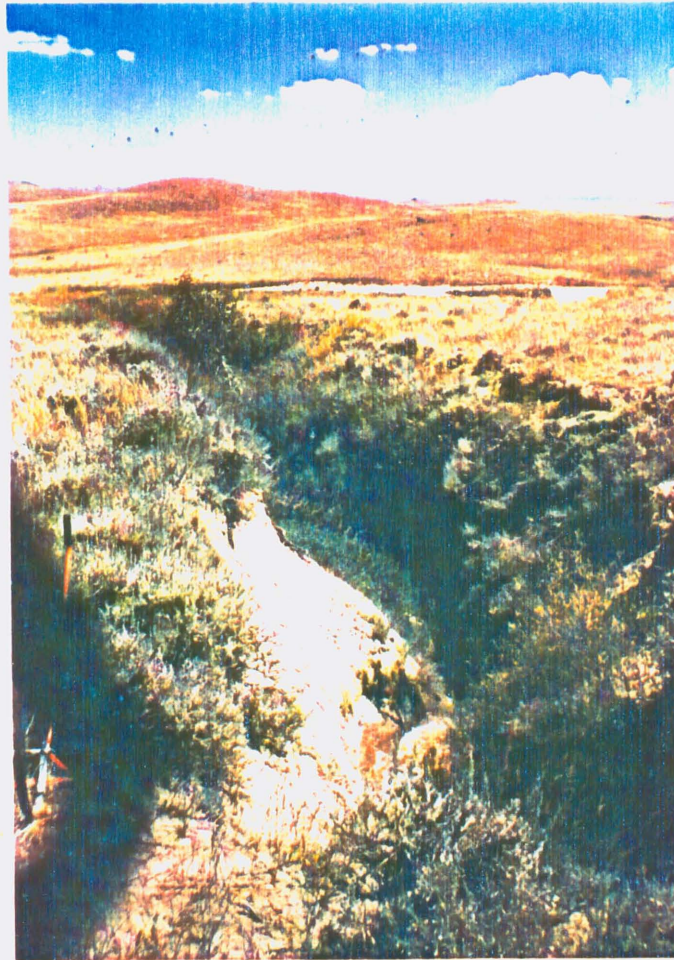
EROSION: NIMICK-FRALEY 41 RANCH
PROJECT NO. 4 - STA 103+96

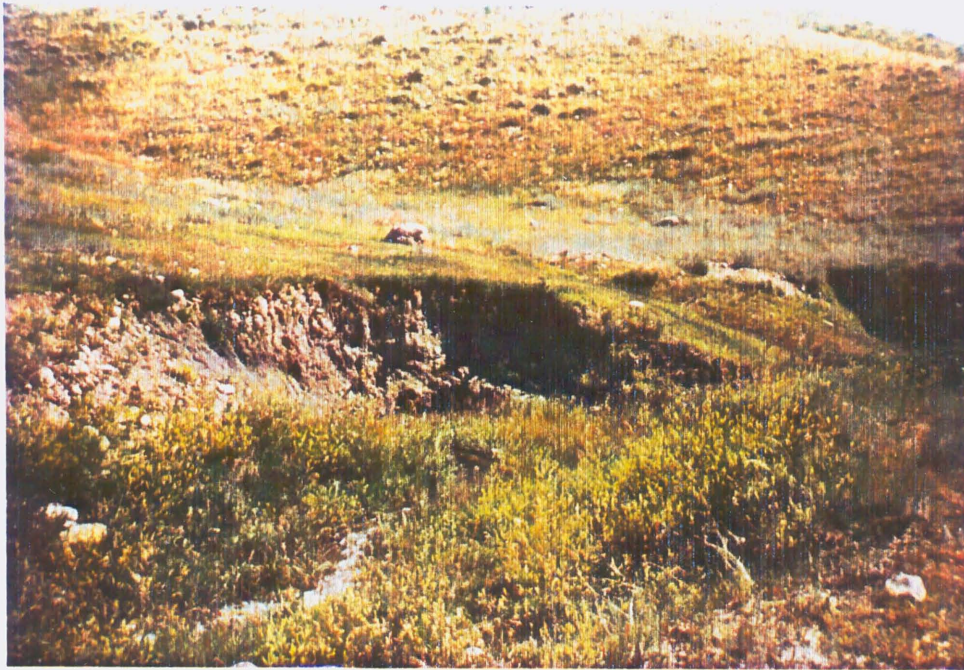
The 41 Ranch-Bauer Ditch is also known as the Kennedy Ditch lateral. (See Figure 2.) The headgate out of the Kennedy Ditch is in good condition. The ditch for the first 6146 feet is in good condition. Severe erosion is occurring in two sections of ditch 260 feet and 265 feet each. Except for the 525 feet of erosion, the 41 Ranch-Bauer Ditch is in good condition. Erosion is shown in Appendix C - on Photographs C-7 and C-8.

EROSION: 41 RANCH
BAUER DITCH
PROJECT NO. 6 - STA 61+46 THRU 64+05

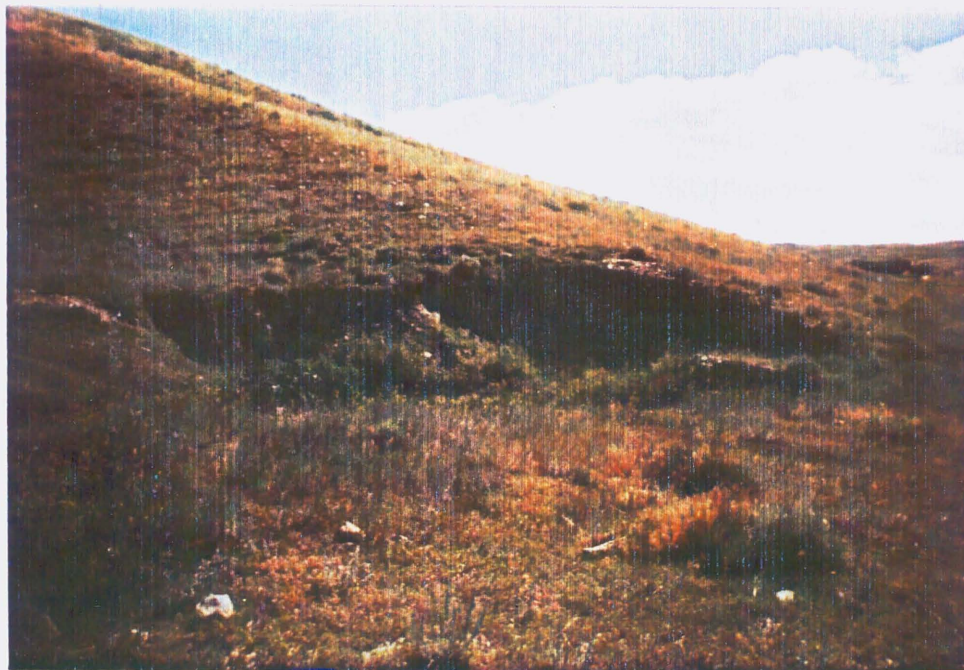
EROSION: 41 RANCH
BAUER DITCH
PROJECT NO. 6 - STA 67+24 THRU 69+87

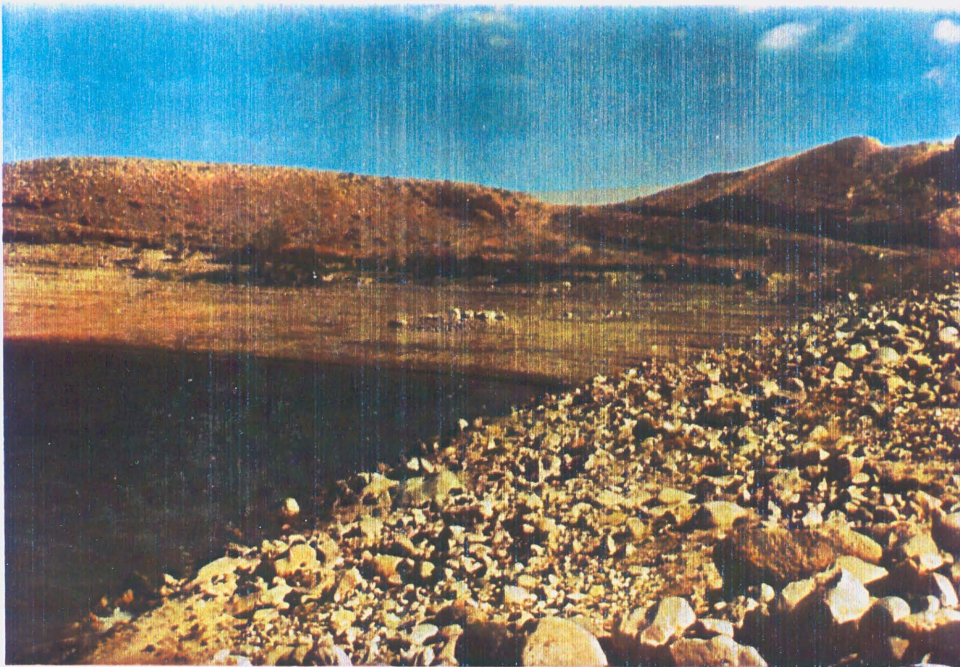
In April 28, 1989 the State of Wyoming, Assistant Dam Safety Engineer inspected the Muddy Guard No. 2 Reservoir pursuant to the Wyoming Safety of Dam's Law (W.S. 41-3-307 through 41-3-318). In that inspection, the south dam of Muddy Guard No. 2 Reservoir was classified as a significant hazard or Class II Dam. During that inspection, significant displacement and erosion resulting from wave action were reported. The inspection report is provided in Appendix E.

LEFT (EAST) ABUTMENT RIPRAP - SOUTH EMBANKMENT
MUDDY GUARD NO. 2 RESERVOIR
PROJECT NO. 7

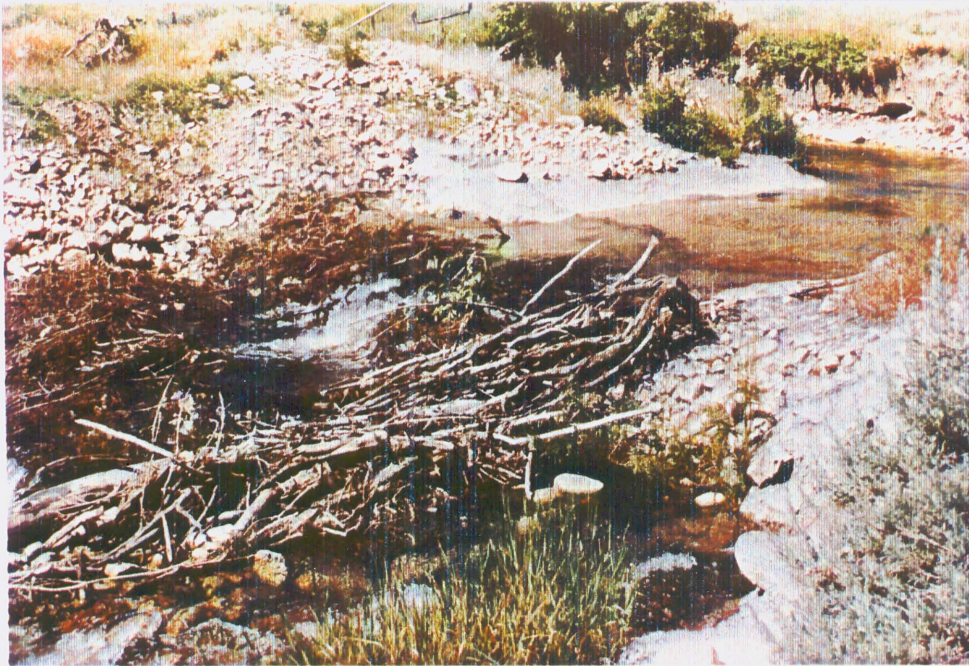
The Cook Ditch diverts water from North Fork of Crazy Woman Creek then brings it a short distance where it is co-mingled with Little North Fork of Crazy Woman Creek and rediverted. (See Figure 2.) The headgate and ditch bringing water from North Fork are in fair condition. The headgate at the Cook Ditch diversion from Little North Fork is also in fair condition. The main concern is that a serious flood event could cause extensive damage or complete failure. It was reported that the dike containing the headgates is frequently overtopped and some bank sloughing has occurred immediately downstream from the spillway (see photograph C-10 of Appendix C).

SPILLWAY CHANNEL AT NO. 9 HEADGATE
LITTLE NORTH FORK CRAZY WOMAN CREEK
PROJECT NO. 8

During the Phase I rehabilitation plan HKM Associates concluded that the Cook Ditch diversion dam and headgate is functioning satisfactorily. However, a new structure is recommended which would be capable of handling a 50 year frequency storm event. The preliminary cost for replacement of the existing structure was estimated at \$31,000. Sheetpiling cost was not verified in the preliminary cost estimate. The cost is increased some in the Phase II, Conceptual Design.

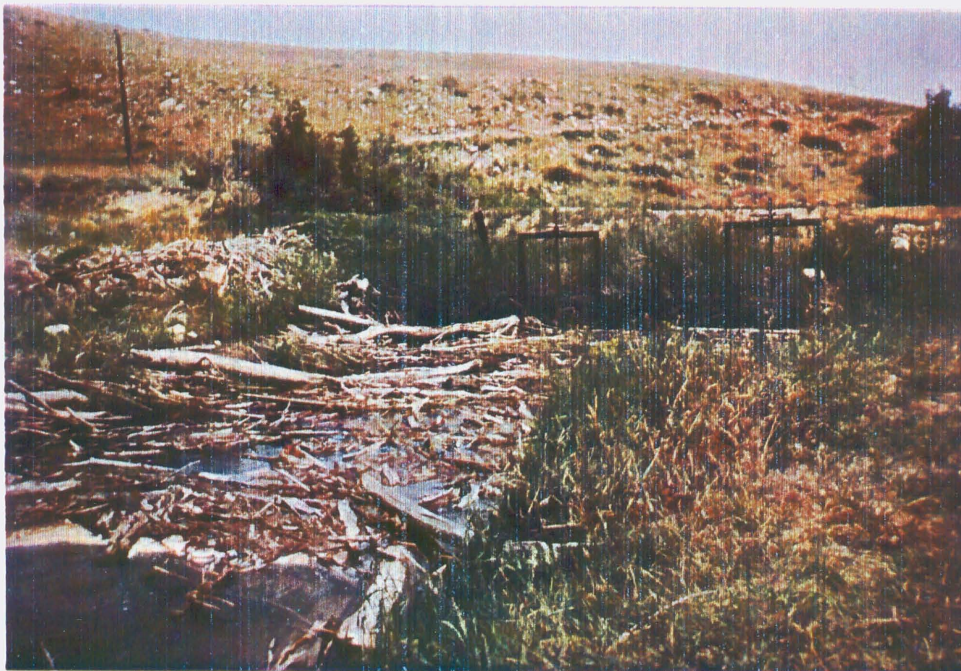
The structure appears to have underwent considerable repair and stabilization. However, it works quite well and appears to be stable at least for normal conditions. A 4-foot Parshall flume located 530 feet downstream in the Cook Ditch provides measurements of the diversion.

HEADGATES ON NO. 9 DITCH
LITTLE NORTH FORK CRAZY WOMAN DITCH
PROJECT NO. 8
