FINAL REPORT
POPO AGIE RIVER
WATERSHED STUDY, LEVEL I

Anderson Consulting Engineers, Inc.
772 Whalers Way, Suite 200
Fort Collins, CO 80525
(ACE Project No. WYWDC17)

July 9, 2003

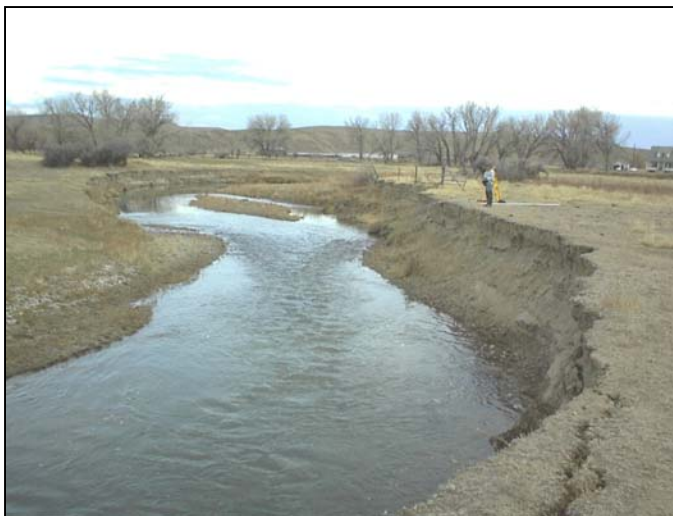
Figure 1.6 Stream Bank Erosion on Little Popo Agie River.

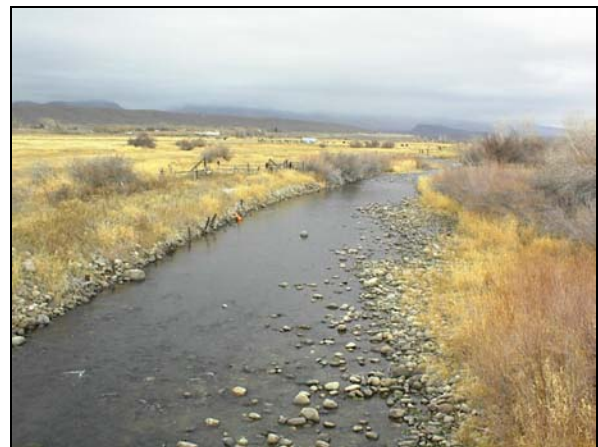
The North Popo Agie River can be generally characterized as geomorphically stable, and flows through a significant riparian corridor. Locally, however, the channel appears aggradational, and riparian grazing and clearing is evident throughout the system. Riparian degradation due to active grazing, and cropland encroachment is evident from the Surrell Creek confluence downstream to its confluence with the North Popo Agie River (Figure 4.14).

Figure 4.14 Riparian Degradation Due to Grazing (North Popo Agie River Upstream of Hwy 287).

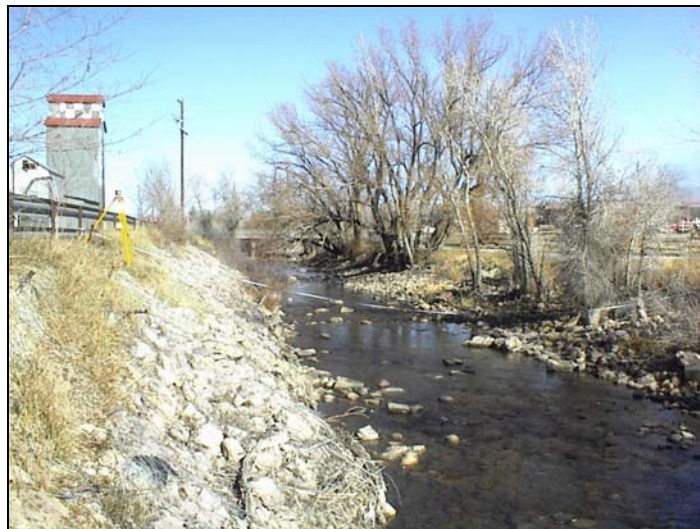
Where the Middle Popo Agie River flows through the City of Lander, it serves as a floodwater conveyance corridor through town. Geomorphic impairment within the downtown reach is a consequence of the flood control efforts. The straight, deep, and trapezoidal condition of the channel indicates that it has been deepened and straightened to improve conveyance and thereby reduce flooding. This cross section and planform reconfiguration has resulted in floodplain isolation and loss of planform and bedform variability. Bankline erosion control methods such as gabions have been applied to protect existing infrastructure in overbank areas. These projects arrest channel migration and limit floodplain function, and thereby geomorphically impair the channel. The riparian corridor has been degraded due to the channel modifications. The channel condition was rated as “fair” by a Level III assessment in the downtown area (Figure 4.17).

Figure 4.17 Bank Stabilization and Channelization of Middle Popo Agie River (Site MPA-4: Type-B3c Channel).

The channel indicates that it has been deepened and straightened to improve conveyance and thereby reduce flooding. This cross section and planform reconfiguration has resulted in floodplain isolation and loss of planform and bedform variability. Bankline erosion control methods such as gabions have been applied to protect existing infrastructure in overbank areas. These projects arrest channel migration and limit floodplain function, and thereby geomorphically impair the channel. The riparian corridor has been degraded due to the channel modifications. The channel condition was rated as “fair” by a Level III assessment in the downtown area (Figure 4.17).

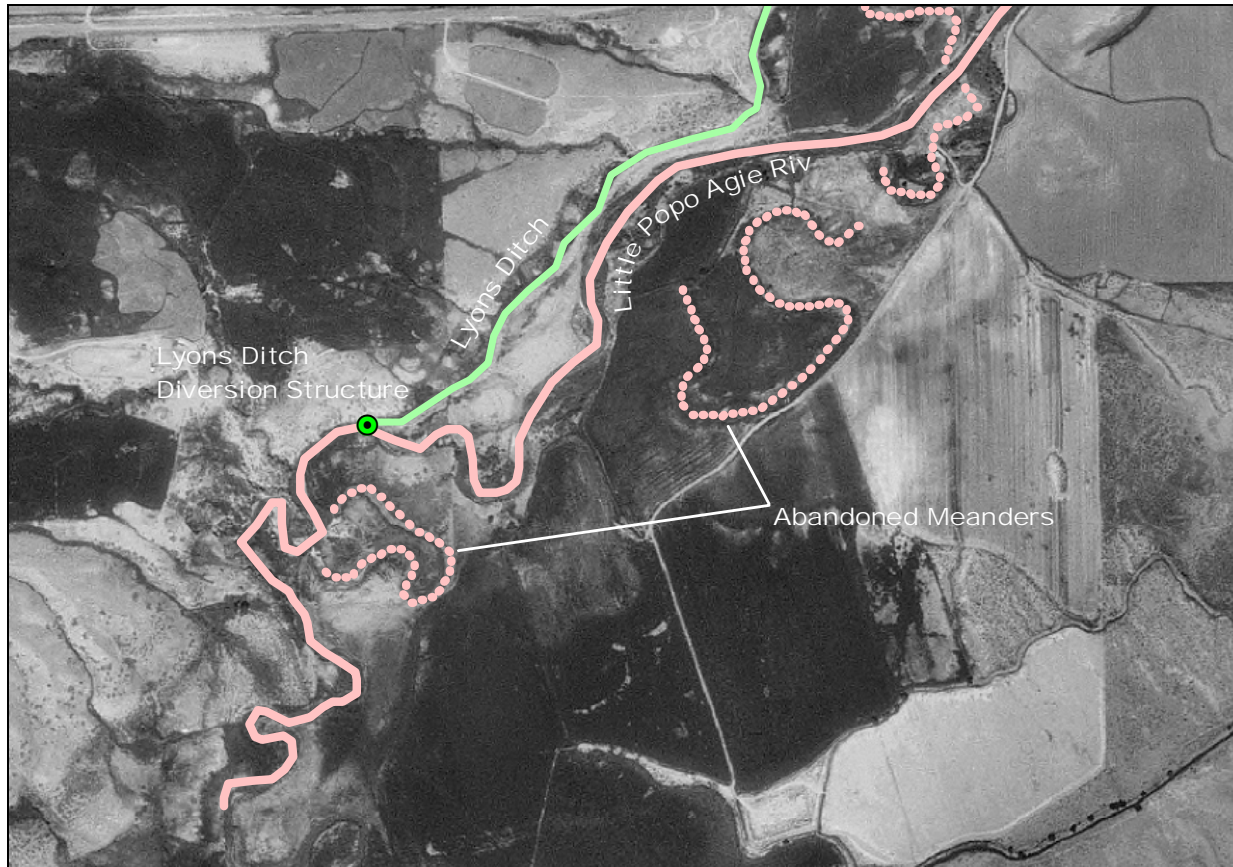
shortened, thereby increasing the channel slope. Consequently, erosion of the channel bed (incision) has been exacerbated (Figure 4.21). The downcutting in the valley is due in part to this channelization, although without a more comprehensive assessment, it is impossible to identify all factors impacting the geomorphic stability, or to develop a more comprehensive assessment of geomorphic evolution of the Little Popo Agie River.

Figure 4.21 Channelization of Lower Little Popo Agie River.

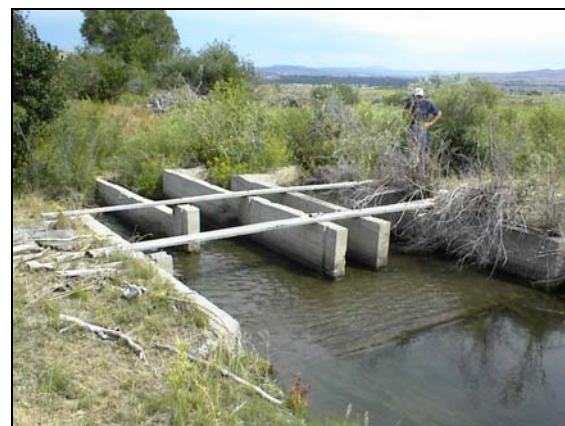
- Within the reach inventoried, the structures are aged but in relatively good condition. These structures consist of several drop structures and turnouts.
- Conveyance appears restricted at the culvert crossing under North Fork Road. The ditch reportedly overtops frequently during storm events. A wasteway from the Mountain Range Ditch, located above the Big Cottonwood Ditch, occasionally spills water to the ditch.
- At mile point 4.2, a splitter box divides flow proportionally into four laterals (Figure 5.4). This structure is in poor condition. There are no measurement devices at this location.

Figure 5.4. Splitter Box on Big Cottonwood Ditch.

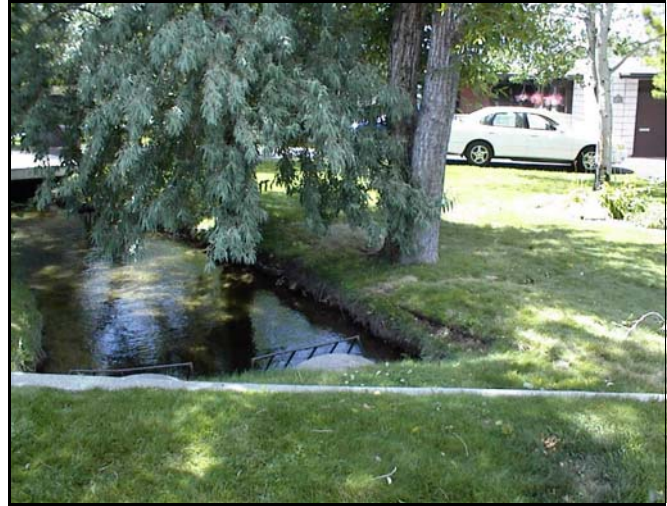
- In its upper reaches, the ditch meanders through several housing subdivisions and the City Golf Course. The encroachment of the subdivisions upon the ditch has created several maintenance problems for the ditch company. Several concrete lining projects have been completed in an effort to mitigate basement flooding and to reduce seepage losses. Culverts under several driveways crossing the ditch appear to restrict ditch conveyance capacity (Figure 5.6). There were also several locations where homeowners have installed pumps on the ditch for lawn irrigation.

**Figure 5.6 Cemetery Ditch in Subdivision
Showing Example of Driveway Culvert
Restricting Conveyance.**

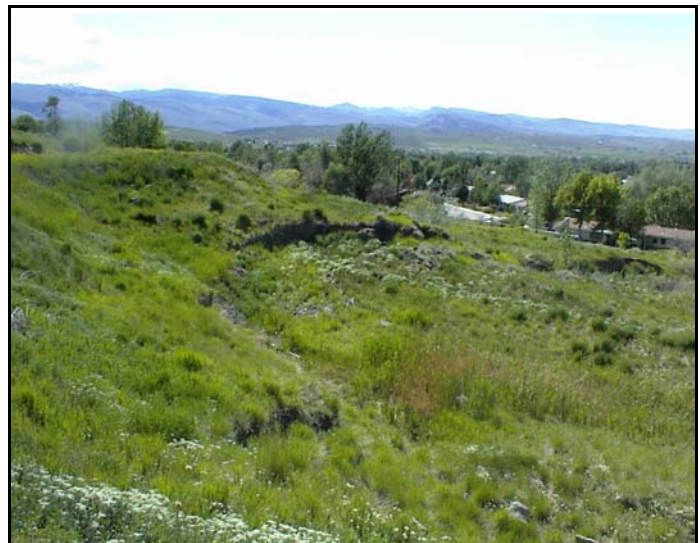
- In the vicinity of Highway 287, the ditch crosses an unstable hillslope. This reach is locally called the “Ford slip” for its proximity to a Ford auto dealership. The site was investigated in 1998 by GEI Consultants, Inc., on behalf of the Wyoming Water Development Commission. The Level II Feasibility study recommended several alternatives to stabilize the failure that has been attributed to seepage from the Dutch Flat/Taylor Ditch. Several efforts to line the ditch are evident; however, these improvements do not appear effective. Seepage and standing water were evident on the hillslope during the field investigation (Figure 5.8).

Figure 5.8 Dutch Flat / Taylor Ditch in Vicinity of Unstable Hillslope.

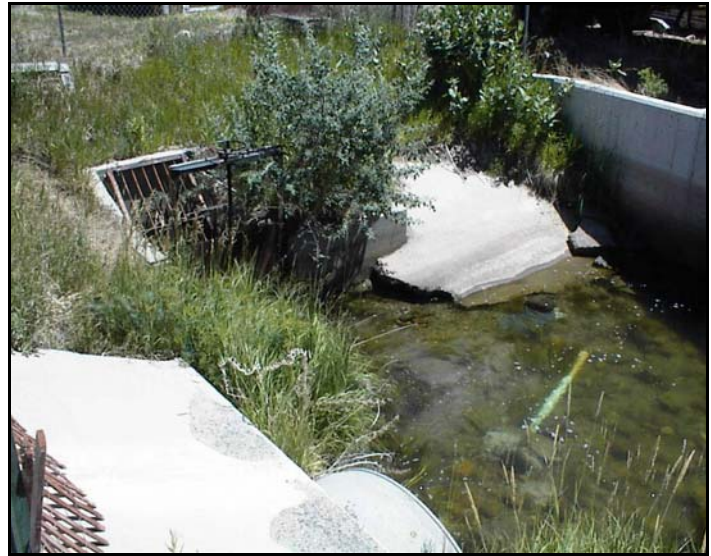
- A 28-inch diameter siphon crosses under the Smith Creek drainage. The siphon has been reported to limit conveyance of the ditch system and represents a continual maintenance problem for the ditch company (Figure 5.9).

Figure 5.9 Taylor / Dutch Flat Ditch Siphon Inlet.

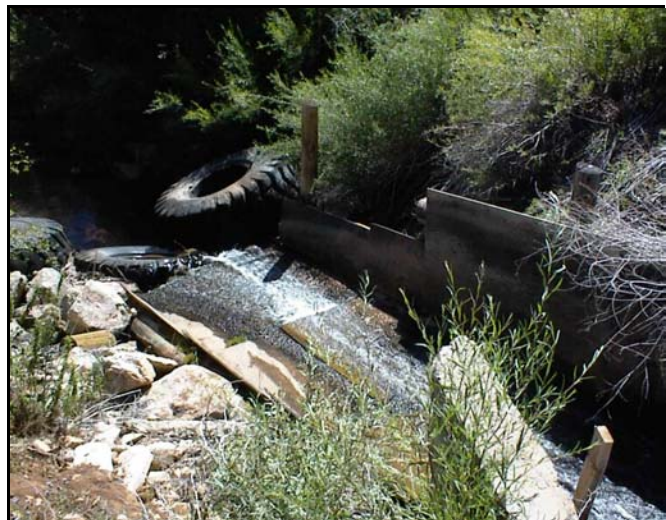
Figure 5. 14 Turnout and Drop Structure in Poor Condition on Enterprise Ditch.

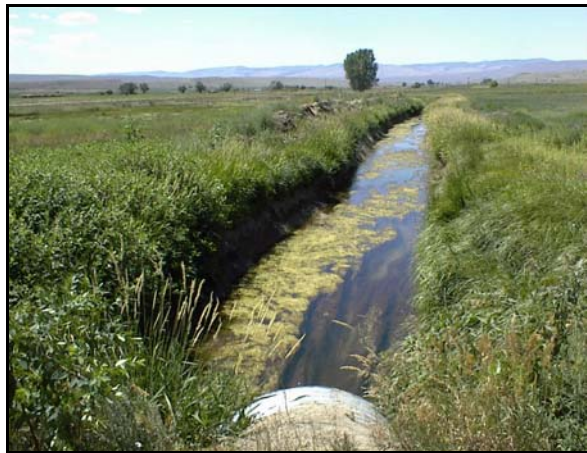
Figure 5.20 Aquatic Vegetation in Lyons Ditch.

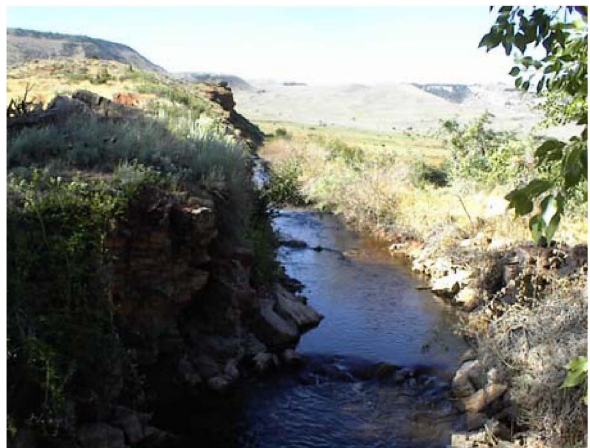
Figure 5.23 Sandstone Bedrock Reach of the Nicol-Table Mountain Ditch with Reduced Conveyance Capacity.

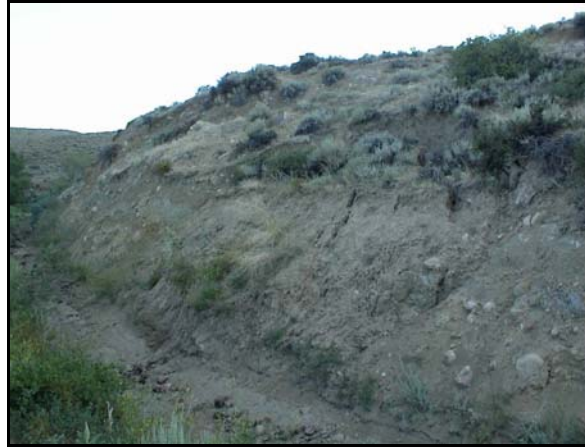
Figure 5-24 Example of Erosive Reach on Nicol-Table Mountain Ditch.

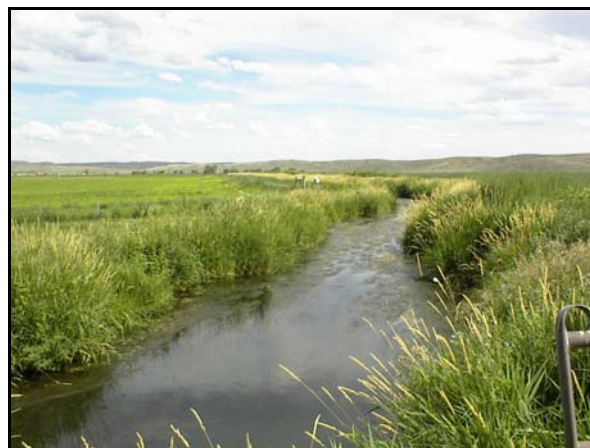
Figure 5.29 Aquatic Vegetation in Snavelly / Grant Young Ditch.

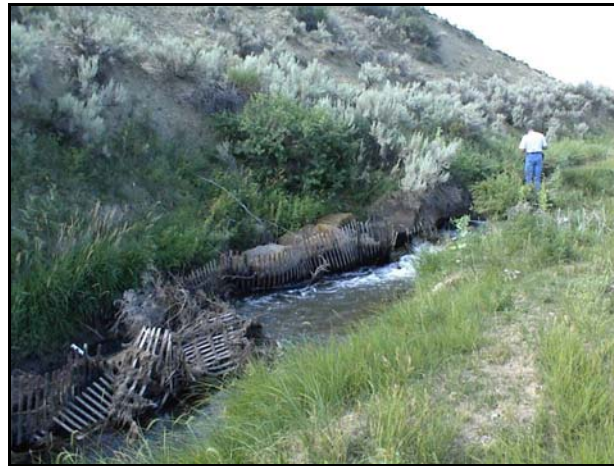
Figure 5.31 Unstable Ditch Conditions on Wise Ditch.

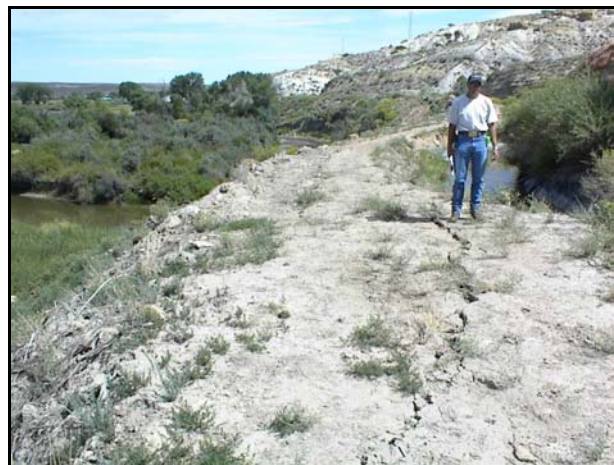
Figure 5.32 Tension Cracks in Wise Ditch Embankment.
