CAID LATERAL 256 CONVEYANCE
LOSS STUDY

WWRC-89-12

Wyoming Water Research Center
University of Wyoming
Laramie, Wyoming

Final Report

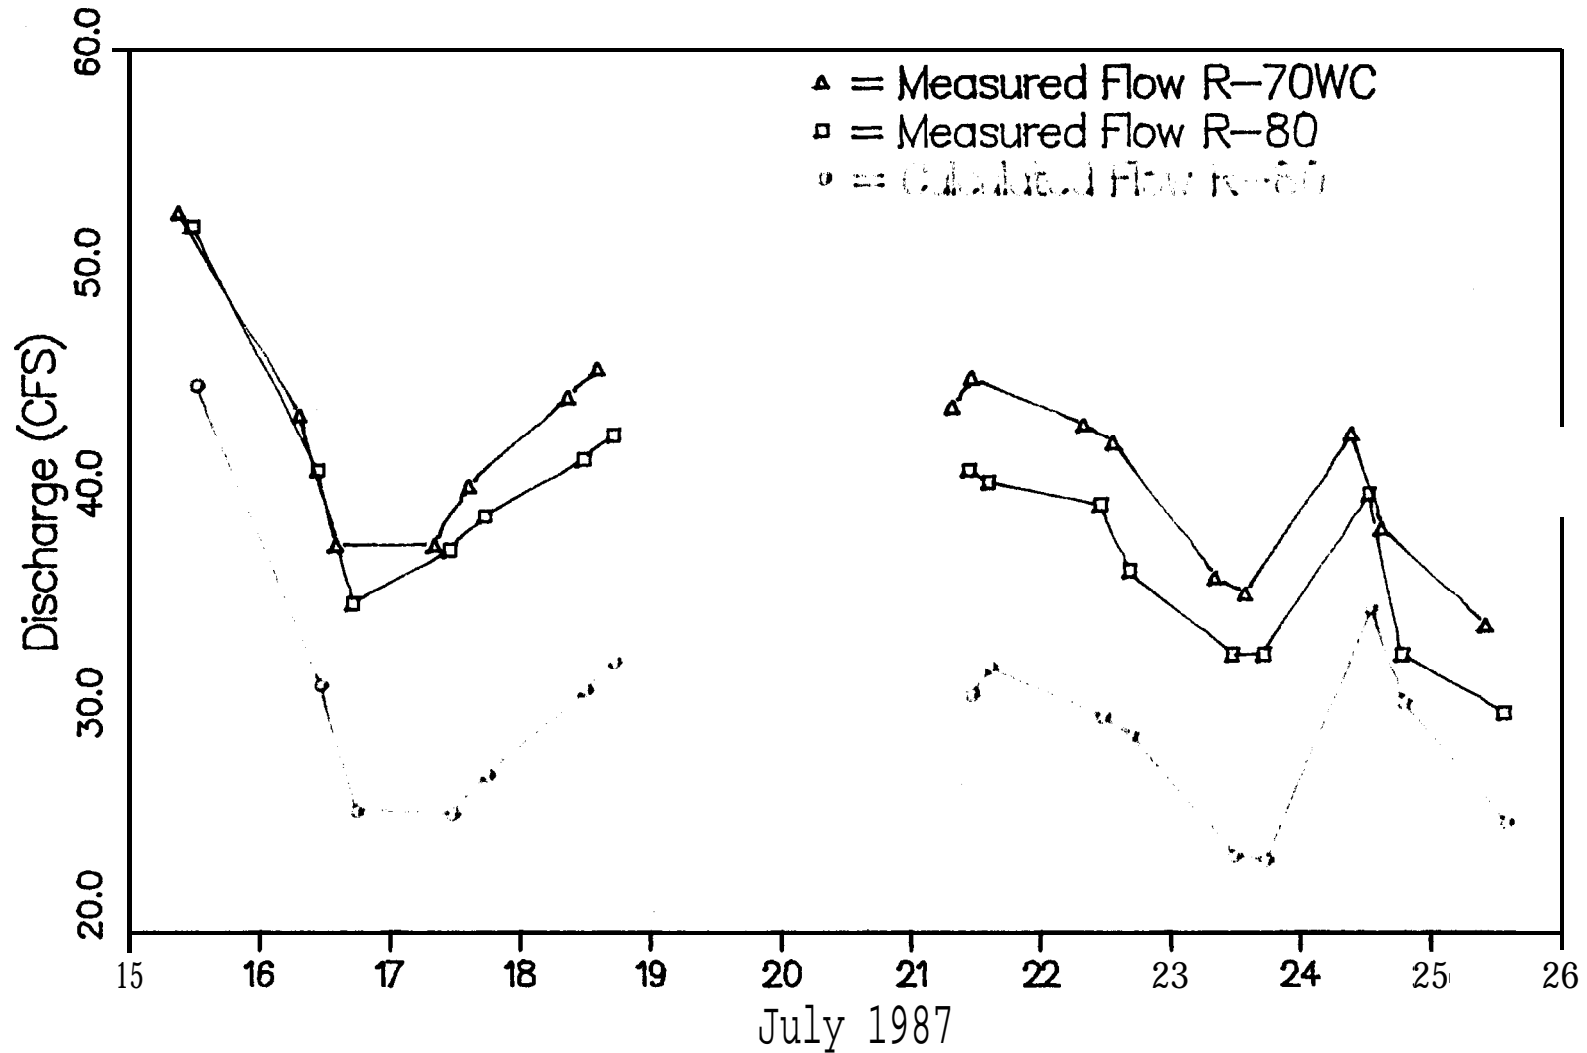
R70WC to the measured discharges from R80WC for the two test periods is shown in Figure 2. Also plotted in Figure 2 is the calculated discharge, which is obtained by subtracting the withdrawals at sublaterals 256-50L, 256-52R and 256-55R from the discharge at the top monitoring point R70WC. This calculated discharge is the amount of water that should arrive at R80 after all withdrawals are taken out of the lateral if no gains or losses occur in the reach. Table III is a listing of calculated discharge figures at R80 compared with the actual measured discharge figures at R80 for the two test periods. Also listed in Table III is the corresponding loss or gain at R80 after subtracting the calculated discharge from the actual measured discharge for the same time period.

In all cases throughout the two test periods a gain in discharge occurred at the lower end of the lateral 256 study section. The average gain for the measured points during the two test periods combined was 8.6 CFS.

Figure 2. Plot comparing measured flows at the R70WC (upper) and R80 (lower) monitoring sites along with the calculated flow after all withdrawals are subtracted from the R70WC (upper) site.

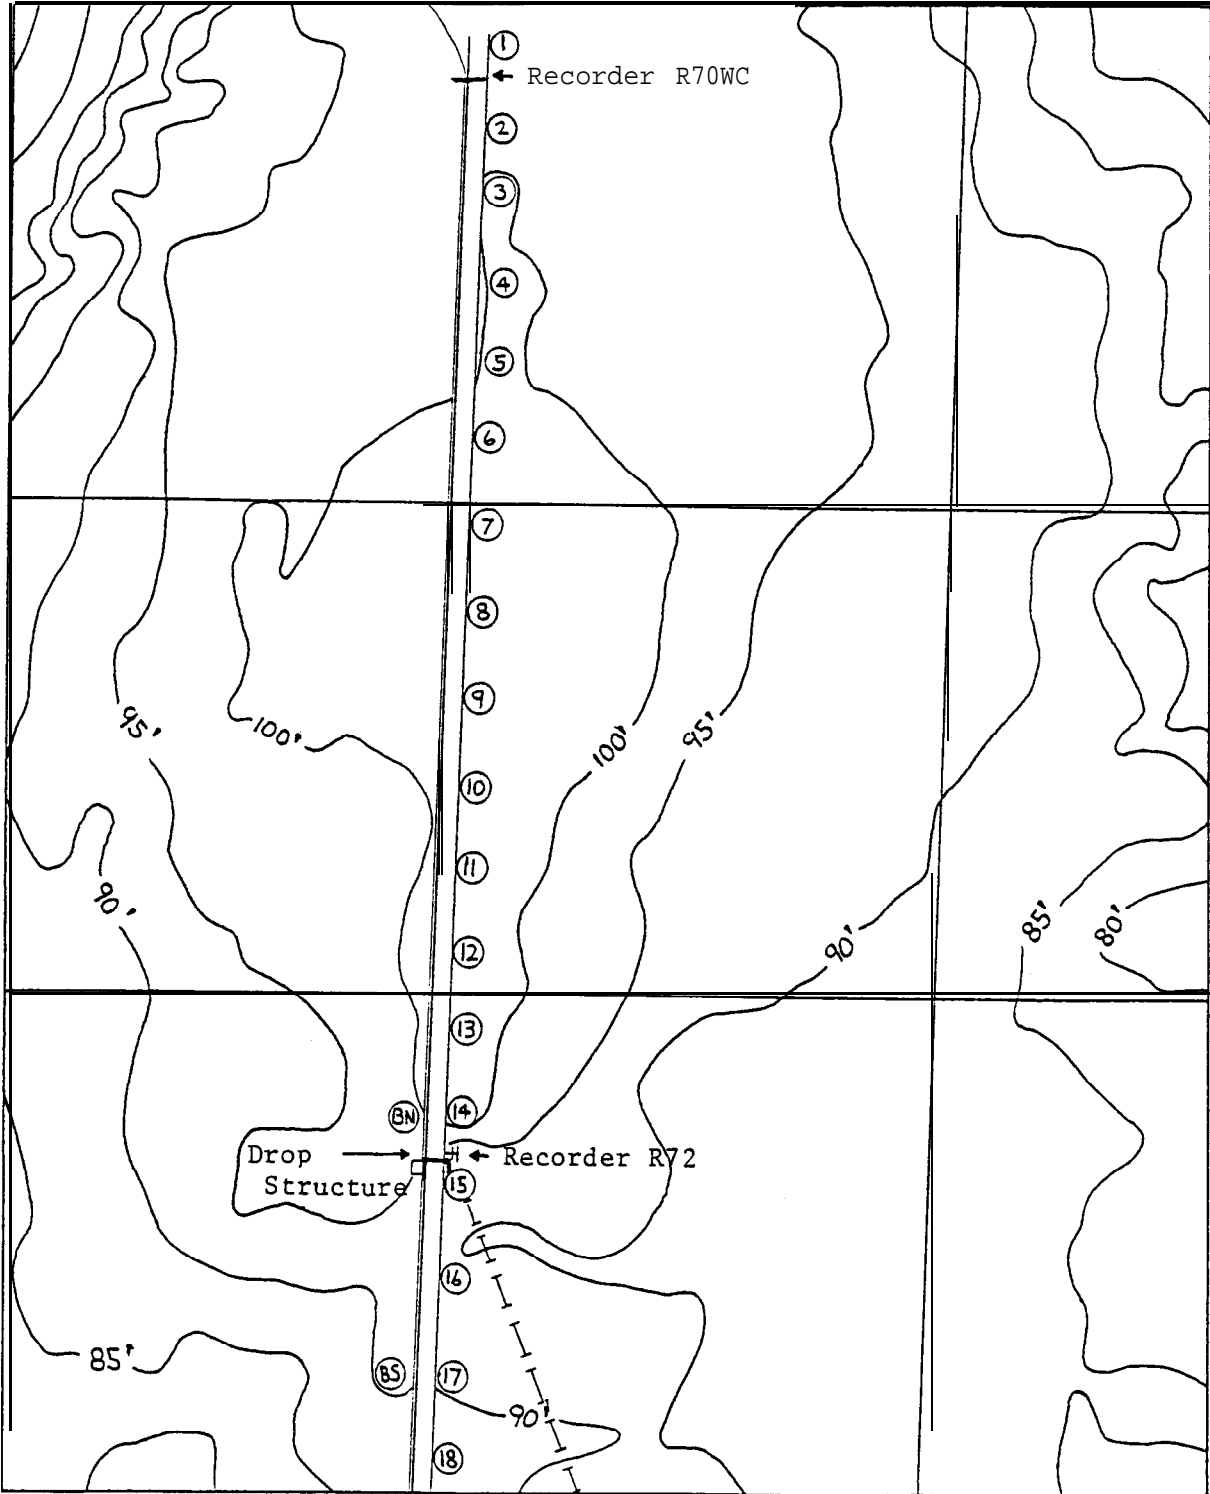
GROUNDWATER MONITORING WELLS

Groundwater wells were installed parallel to lateral 256 on the east side of the canal by CAID in 1986 to monitor seepage losses from the canal to the adjacent areas (Figure 3). Eighteen wells spaced approximately 200 feet apart and 150 feet from the center of the lateral were established along the east side of the main lateral from R70WC to approximately 800 feet below the drop structure at R72. Two wells were established on the west side of the canal approximately 100 feet from the center of the lateral, the first approximately 150 feet above the drop structure at R72 and the second approximately 550 feet below the drop structure. Neither of these wells had continuous recorders installed but hand measurements were taken by CAID personnel throughout the irrigation season. Records of groundwater elevations measured in the wells versus surface water elevations in the main lateral were provided to the Water Center after the irrigation season was completed. Because the Water Center did not work directly with these wells, only an overview will be provided here to explain the relationship of the wells to lateral 256.

Figure 3. Groundwater monitoring well locations on lower lateral 256. (Contours are area elevation differences.)

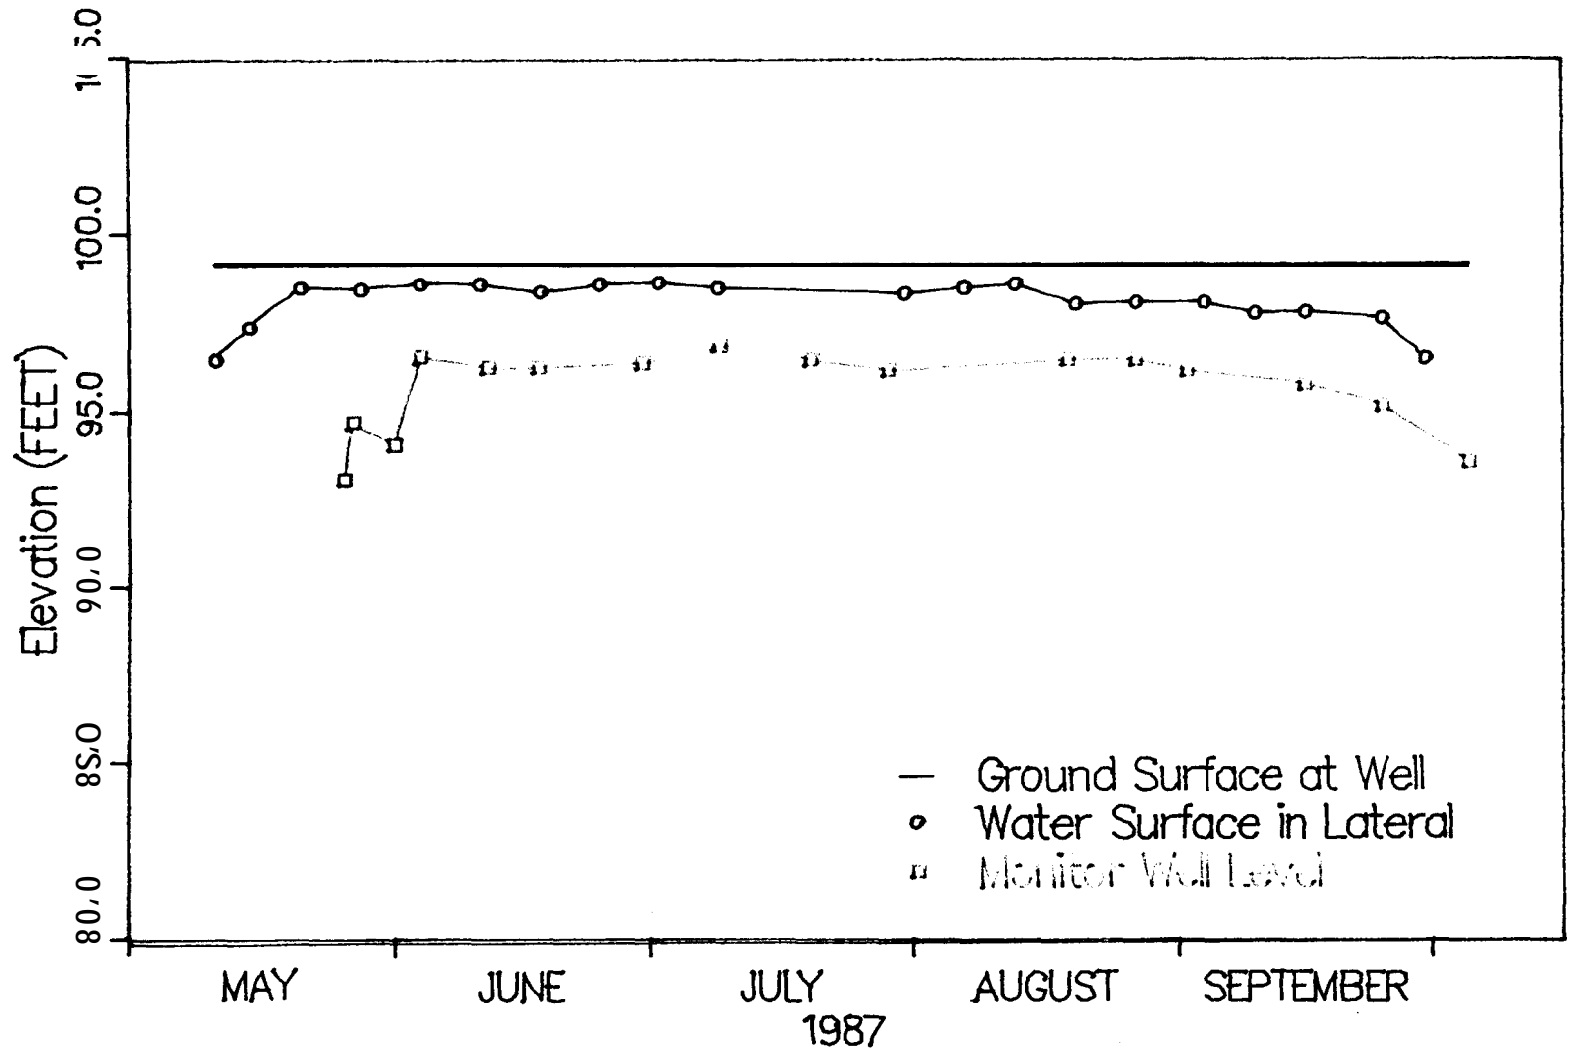
#1 WELL

When comparing the water surface elevation in the wells located above the drop structure at R72 with the water surface elevation of the canal, a general trend seems to exist as indicated below. Upon release of water in the canal on May 10 and its continual rise to a full condition, the wells show a corresponding rise. As the canal water surface rises, water levels in the wells also rise and then reach a relatively steady level after the canal reaches its full state. At this steady level, the water surface elevations in the wells are lower than the water surface elevation in the canal. The canal water seems to

Figure 4. Monitoring well #1 compared to the water surface in lateral 256 at the upper end of the study section.

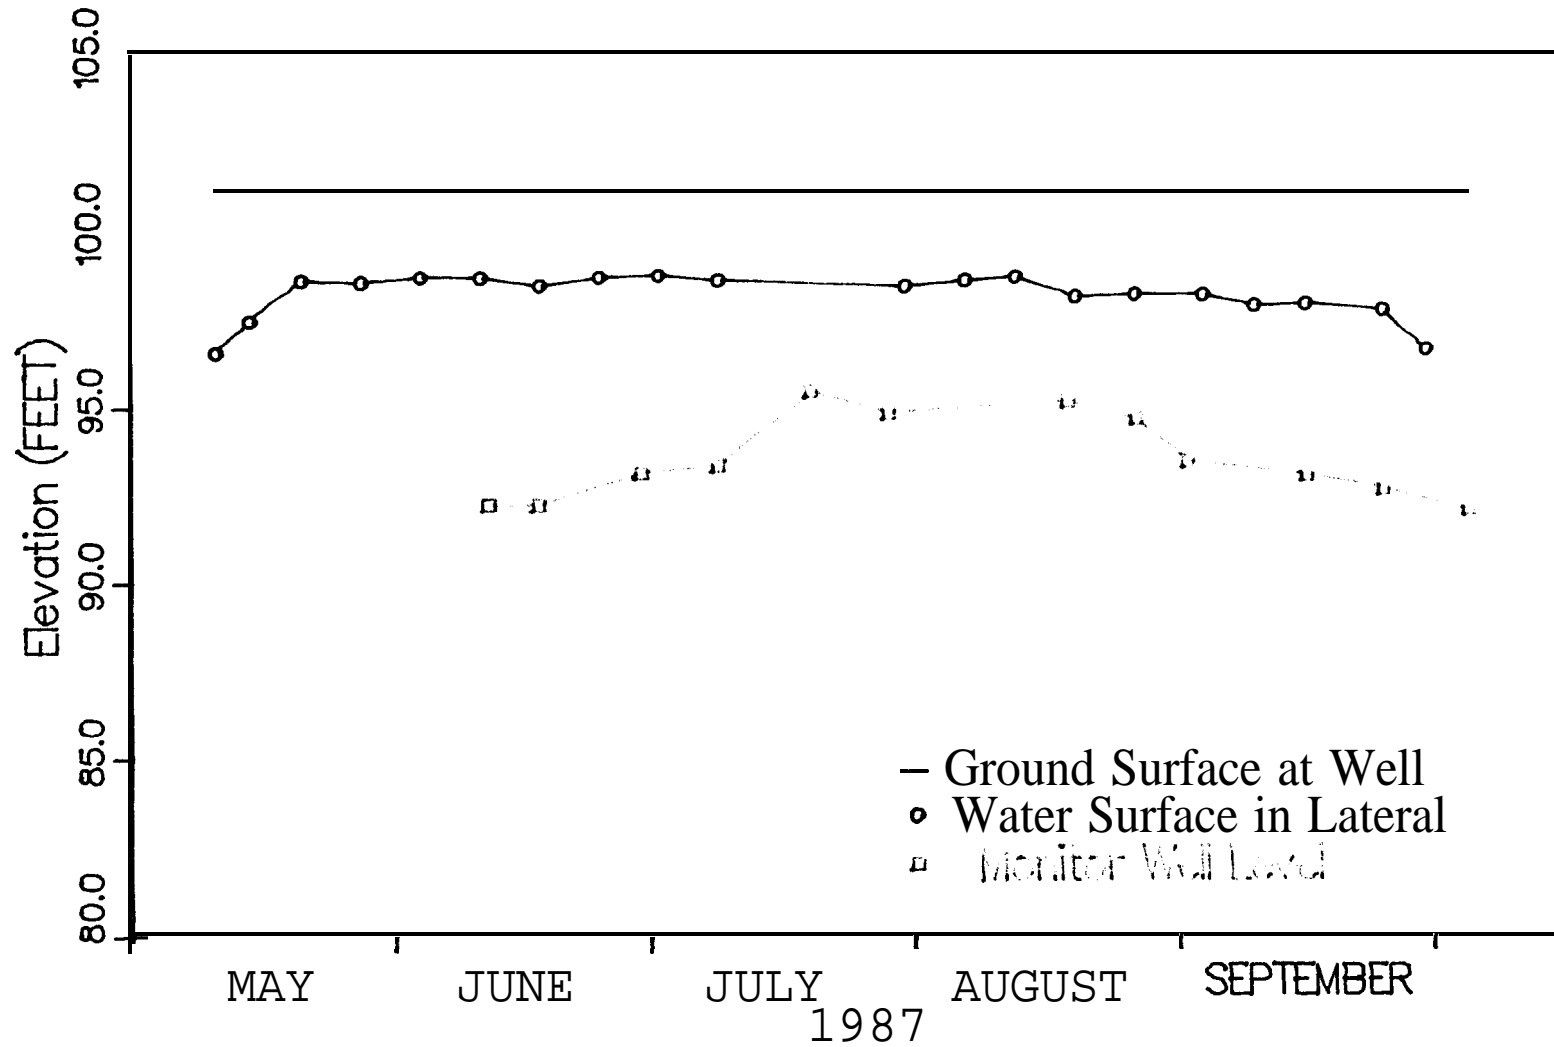
#13 WELL

Figure 5. Monitoring well #13 compared to the water surface in lateral 256 directly above the R72 recording site.

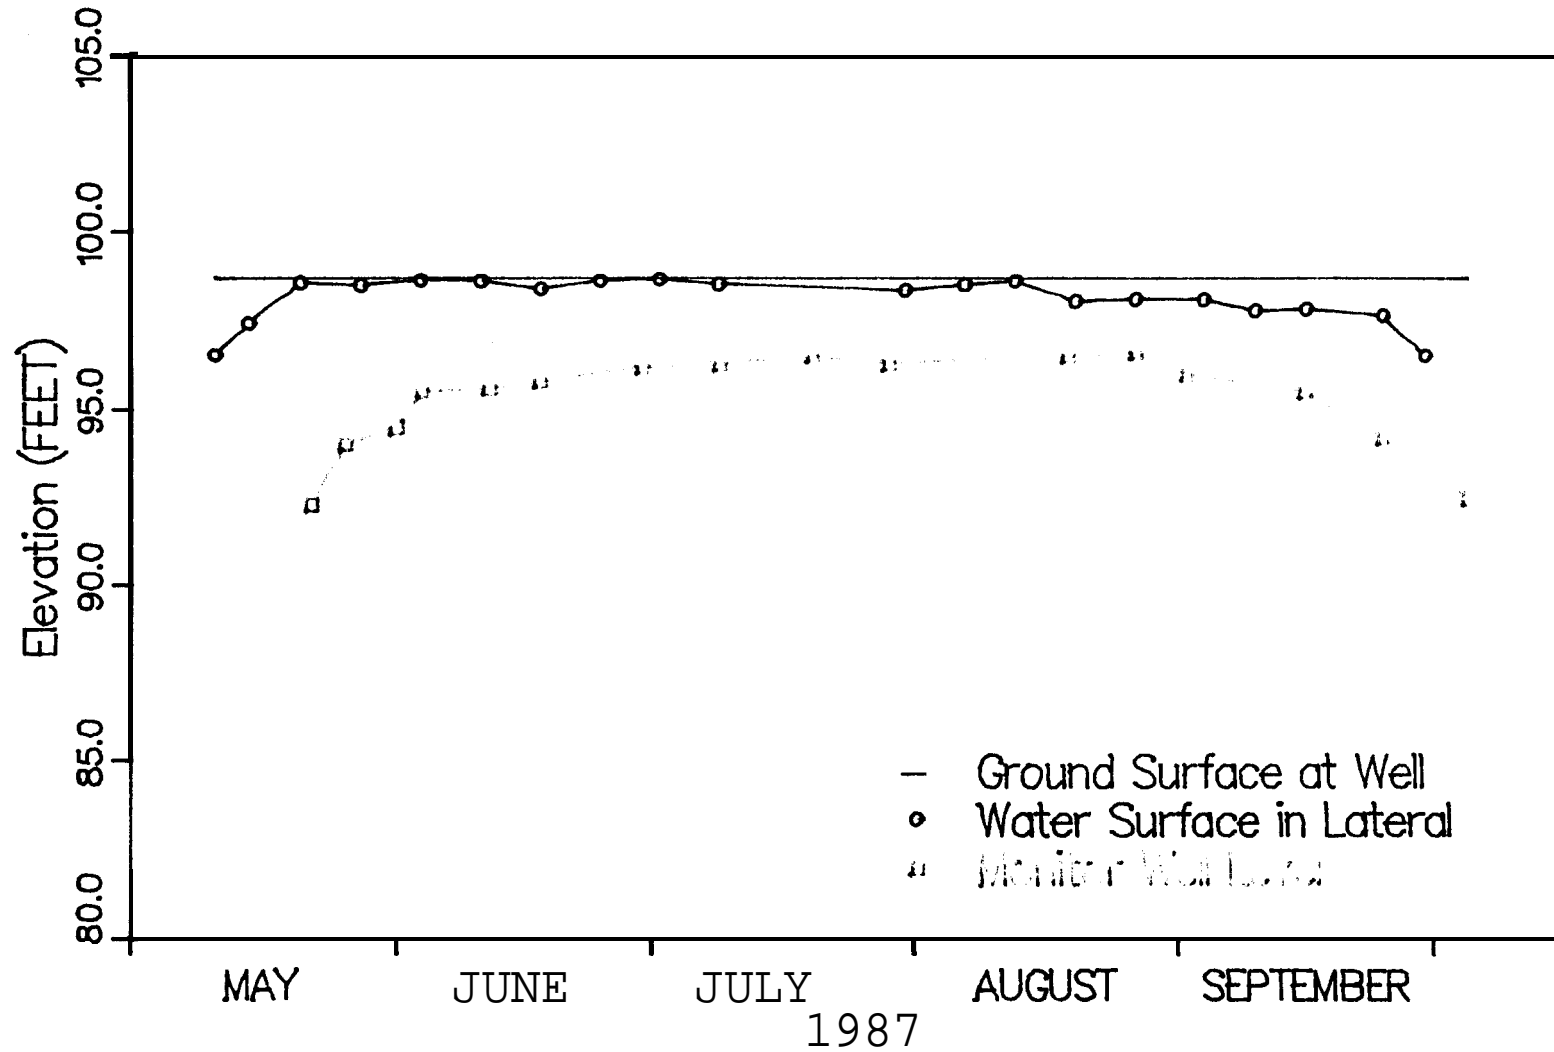
BN WELL

Figure 6. Monitoring well BN on the west side of the lateral compared to the water surface in lateral 256 above the drop structure near the R72 recording site.

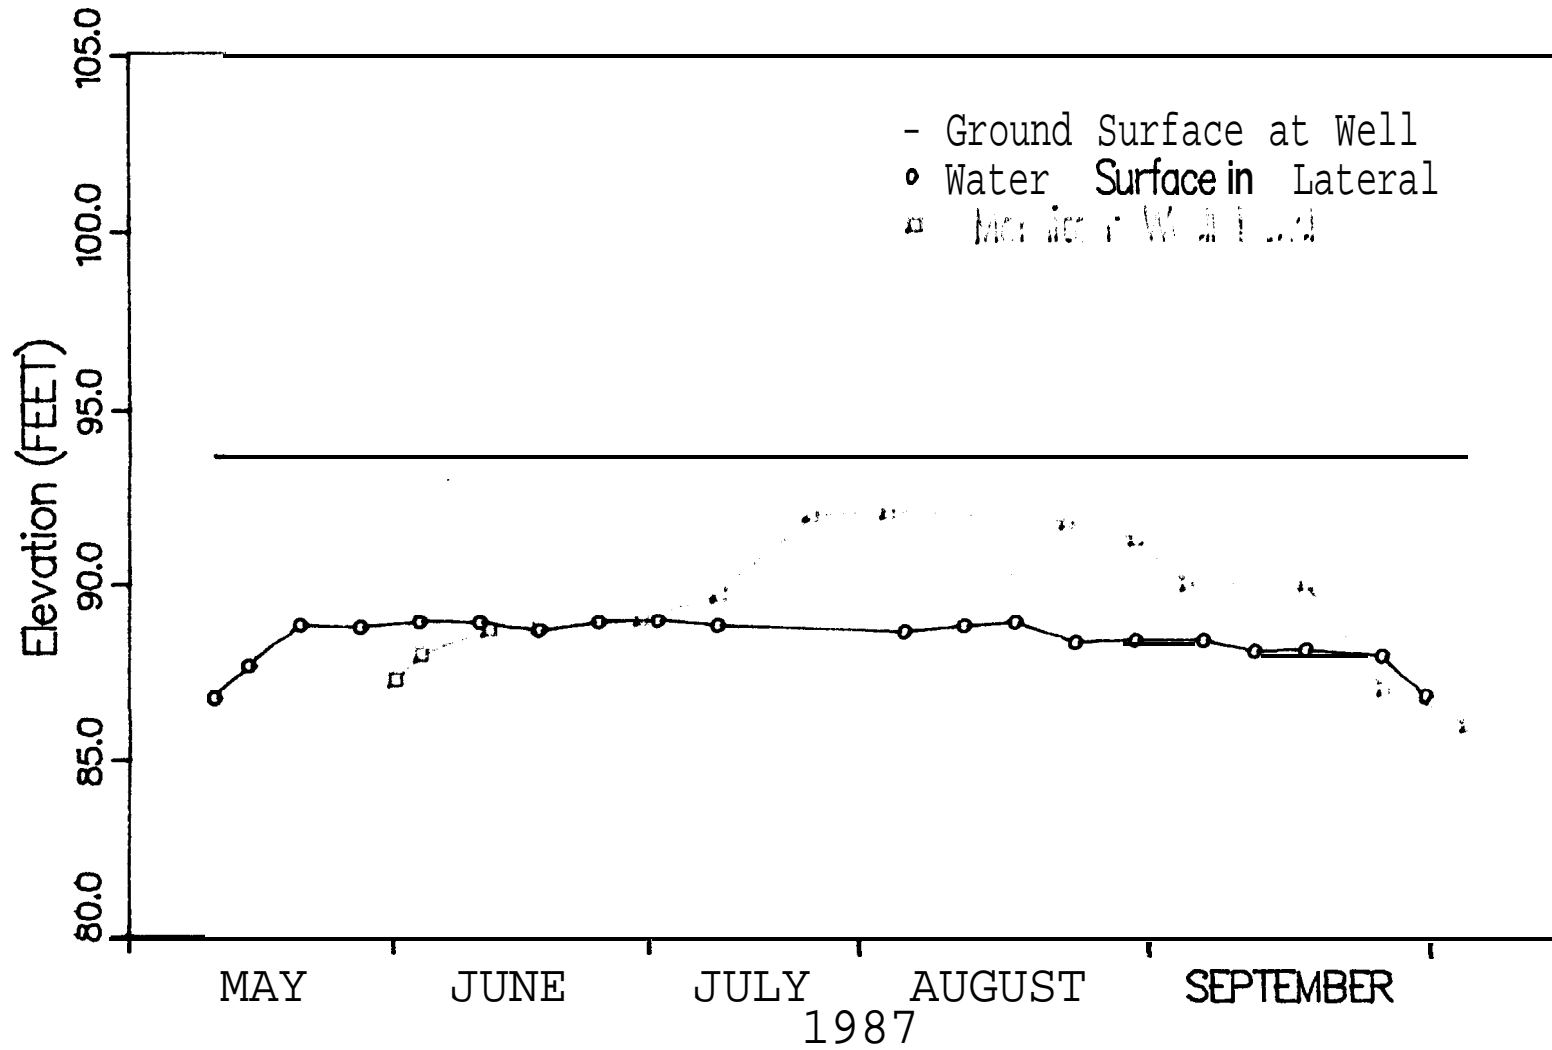
#15 WELL

Observation wells 15, 16, 17, 18 and BS located below the turnout for sub-lateral 50L show a different relationship with respect to the lateral surface water elevations above the drop structure at R72. Figure 7 shows observation well #15 water elevation compared to the surface water elevation in the lateral below the drop structure. The well water elevation after release of water into the lateral rises above the elevation of the water surface in the lateral and remains there through July, August and part of September until water in the lateral was shut off. This same general trend is also seen in well 16 (Figure 8). In wells 17, B.S., and 18 (Figures 9-11) the water levels are

Figure 7. Monitoring well #15 directly below recorder site R72 compared to the water surface in lateral 256 below the drop structure.

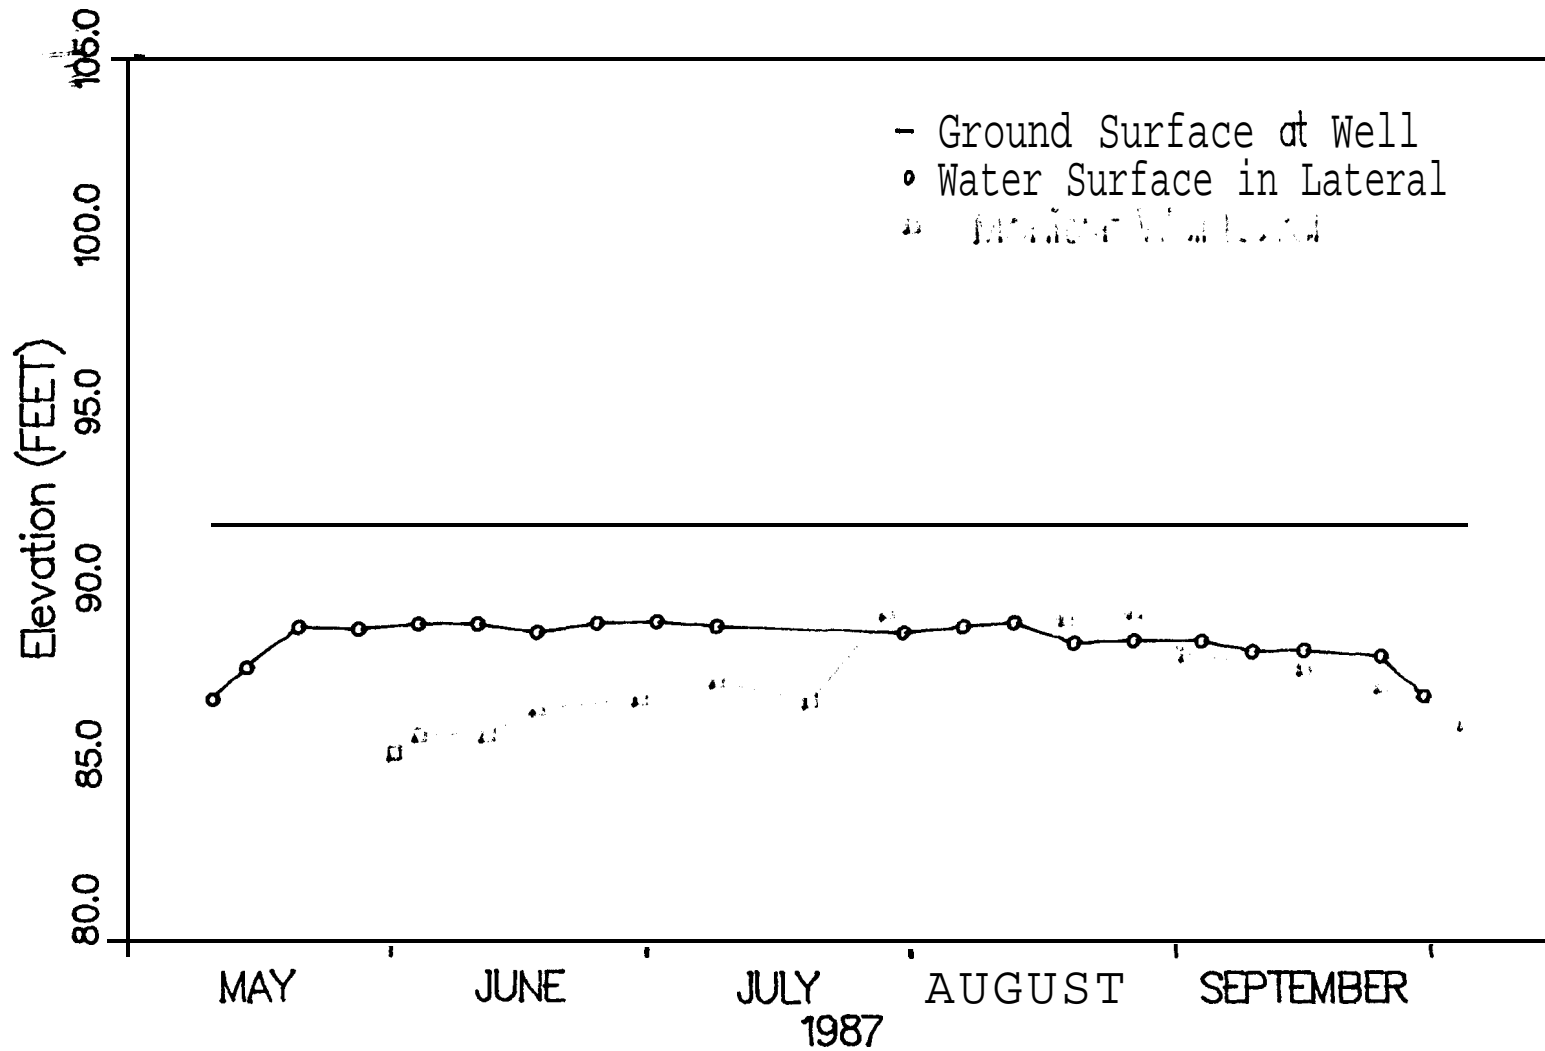
#16 WELL

Figure 8. Monitoring well #16 compared to the water surface in lateral 256 below the drop structure.

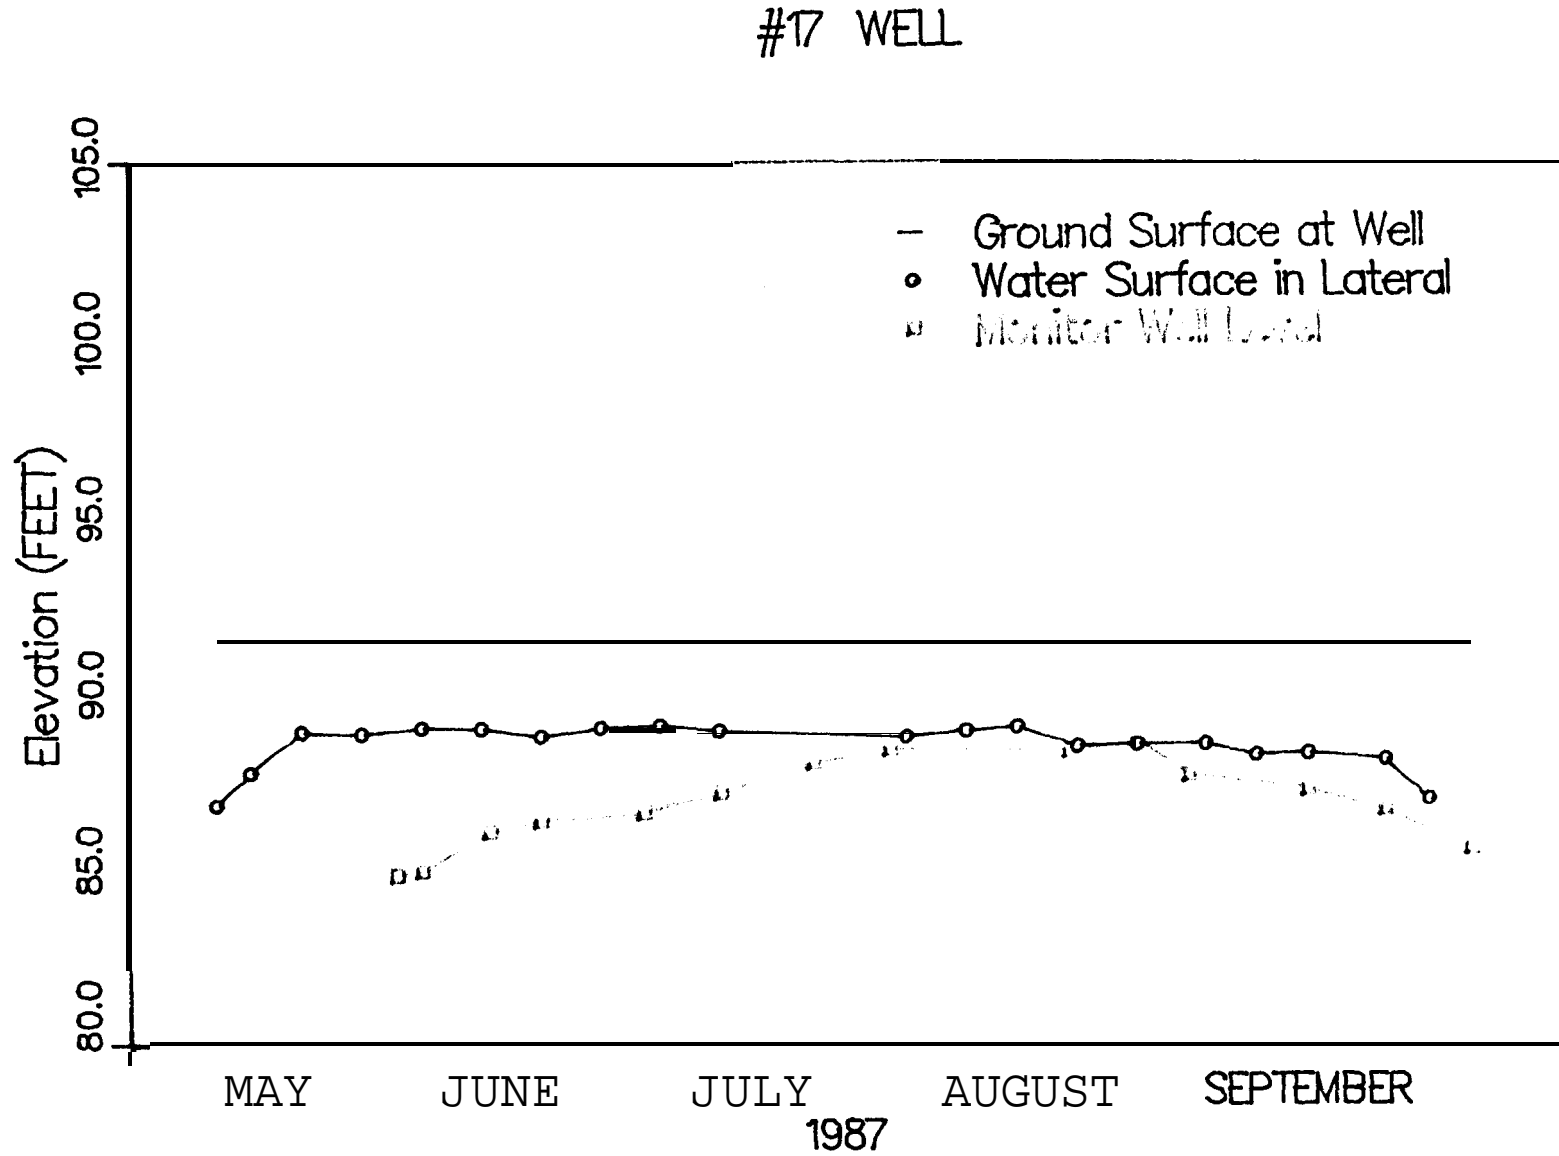
Figure 9. Monitoring well #17 compared to the water surface in lateral 256 below the drop structure.

below, but remain close to, the water surface elevation in the lateral except for one measurement in well 17 on August 27 which is above the elevation in the lateral. With the area below the drop structure at R72 appearing to have the largest amount of gain in the study section of lateral 256, indicated from tests during the study period, it would appear that the difference in head between the water surface above the drop and that below the drop is a major cause of inflow (gain) back to the lateral. A profile comparing the well water elevations with the surface water elevations in the lateral, above and below the drop structure, is shown in Figure 12. The head differential resulting from the drop structure, coupled with the high water table from irrigation below and adjacent to the drop structure together, take advantage of the seepage face available along the banks of the lateral below R72 caused by the drop structure. Subsurface return flow appears to occur in this area.

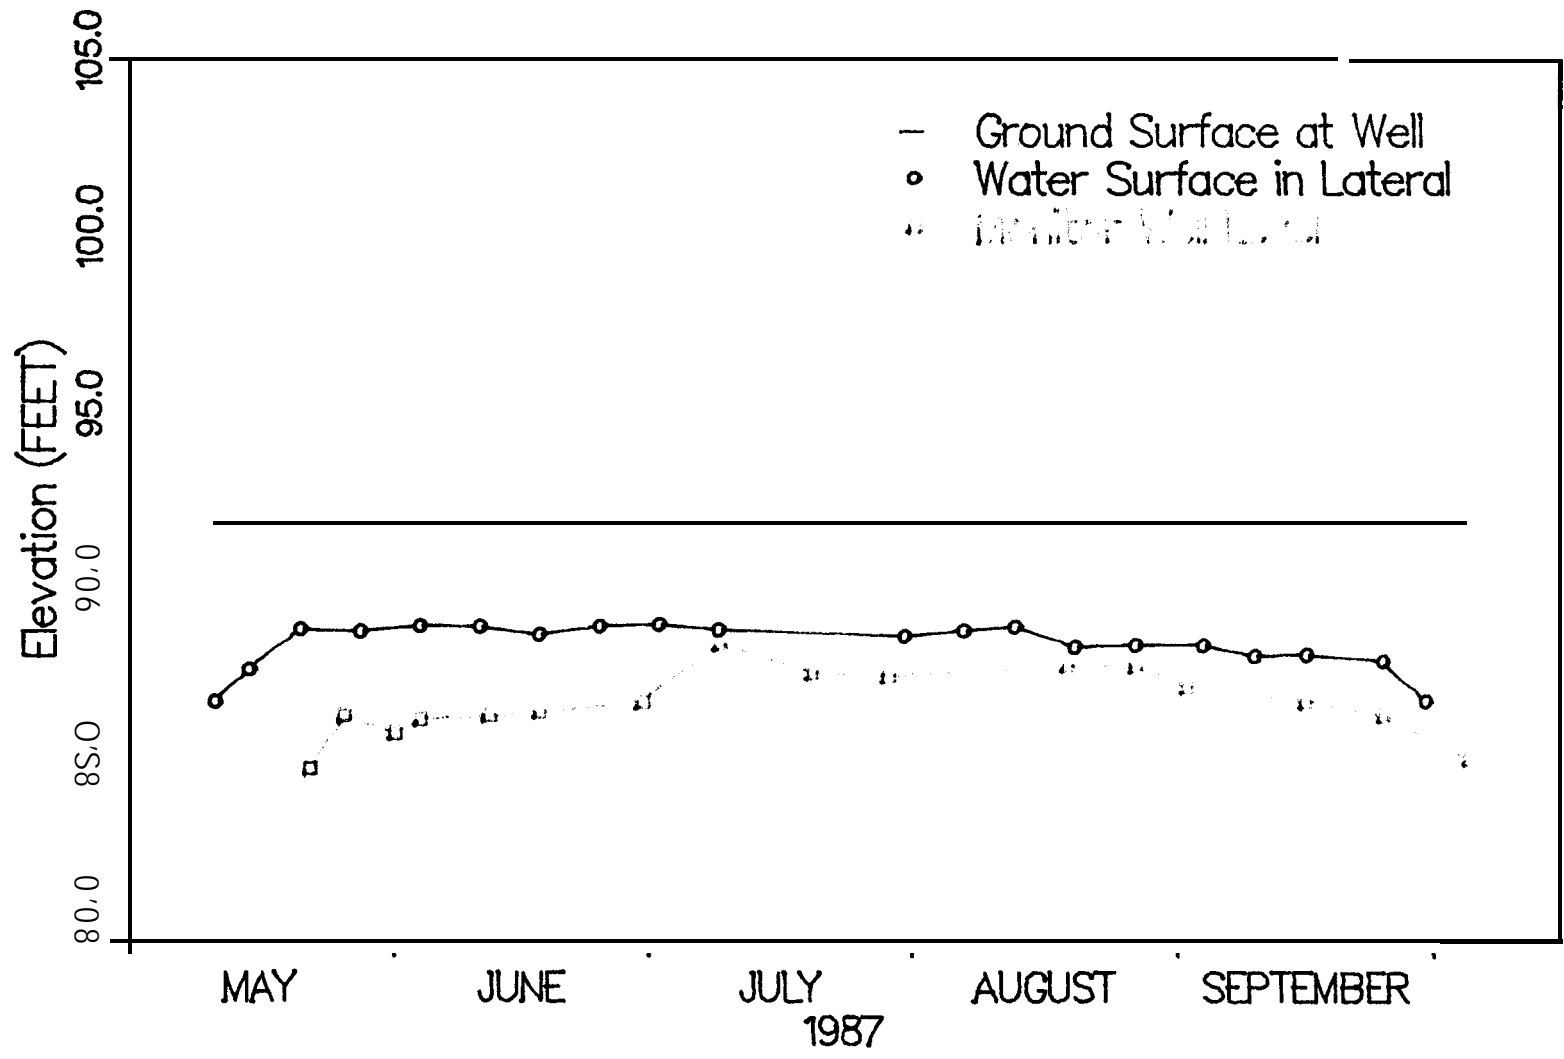
BS WELL

Figure 10. Monitoring well BS compared to the water surface in lateral 256 below the drop structure on the west side of the lateral.

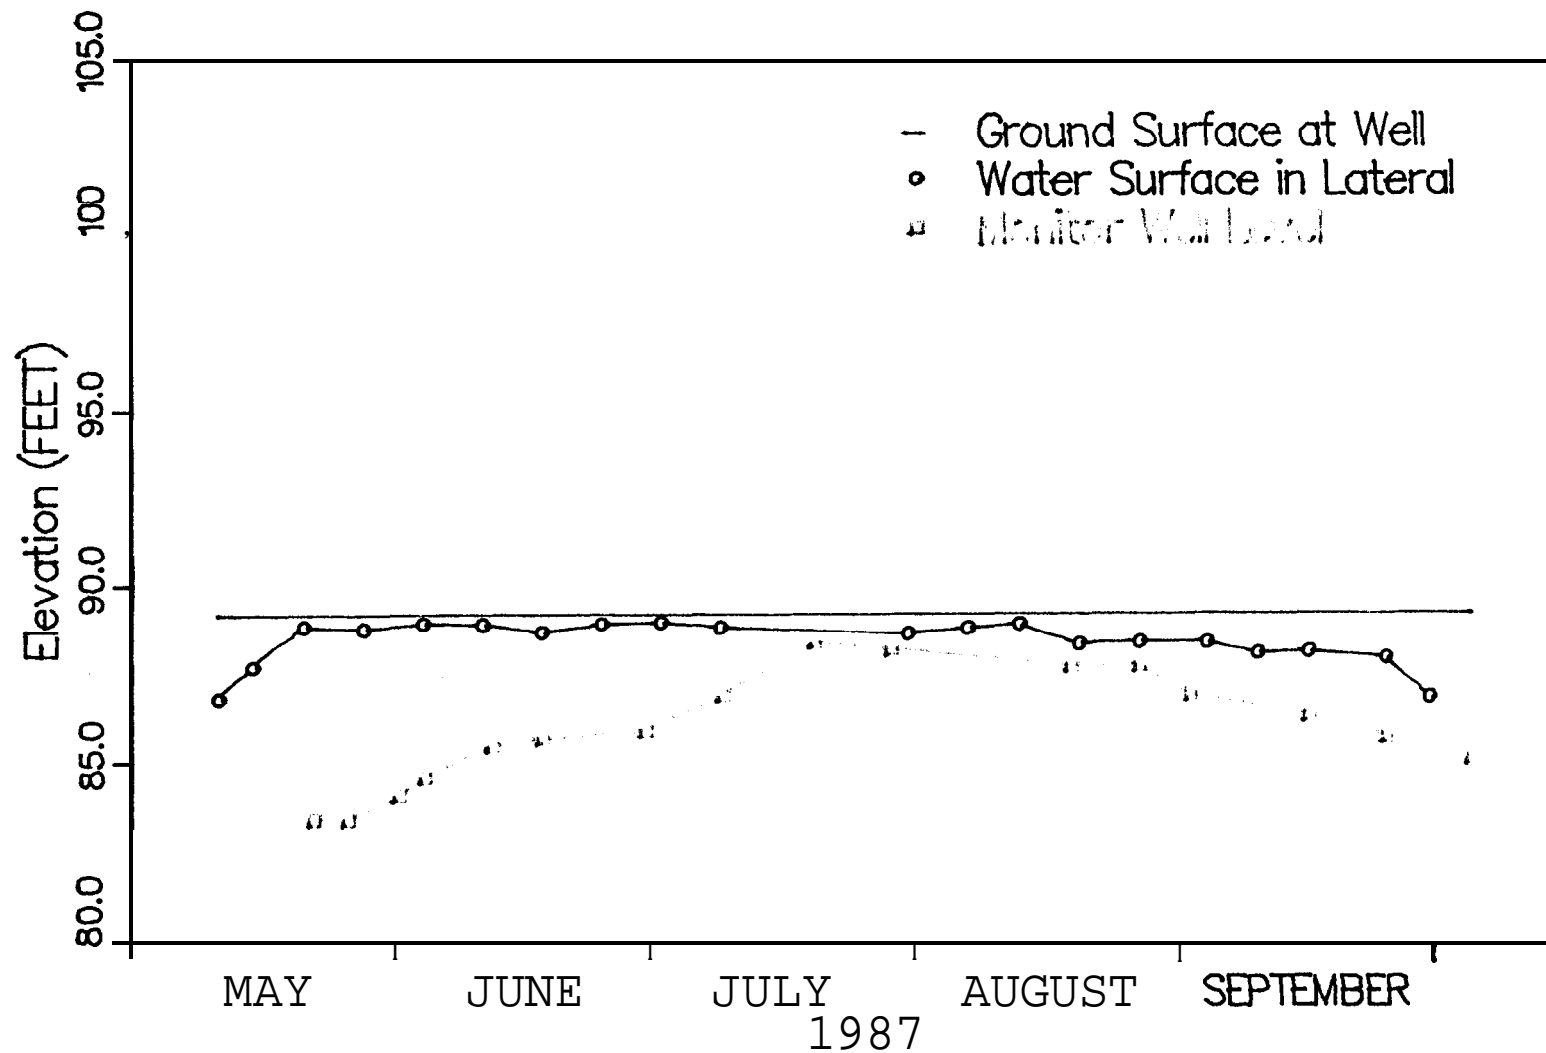
#18 WELL

Figure 11. Monitoring well #18 compared to the water surface in lateral 256 below the drop structure.

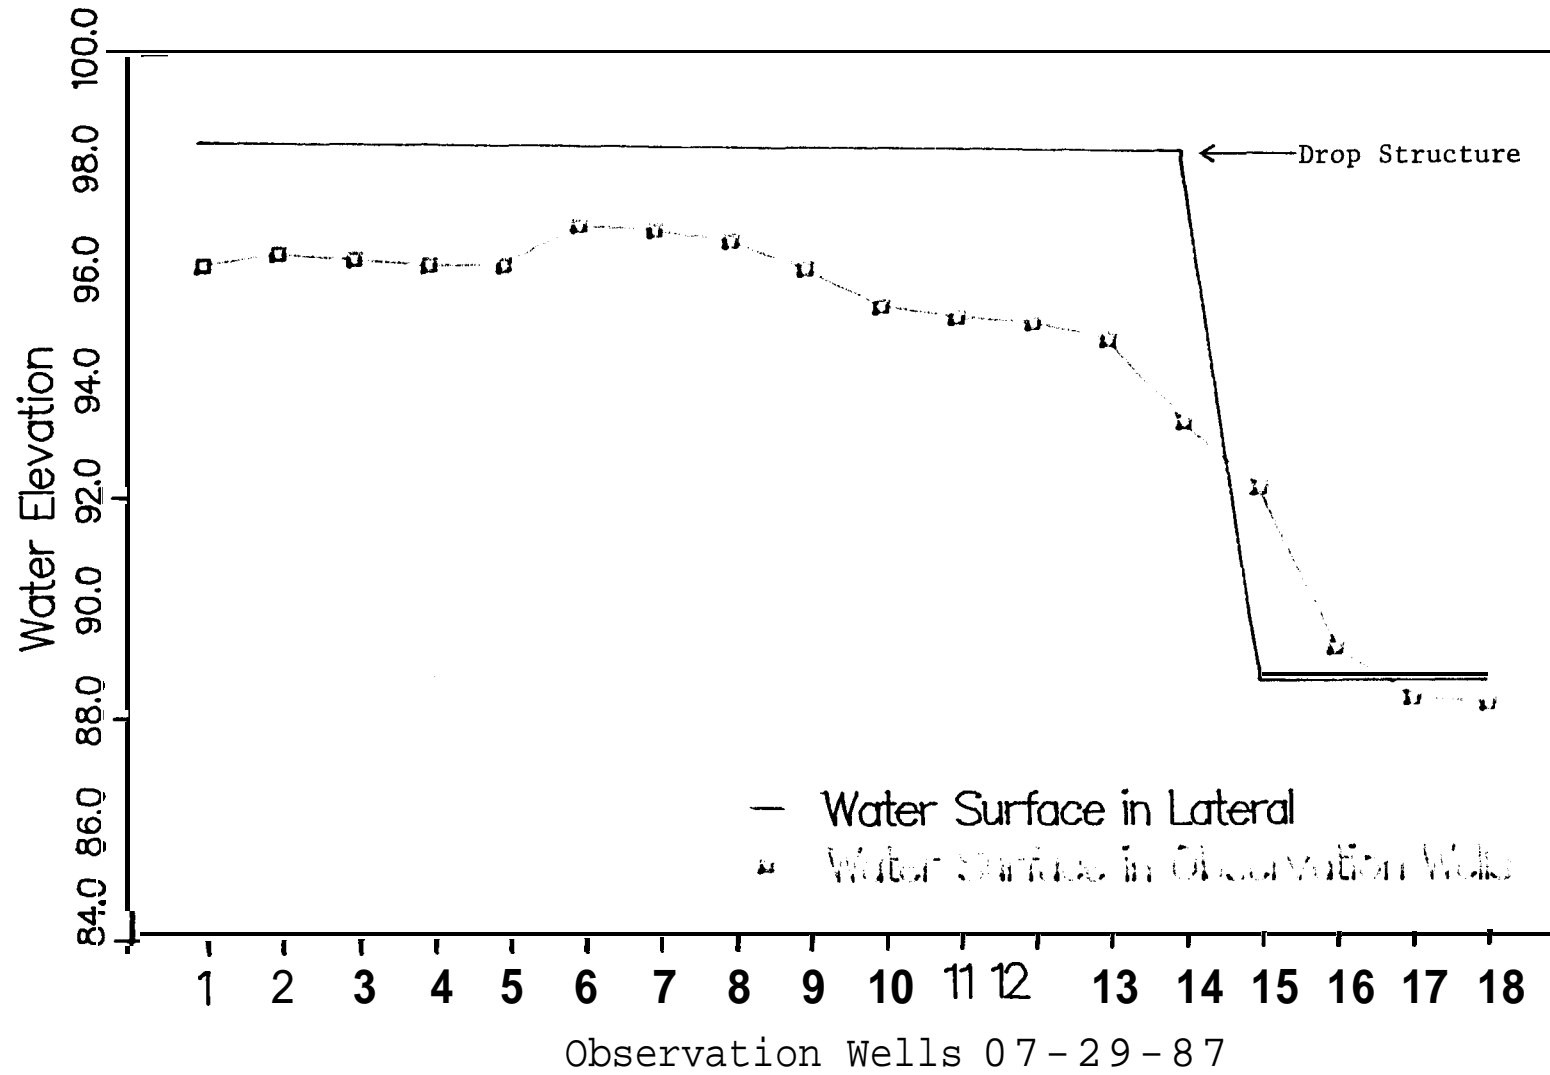
Figure 12. Profile comparing lateral 256 water surface elevations with well water elevations.

system. During the second test period an average withdrawal discharge for the points measured indicated 11.37 CFS. An average discharge of 7.40 CFS or 65 percent was returned through seepage back into the system. Measurements throughout the study section indicated that gains back to the lateral occur below the drop structure R72 measuring site. Well levels below the R72 area indicate higher elevations than the water surface in the lateral directly below the drop structure.
