CAID LATERAL 256 CONVEYANCE  
LOSS STUDY

WWRC-89-12

Wyoming Water Research Center  
University of Wyoming  
Laramie, Wyoming

Final Report

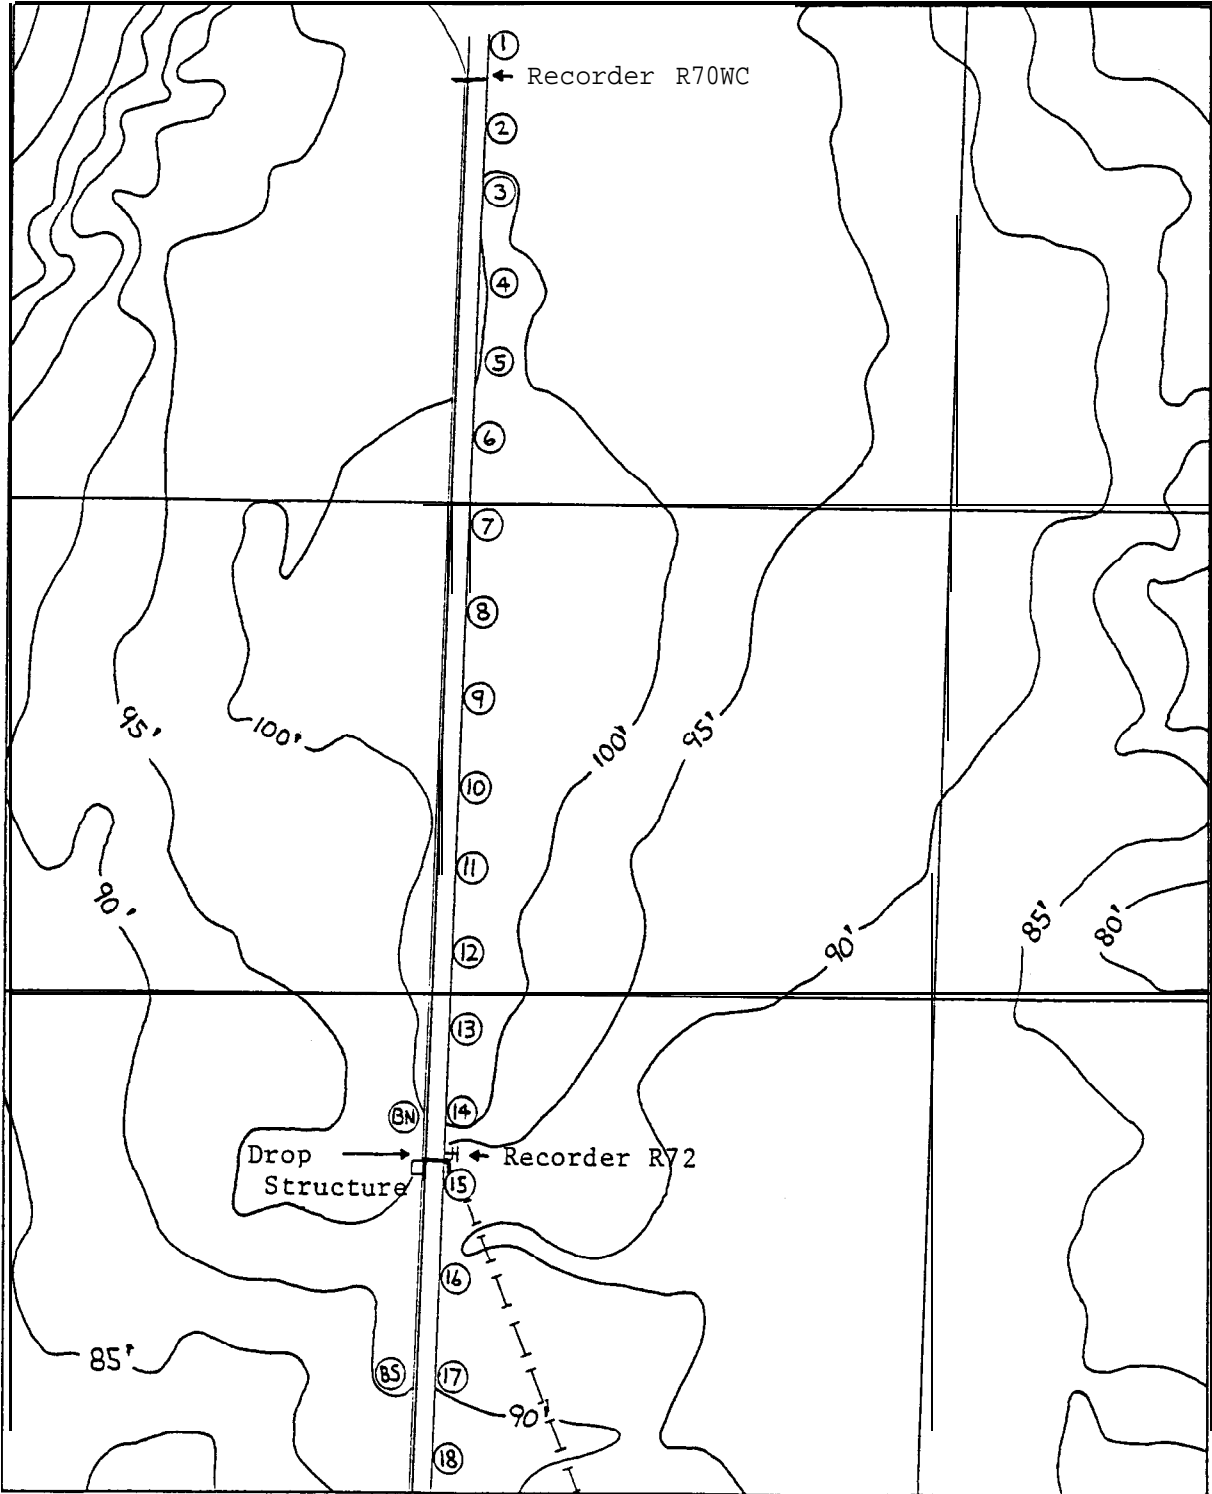
GROUNDWATER MONITORING WELLS

Groundwater wells were installed parallel to lateral 256 on the east side of the canal by CAID in 1986 to monitor seepage losses from the canal to the adjacent areas (Figure 3). Eighteen wells spaced approximately 200 feet apart and 150 feet from the center of the lateral were established along the east side of the main lateral from R70WC to approximately 800 feet below the drop structure at R72. Two wells were established on the west side of the canal approximately 100 feet from the center of the lateral, the first approximately 150 feet above the drop structure at R72 and the second approximately 550 feet below the drop structure. Neither of these wells had continuous recorders installed but hand measurements were taken by CAID personnel throughout the irrigation season. Records of groundwater elevations measured in the wells versus surface water elevations in the main lateral were provided to the Water Center after the irrigation season was completed. Because the Water Center did not work directly with these wells, only an overview will be provided here to explain the relationship of the wells to lateral 256.

Figure 3. Groundwater monitoring well locations on lower lateral 256. (Contours are area elevation differences.)

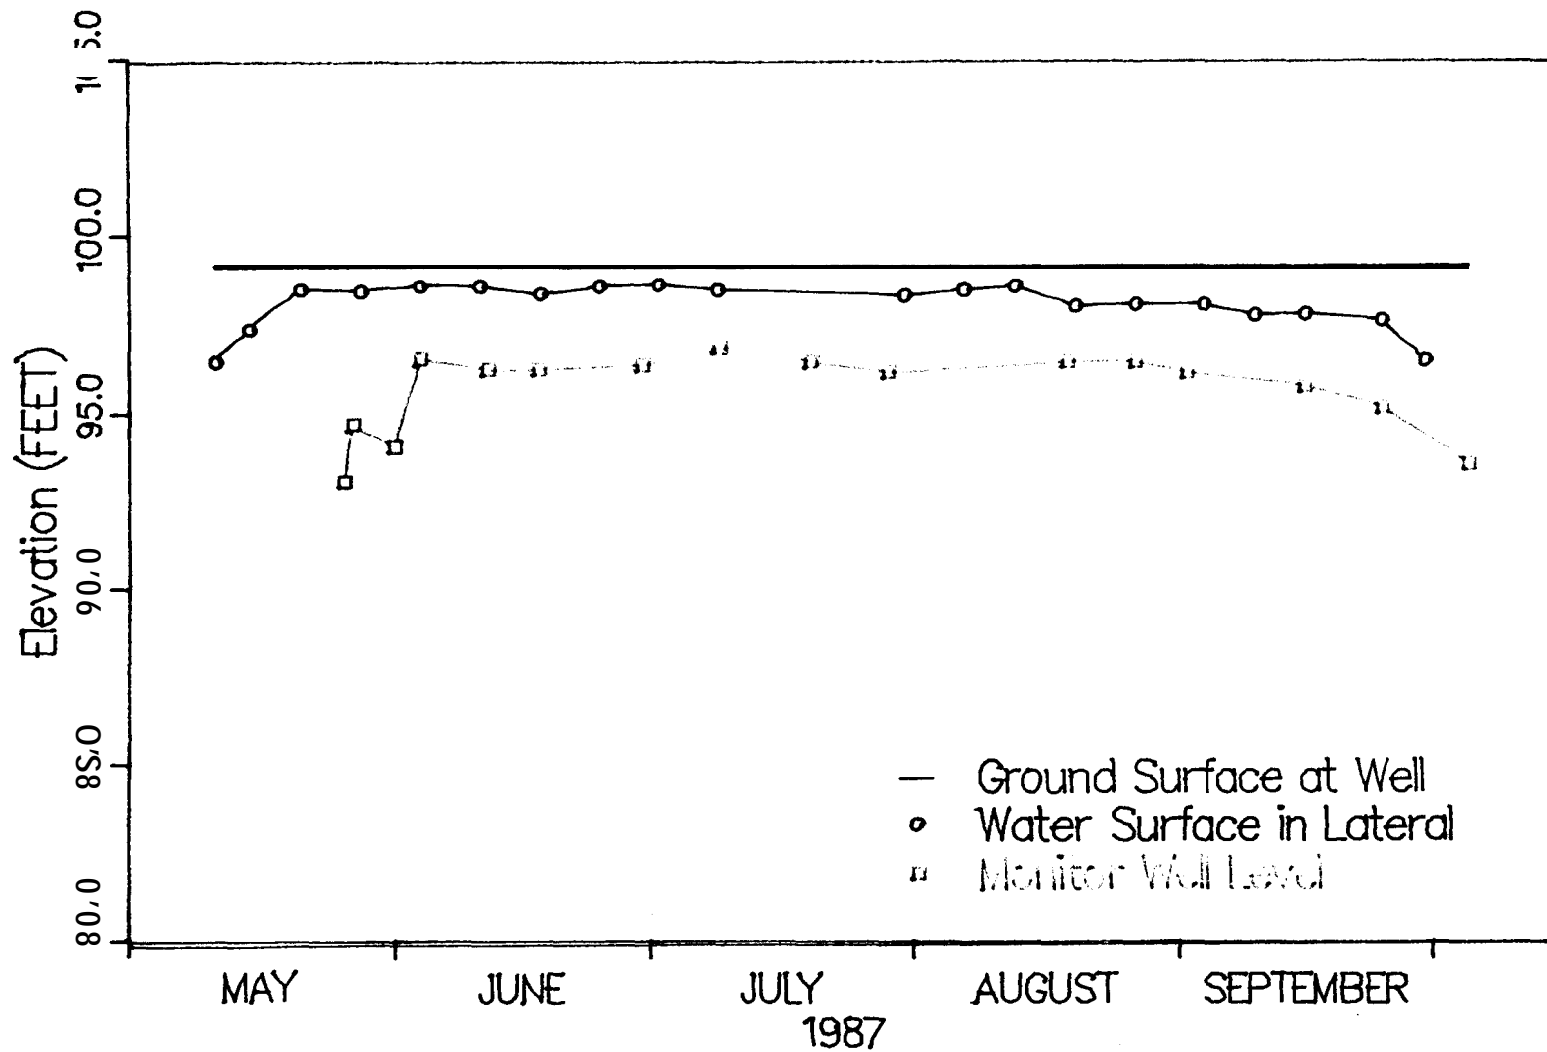
# #1 WELL

When comparing the water surface elevation in the wells located above the drop structure at R72 with the water surface elevation of the canal, a general trend seems to exist as indicated below. Upon release of water in the canal on May 10 and its continual rise to a full condition, the wells show a corresponding rise. As the canal water surface rises, water levels in the wells also rise and then reach a relatively steady level after the canal reaches its full state. At this steady level, the water surface elevations in the wells are lower than the water surface elevation in the canal. The canal water seems to

initially be charging the subsurface region adjacent to the canal as the canal is filled, but then the system appears to reach an equilibrium. This equilibrium is maintained throughout the irrigation season until the water in the canal is shut off. At that time, water flows from the area of the wells back into the canal system. Figures 4 and 5 are representative examples of the general trends shown by plotting the data obtained from the canal water surface elevation and the well water surface elevation from two of the fourteen wells above drop structure R72. The B.N. well (Figure 6) located above the drop structure on the west side of the canal also followed the same trend as the wells on the east side of the canal above drop structure R72. The same rise in well level follows the canal water surface upon release of water into the canal, followed by a leveling out during the irrigation season and a drop in well level following shut off of water in the canal in late September. With monitoring wells located parallel and close to the lateral, it is not possible to determine what influence the canal water has on the subsurface at greater distances from the lateral.

Figure 4. Monitoring well #1 compared to the water surface in lateral 256 at the upper end of the study section.

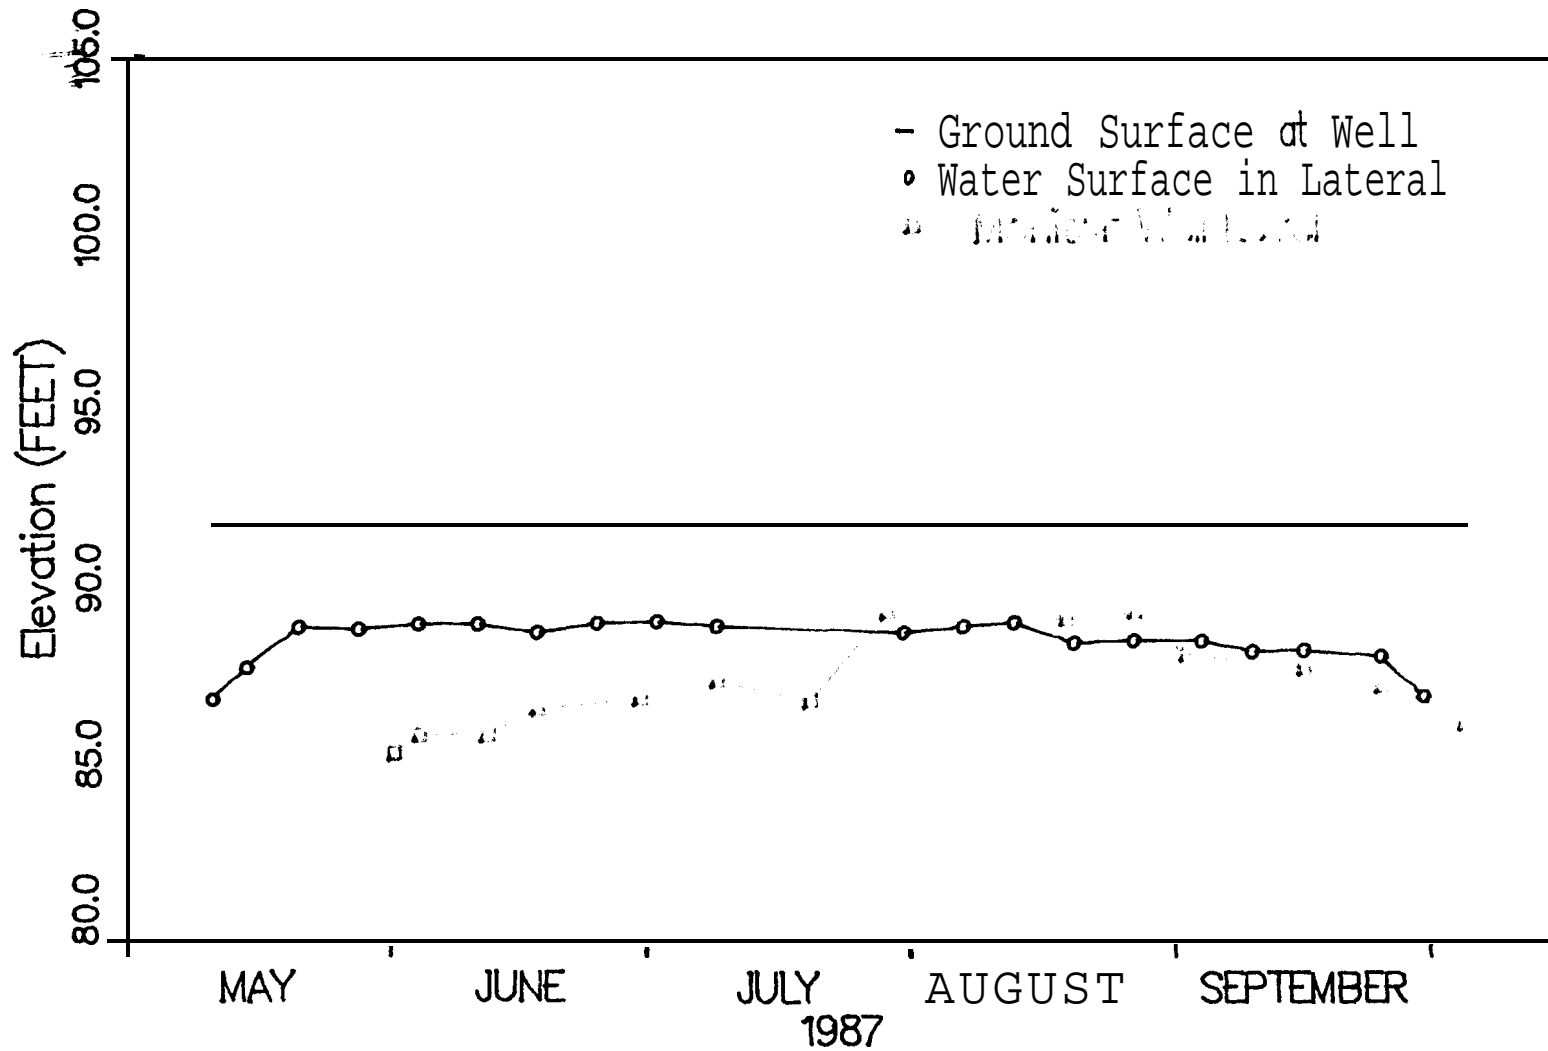
# #16 WELL

Figure 8. Monitoring well #16 compared to the water surface in lateral 256 below the drop structure.

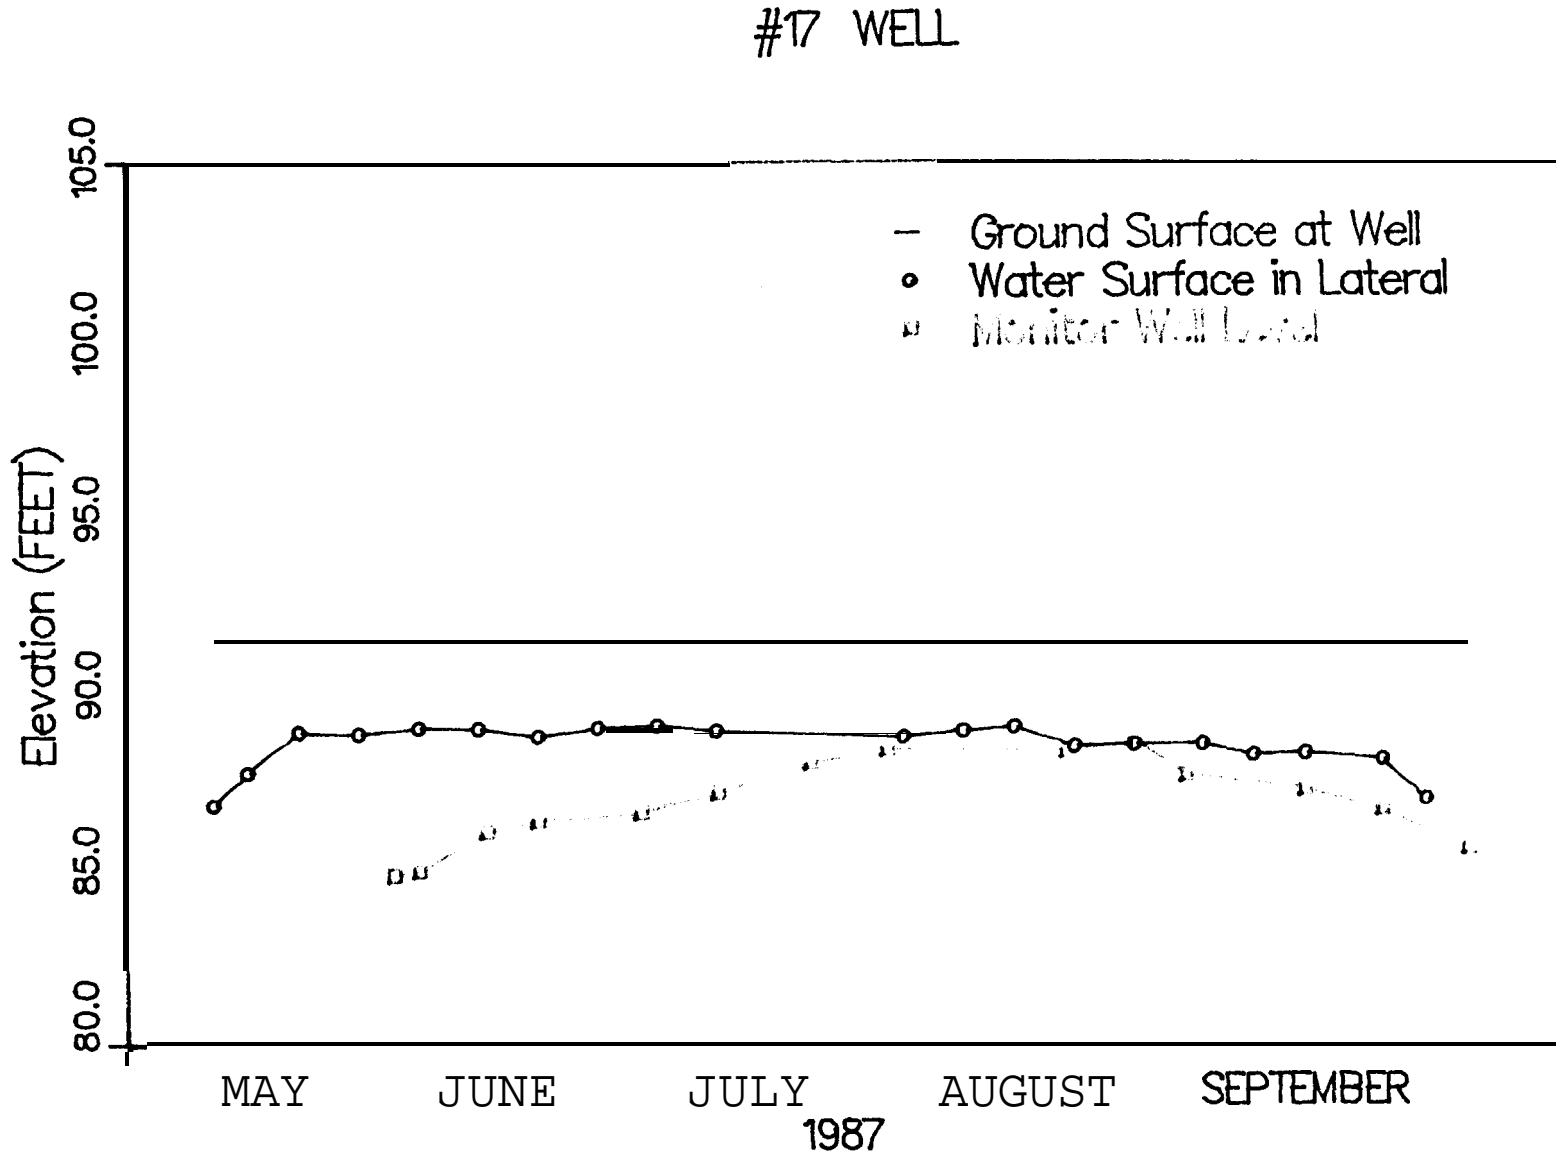
Observation wells 15, 16, 17, 18 and BS located below the turnout for sub-lateral 50L show a different relationship with respect to the lateral surface water elevations above the drop structure at R72. Figure 7 shows observation well #15 water elevation compared to the surface water elevation in the lateral below the drop structure. The well water elevation after release of water into the lateral rises above the elevation of the water surface in the lateral and remains there through July, August and part of September until water in the lateral was shut off. This same general trend is also seen in well 16 (Figure 8). In wells 17, B.S., and 18 (Figures 9-11) the water levels are

Figure 9. Monitoring well #17 compared to the water surface in lateral 256 below the drop structure.

below, but remain close to, the water surface elevation in the lateral except for one measurement in well 17 on August 27 which is above the elevation in the lateral. With the area below the drop structure at R72 appearing to have the largest amount of gain in the study section of lateral 256, indicated from tests during the study period, it would appear that the difference in head between the water surface above the drop and that below the drop is a major cause of inflow (gain) back to the lateral. A profile comparing the well water elevations with the surface water elevations in the lateral, above and below the drop structure, is shown in Figure 12. The head differential resulting from the drop structure, coupled with the high water table from irrigation below and adjacent to the drop structure together, take advantage of the seepage face available along the banks of the lateral below R72 caused by the drop structure. Subsurface return flow appears to occur in this area.
