**EXECUTIVE SUMMARY
FOR
BIG HORN CANAL REHABILITATION
LEVEL II STUDY**

April 20, 2007

**BIG HORN CANAL REHABILITATION
LEVEL II STUDY**

*Anderson Consulting Engineers, Inc.
772 Whalers Way, Suite 200
Fort Collins, CO 80525
(ACE Project No. WYWDC22)*

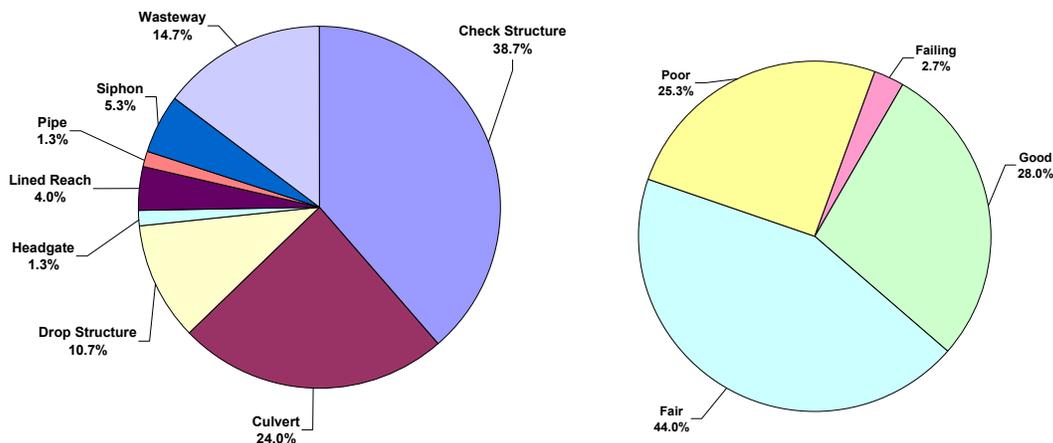
Figure 1. General Characterization of Big Horn Canal Conveyance Structures.

A total of 402 individual structures were inventoried on the Big Horn Canal (Table 1). Of this total, 75 are considered to be flow conveyance and control structures. This number excludes farm turnouts (283), bridges (39) and measurement devices (5). The general character of these conveyance structures is displayed in Figure 1. The Big Horn Canal system suffers from age; many of its structures were built in the early 1900's. Consequently, there are several major structures which are currently in poor or failing condition.

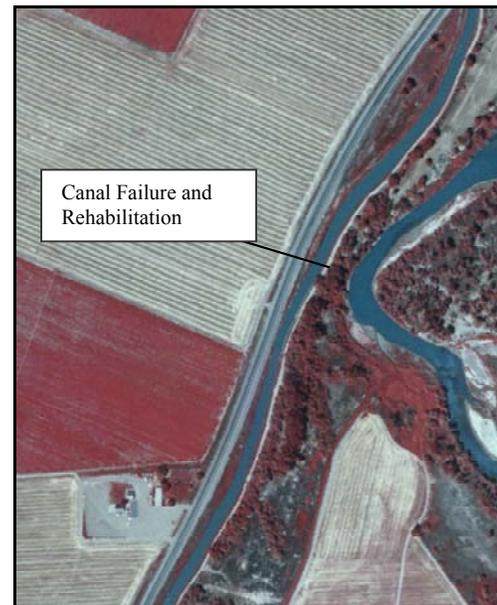
Figure 2. Location of Canal Failure.

In the early 1980's, the canal experienced a catastrophic failure. At the location indicated in Figure 2, the canal is confined to a very narrow strip of land between Highway 20 and the Big Horn River. A culvert conveying percolated irrigation water captured by subdrains and stormwater and surface irrigation returns runoff under the canal failed. Canal flows were lost to the Big Horn River and water deliveries interrupted. An emergency repair effort was reported to have been completed in less than one week.

The District requested funding during the 2005 legislative session to evaluate the structural integrity of the culvert. Based upon a presumed design life of approximately 20 years, the District was aware that the culvert's utility might be limited. During the August 2006 field investigations, the existing culvert failed.

District personnel report that the slope between the canal and the Big Horn River experiences seepage over a large area beneath the canal. During the field inspection, significant seepage was not visible, however, this could be an attribute of the reduced flows in the canal. The seepage may have a destabilizing effect on the slope, and potential for future slope failure of this section cannot be ruled out pending further analyses. A deep slope failure could potentially be more difficult to repair than the previous failure. Extensive seepage could also result in piping (internal soil erosion) of the slope, similar to the mechanism that caused failure previously. The concrete liner upstream of this location has failed and no longer provides

protection against canal seepage in this vicinity. Consequently, given the precarious nature of the canal's location and the importance of protecting the slope from saturation, replacement and extension of the liner was included in the rehabilitation plan.

Following the irrigation season, the District hired a local contractor to replace the culvert. The damaged culvert was excavated and replaced with two hundred feet (200 ft) of 24-inch diameter fusible polypipe (SDR-11). The culvert section underlying Highway 20 was not replaced. A vertical section of four-foot diameter corrugated metal pipe was used as a manhole at the location of the joint which failed in 2006. The manhole facilitates the vertical drop required to enable the culvert to run under the canal and provides access for inspection and maintenance. Joints between the culvert and the manhole were encased in concrete.

- e. Replacement of the concrete liner at the location of the previous failure should be given high priority. The majority of District acreage lies downstream of this location. Given the topographic layout of the site and existing seepage, future failures could be likely.
