SAHARA DITCH IMPROVEMENTS - LEVEL II

EXECUTIVE SUMMARY

HKM ASSOCIATES
1842 Sugarland Drive, Suite 103
Sheridan, WY 82801
Ph. 307-672-9006

November, 1992

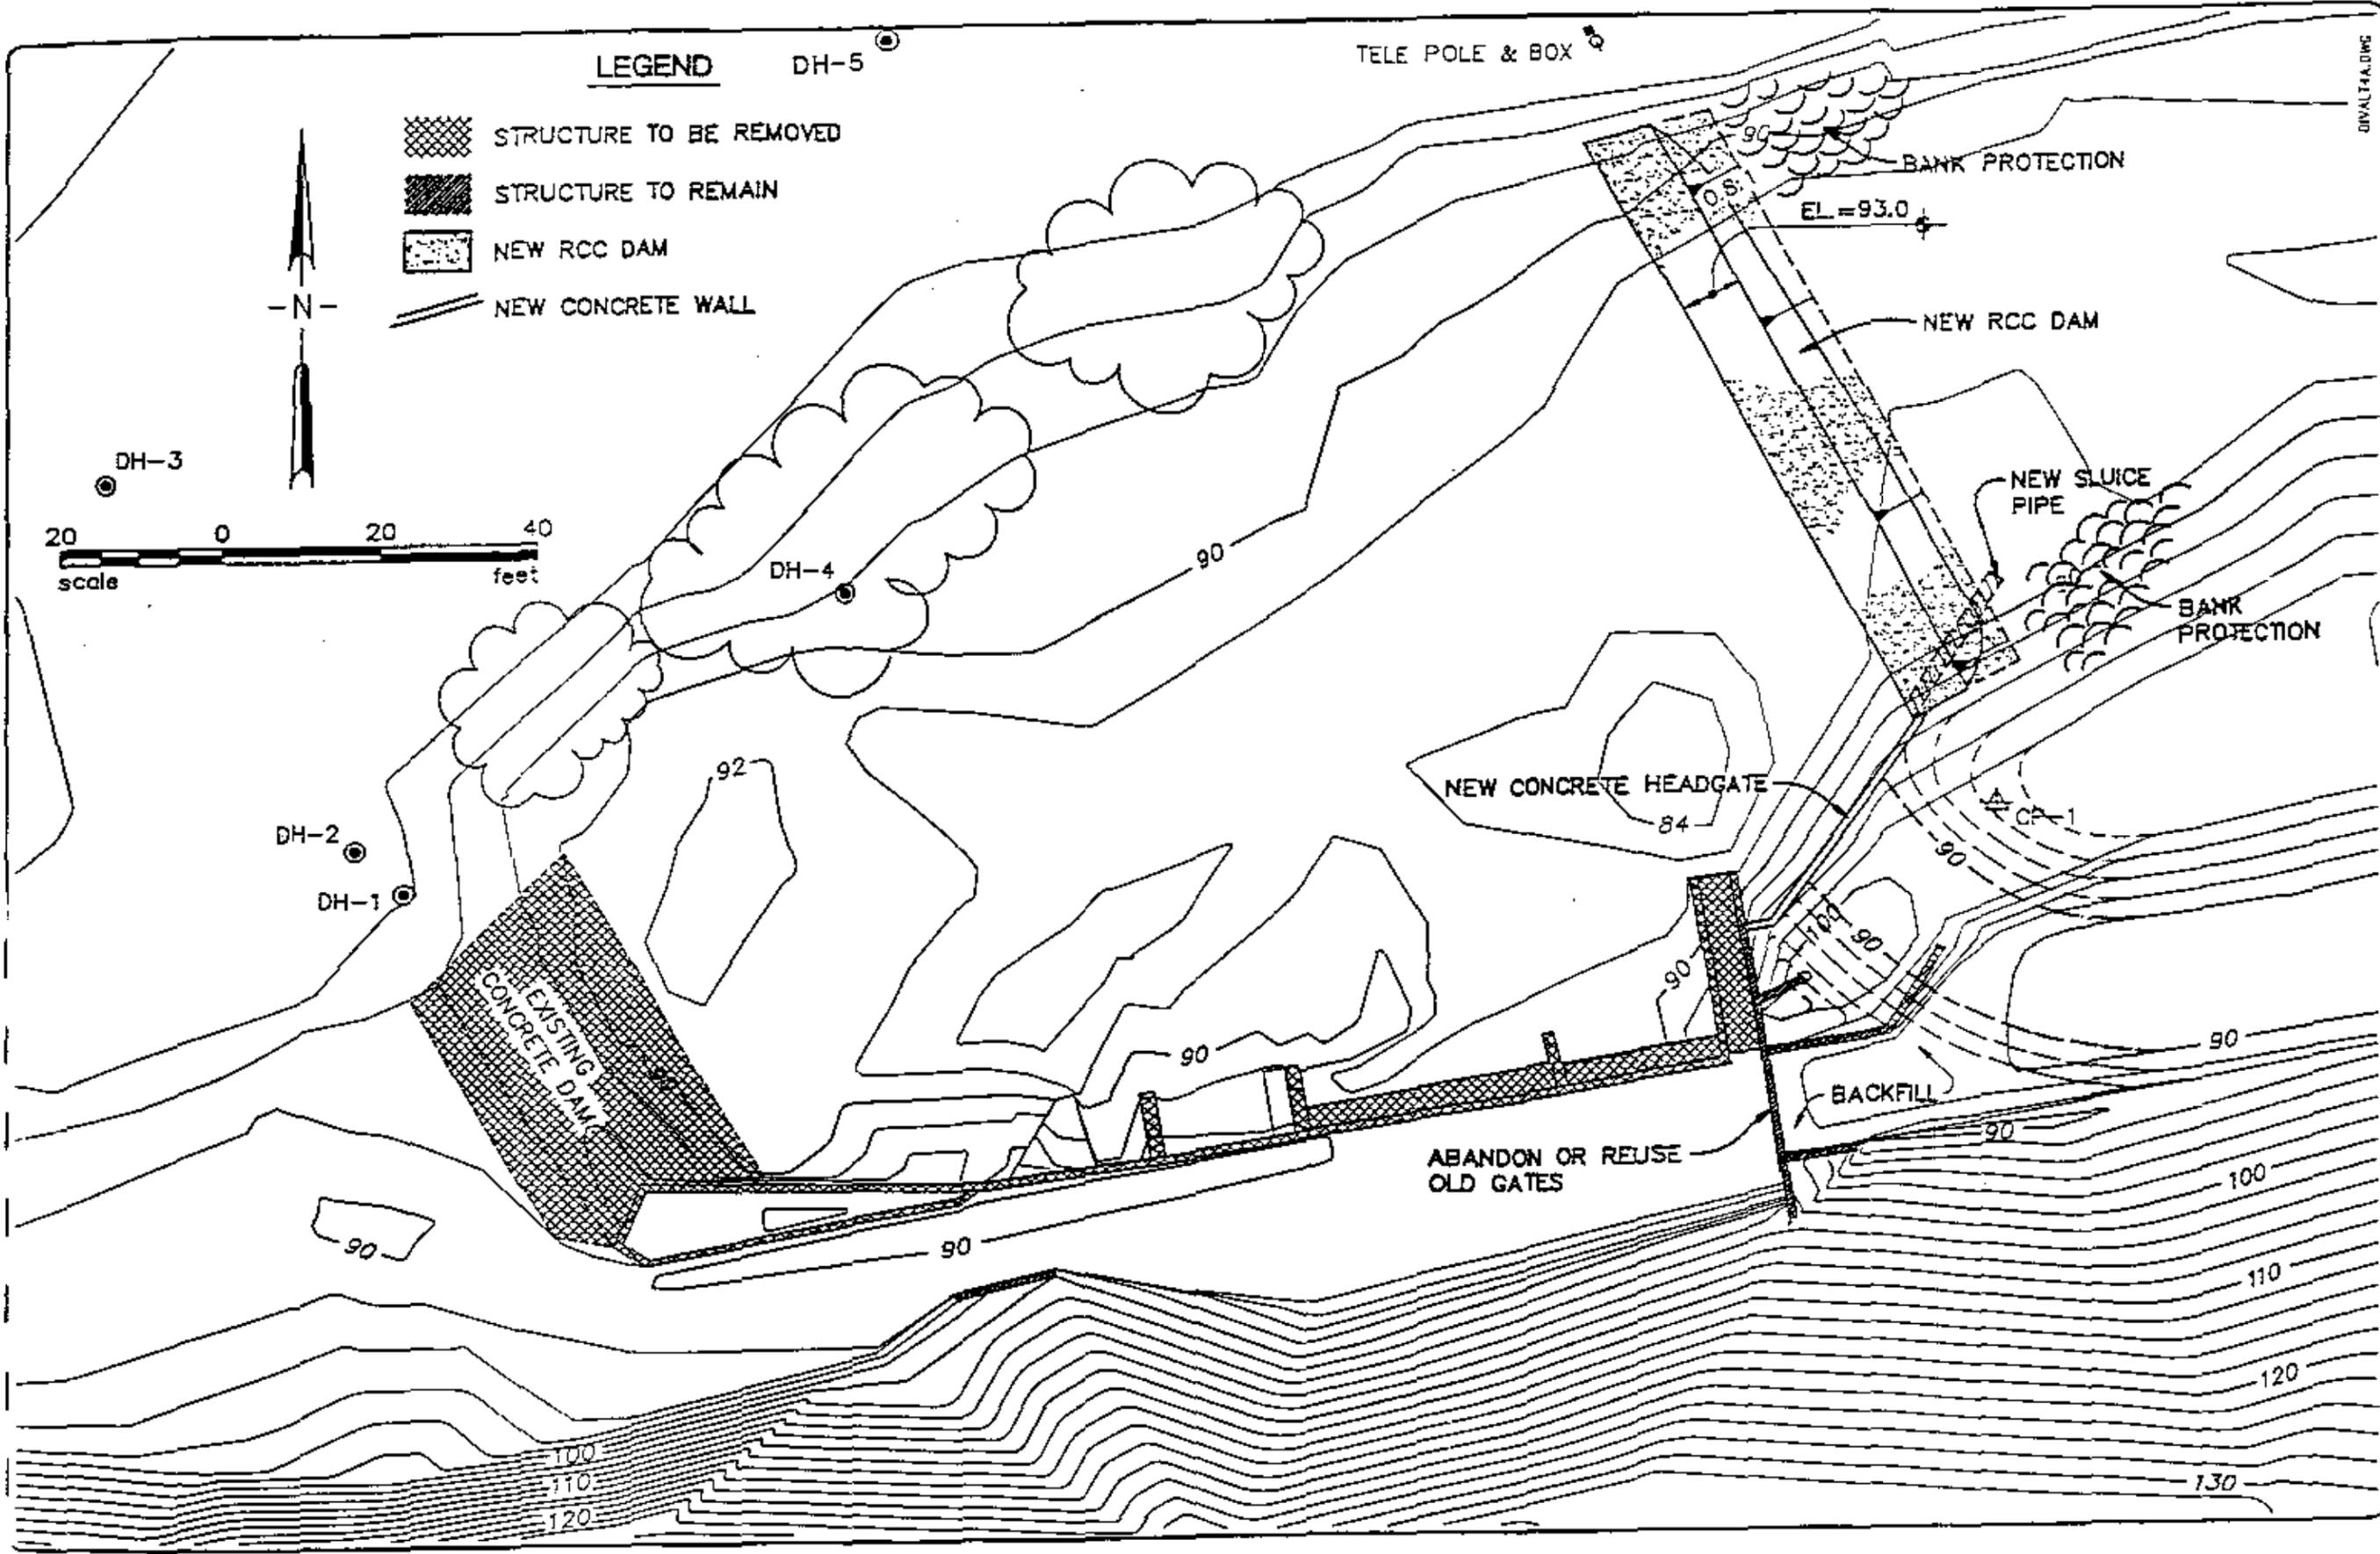
SAHARA DIVERSION DAM
 DIVERSION DAM IMPROVEMENTS
 ALTERNATIVE 4

In most years the diversion dam experiences overflows during the spring runoff season typically occurring in June and thereafter, most of the river flow is diverted into the canal. During the study period from June until August, 1992 the Middle Fork Powder River was unusually high in response to continuous rainfall. This allowed for observations of how the structure performs, but it created difficulty in access for geotechnical exploration. Trash on the diversion dam and in the inlet channel or headgate is a major problem. Access for removal of trash is also a problem. Considerable floating debris in the river accumulates and requires extensive manual labor to removed. The diversion dam currently seeps water from underneath the concrete cap in several locations, has foreign material interbedded in the rock, and the concrete cap has collapsed at the downstream toe. The headgate is serviceable and the 2-4'x4' gates will open and close completely. The concrete wall forming the inlet channel has areas of serious deterioration. The worst deterioration is in the upstream section of the wall that was part of earliest structure.

Sahara Diversion. It is recommended that the dam and headgate structure be replaced with an entirely new facility as shown in Figure 1.
