SINNARD RESERVOIR REHABILITATION PROJECT

LEVEL II FEASIBILITY STUDY

EXECUTIVE SUMMARY

MARCH, 1993

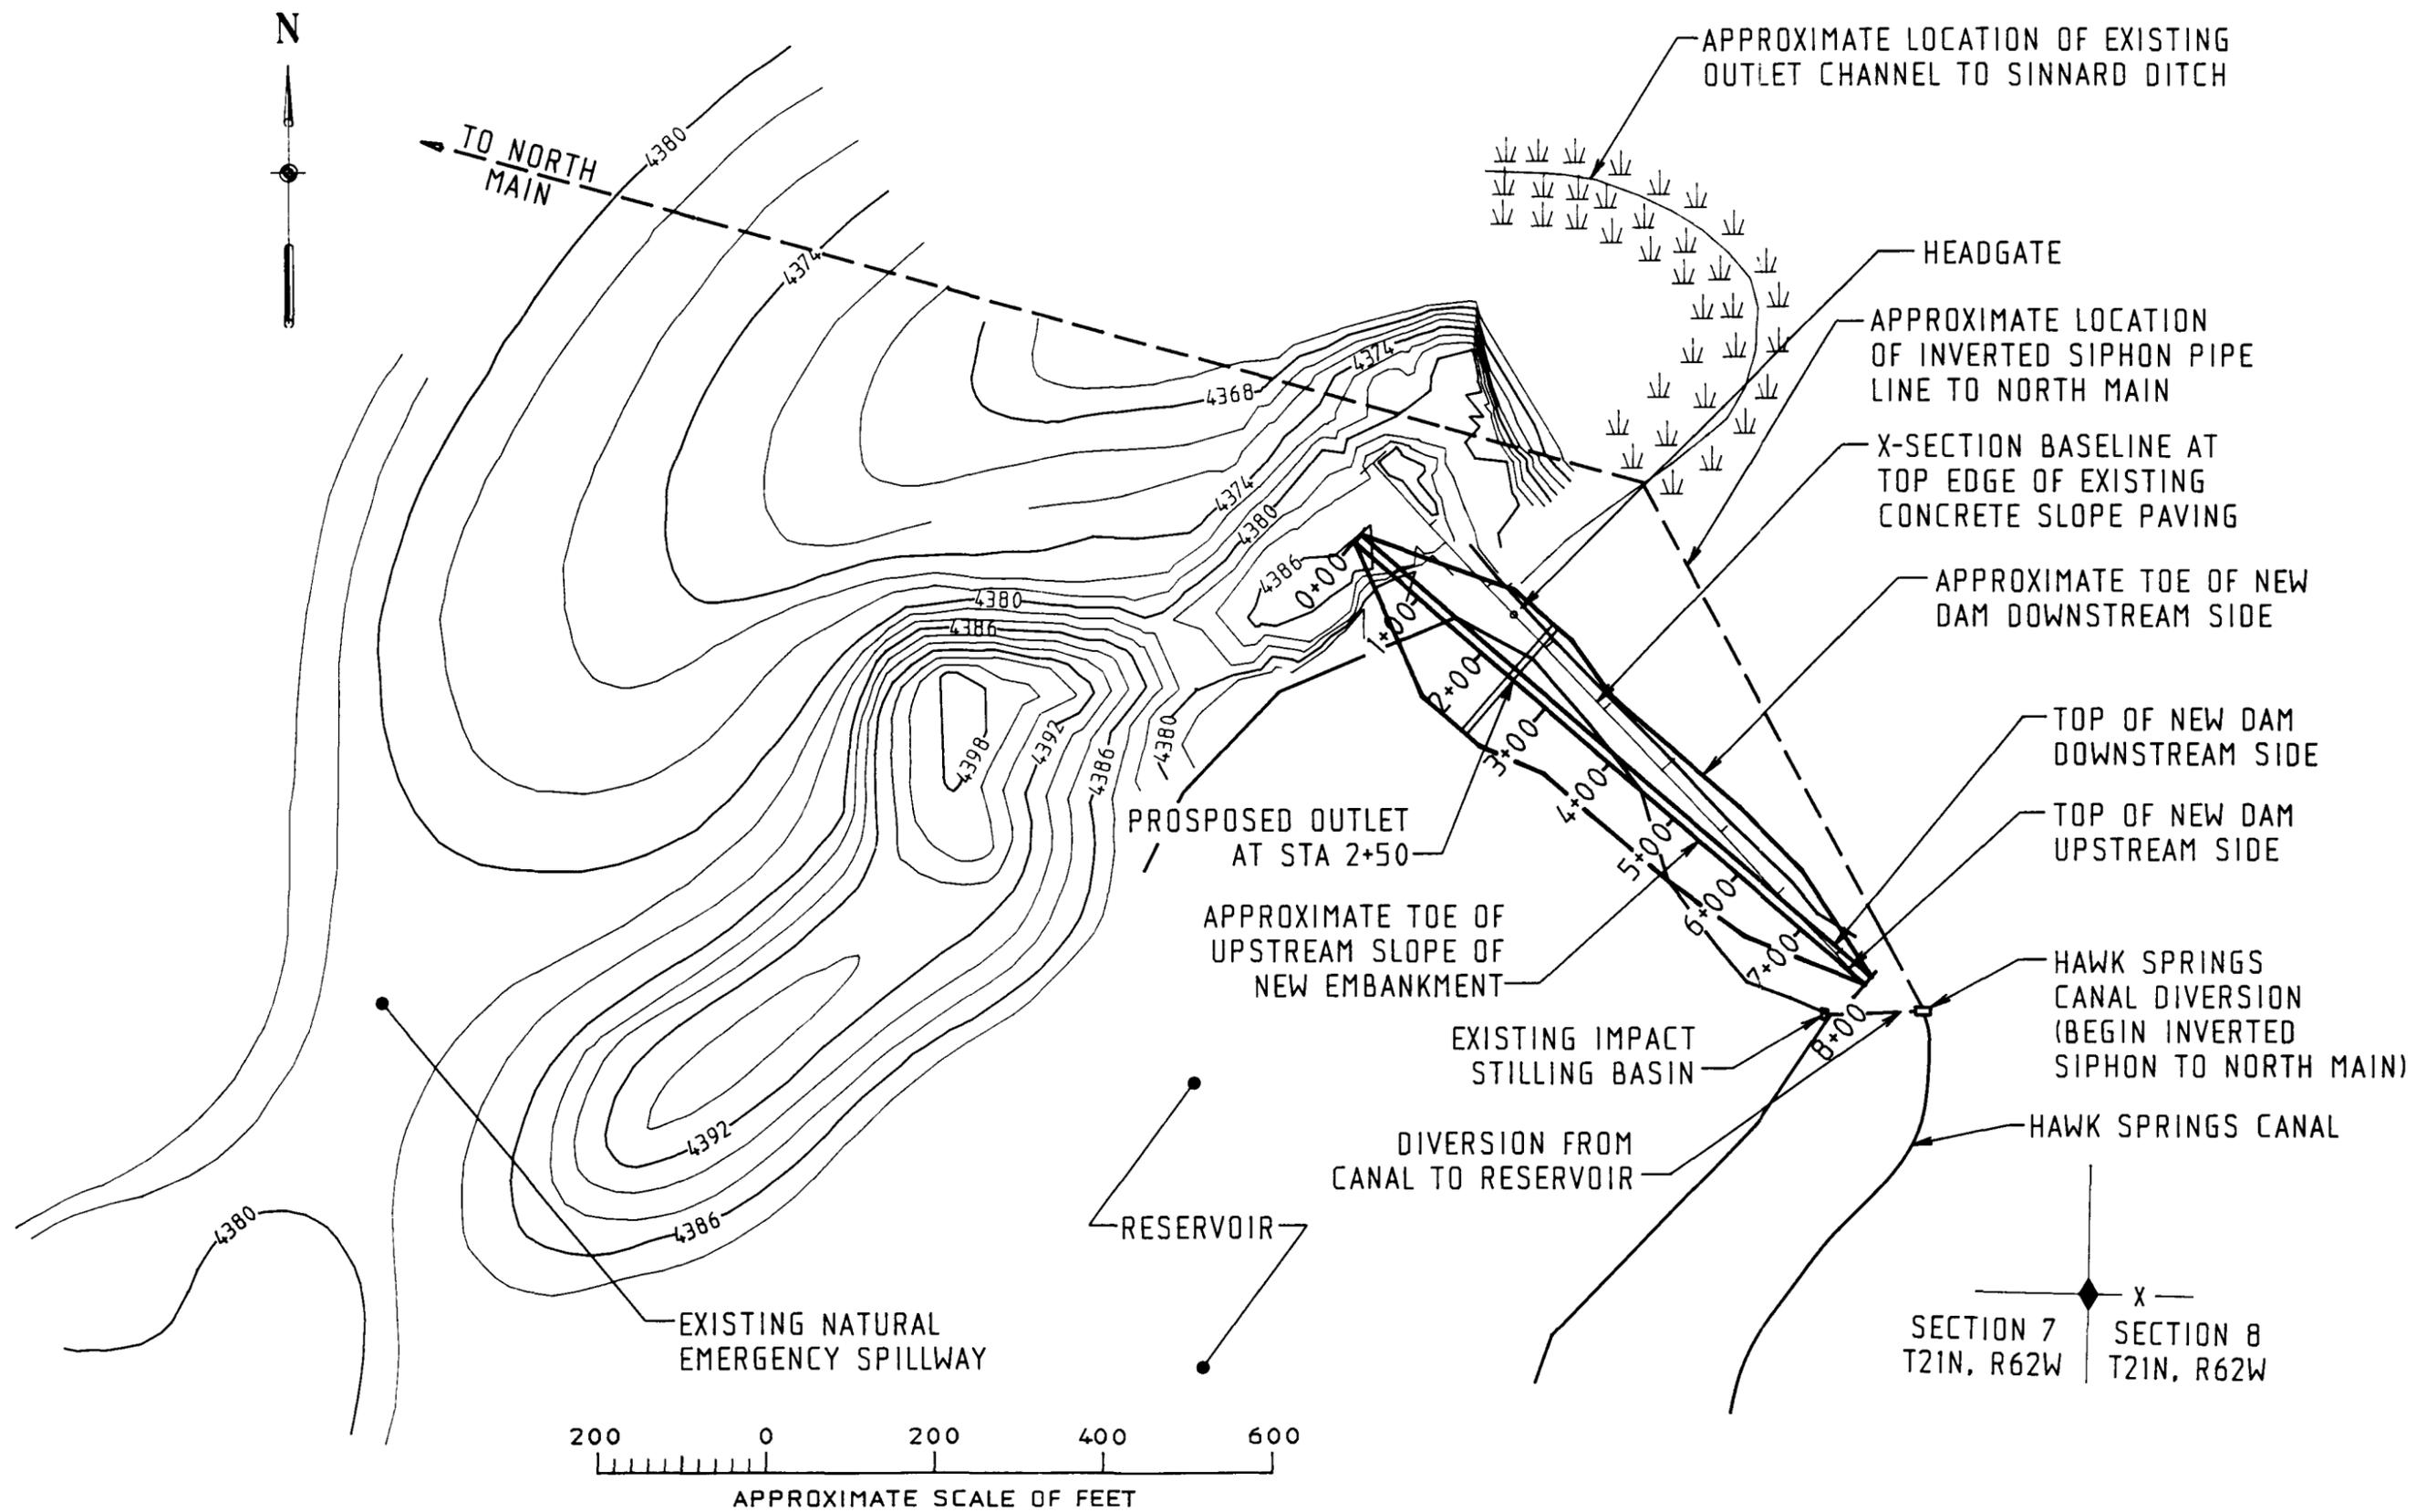
FIGURE
3

Alternative I is the complete removal of the existing dam embankment and outlet works and construction of a new earthen embankment and ancillary facilities. Refer to Figure 3 for the plan location of the new dam embankment. Suitable material for construction of the new dam embankment is believed available at the site. Riprap and granular materials needed for construction of upstream slope protection, the blanket drain, toe drain and roadway are planned to be imported. The plan includes construction of a new embankment with a 3(H):1(V) upstream slope, a 15-foot crest width and a 2.5(H):1(V) downstream slope. The conceptual design incorporates features to mitigate the potential for a piping failure such as has been observed in the existing dam. A 3-foot thick blanket drain and toe drain, encapsulated in a geotextile filter fabric, is proposed to provide drainage for seepage flows anticipated through the foundation and embankment (see Figure 4).

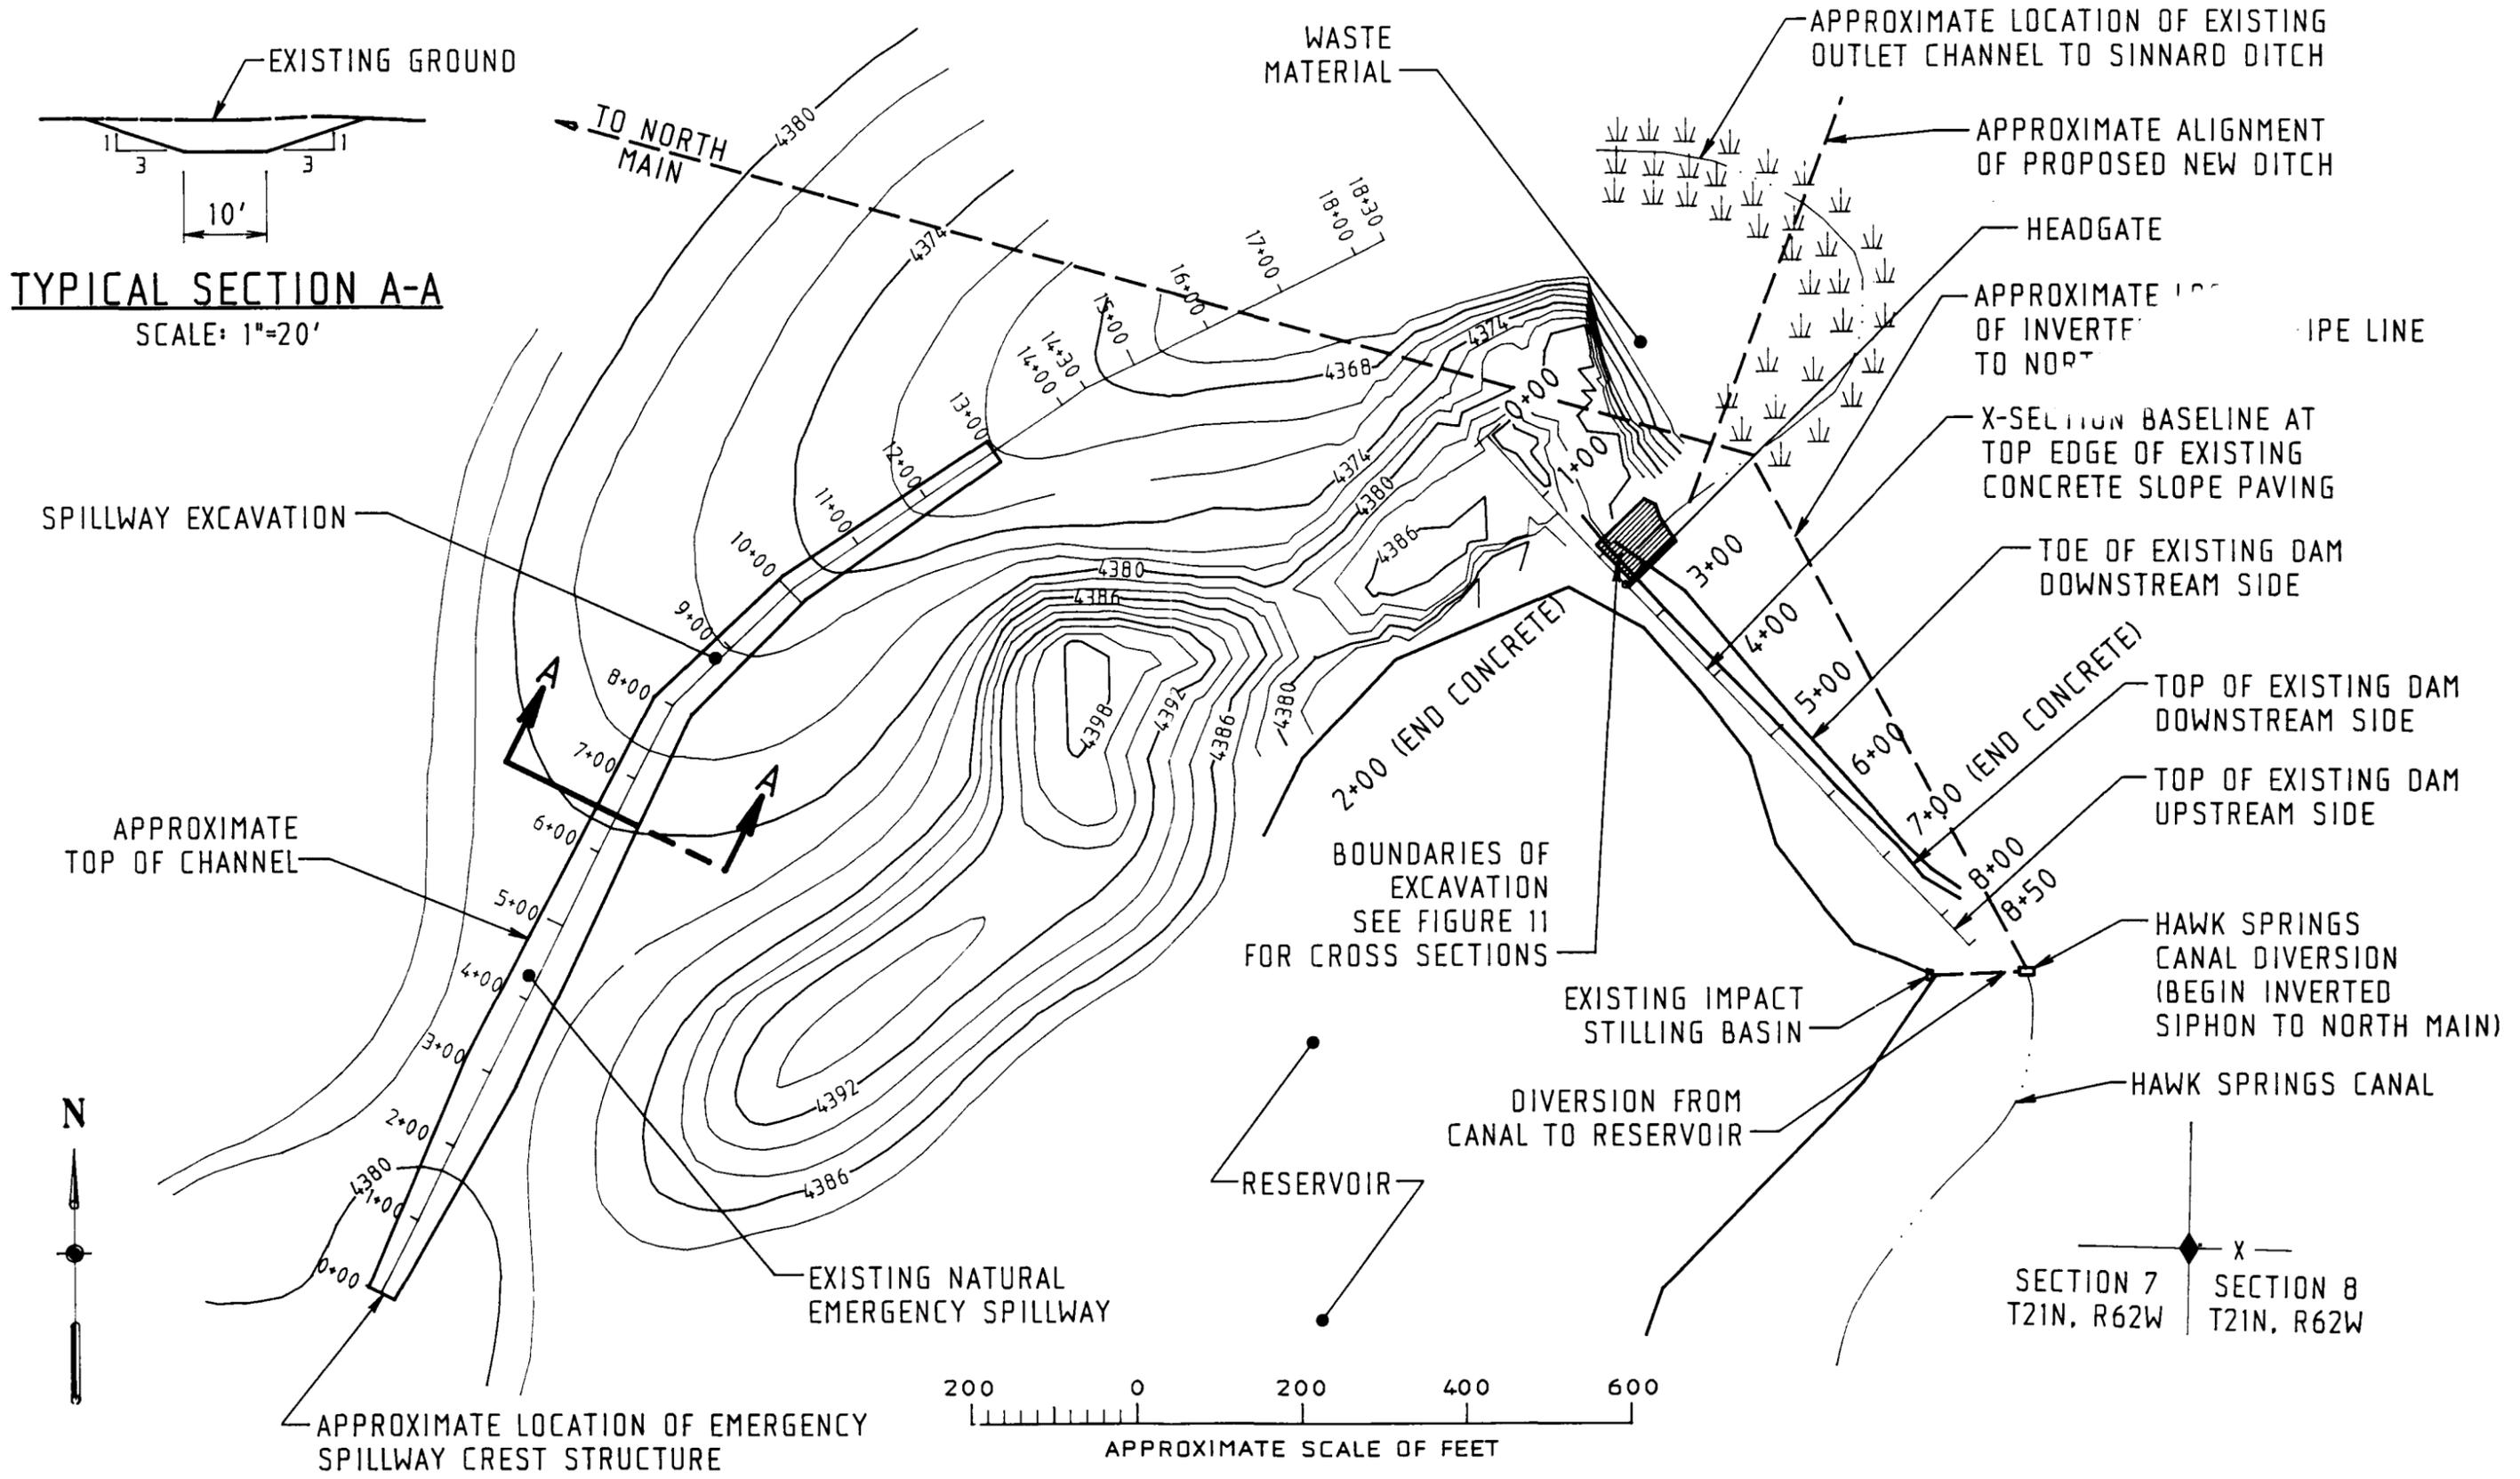
FIGURE:
5

Alternative II is the remedial repair of the existing dam embankment and outlet works. This plan is provided on the premise that the cause of the observed failure will be effectively mitigated by restriction of the reservoir level to an elevation of 4374, 10 feet below the top of the dam.

The plan for remedial repair considers excavation and fill of the area of sloughing on the downstream face of the dam (see Figure 5). Suitable natural fill material is believed to be available on site from the area of the natural emergency spillway. A drainage blanket covering the area of the base of the excavation is also

The maximum reservoir level, at 4374 feet, will be maintained by excavating a trapezoidal channel, approximately 1300 feet in length, along the existing natural spillway (see Figure 5). A concrete spillway crest structure will be located at the entrance to the channel. The design of the crest structure provides a V-notch weir which allows the restriction to be effected with minimal spill due to wave action.

considered in the plan. Granular material, suitable for use in a drainage blanket, is believed available from Torrington. Access to the area of repair is very restricted which contributes to higher unit prices relative to those shown for Alternative I. Attention will need to be made to restricting construction activity away from the area of the inverted siphon of the pipeline to the North Main Canal.
