# FINAL REPORT

## Highline Watershed Improvement District Ditch Rehabilitation Project Level II

Anderson Consulting Engineers, Inc.  
2900 South College Avenue, Suite 3B  
Fort Collins, CO 80525  
(ACE Project WYWDC14)

November 1, 1999

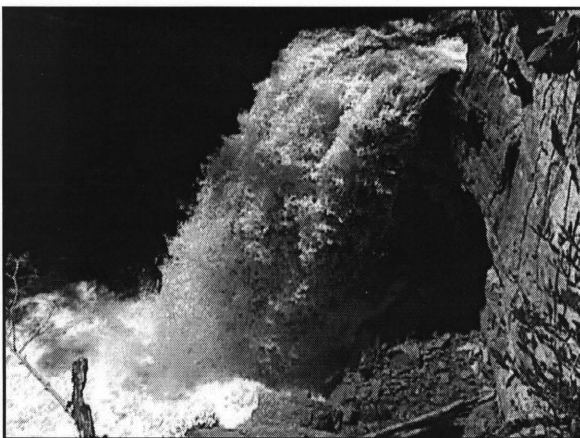
Figure 1.2 Headcut on Highline No. 4 Ditch, During Irrigation Season.

As stated previously, major erosion and canal stability problems continue to plague the Highline Ditch, Elk Hollow Ditch and Wiant Ditch. Sheet 1, attached to this report, displays these ditches and highlights the problem areas. The Highline Ditch is threatened by a massive headcut that is moving upstream and endangering existing facilities and adjacent irrigation ditches (Figure 1.2). This headcut is more than 25 feet high and is actively migrating upstream (Figure 1.3). Channel incision upstream of the headcut has produced near vertical streambanks greater than 20 feet.

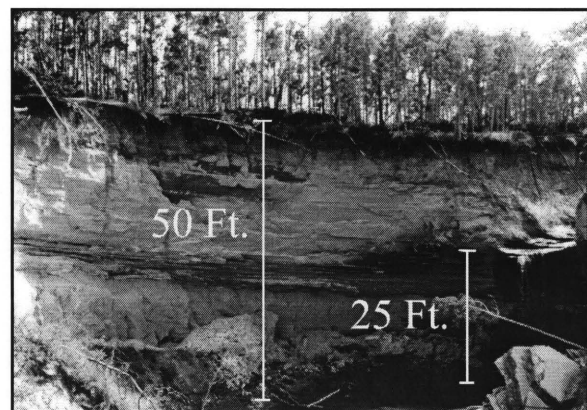
Figure 1.3 Headcut on Highline No. 4 Ditch, Approximately 25 Feet High.

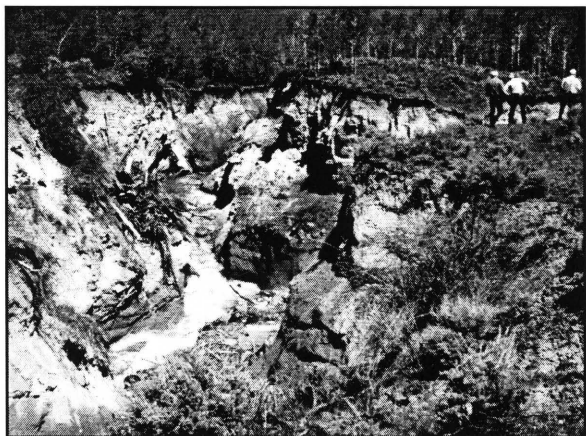
Figure 1.4 Degradation of Wiant Ditch in Vicinity of Elk Hollow Washout.

The Wiant Ditch is also deeply incised and is experiencing actively migrating headcuts as shown in Figure 1.4. This type of canal erosion continues to threaten existing structures/flumes plus existing roadways next to the ditch. Recently, the county had to relocate County Road 504 because of encroachment of the Wiant Ditch. Three diversions from the Highline Ditch cross the Wiant Ditch via suspended pipelines. Efforts have been made to protect these pipelines from canal degradation by placing auto bodies along the banks (Figure 1.5).

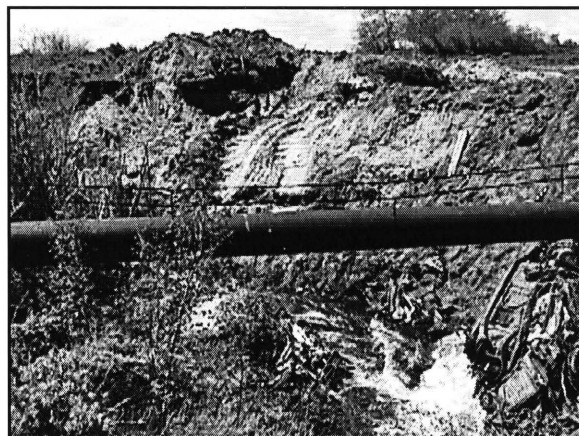
Figure 1.5 Degradation of Wiant Ditch at Ryan Foreman Pipeline Crossing.

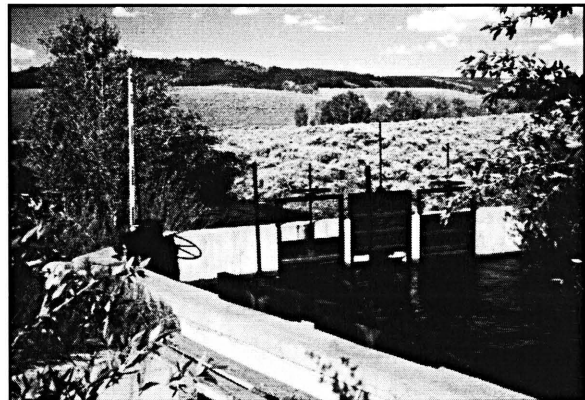
Figure 3.2 Diversion Structure No. 1.

The first diversion structure in the inventoried reach of the Highline Canal is Diversion Structure No. 1 at Station 3+00 (Figure 3.2). From this structure the District returns Buffalo Gulch appropriations carried in Highline No. 4 to the Buffalo Gulch Channel. Highline water may also be diverted to the Wiant Ditch as required by the District. The structure consists of a concrete headwall with six slide gates; one servicing the Wiant Return Canal, two spilling to Buffalo Gulch Channel, and three controlling flows down the main Highline No. 4 Ditch. The headwall and gates are in excellent condition. Minor erosion was noted at the lip of the downstream aprons to the Buffalo Gulch and Wiant Return Channel. Both aprons have rounded riprap protection; future inspections should be aware of the potential for increased erosion. A large amount of debris was noted in and around Diversion Structure No. 1. A debris collection system could simplify maintenance and insure that flow settings remain accurate while the structure is unattended. Sediment accumulation does not appear to be a problem at this structure. There are no flow measuring devices at the diversion structure.

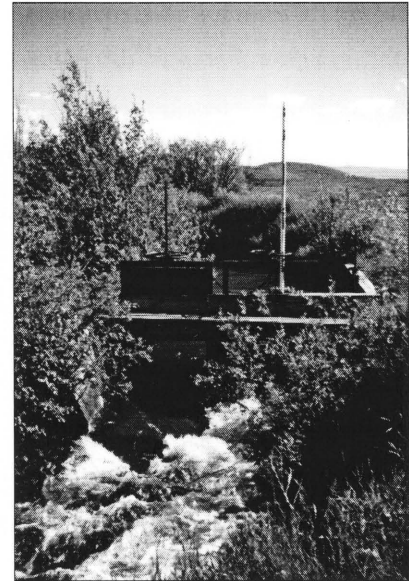
Figure 3.3 Diversion Structure No. 2.

The structure consists of a headwall and four slide gates: one each for the Gross/Twin and Ryan Foreman inlets and two for the Highline No. 4 Ditch. The headwall and gates are in good condition, only minor cracking and spalling of the concrete were noted. Minimum debris and sediment accumulation was noted at Diversion Structure No. 2. There are no flow measuring devices at the diversion structure.

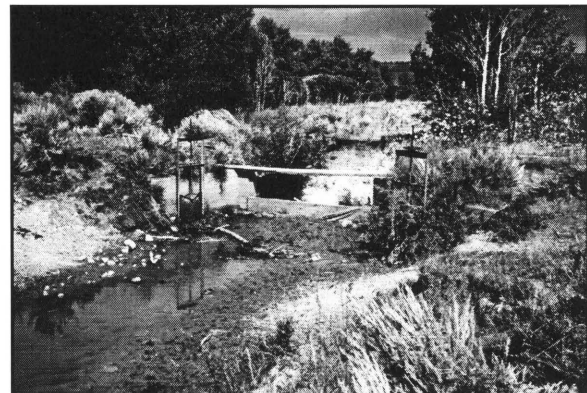
Figure 3.4 Diversion Structure No. 3.

Diversion Structure No. 3 is located in the vicinity of Station 76+00 (Figure 3.4). This structure can divert flow into the Hill No. 1 and No. 2 ditches. Water that is not diverted continues down the Highline No. 4 Ditch to its confluence with South Cedar Creek. The structure consists of concrete headwalls with a timber board check structure and two turnout gates. The main ditch apron consists of welded steel plate on top of remnant concrete from a previous apron. The headwalls and timber check structure are in fair condition. The apron areas of the main ditch and both turnouts are experiencing moderate to severe erosion. Debris blockages of the turnout gates and one to two feet of sediment accumulation were evident during the field inspection. There are no flow measuring devices at the diversion structure.

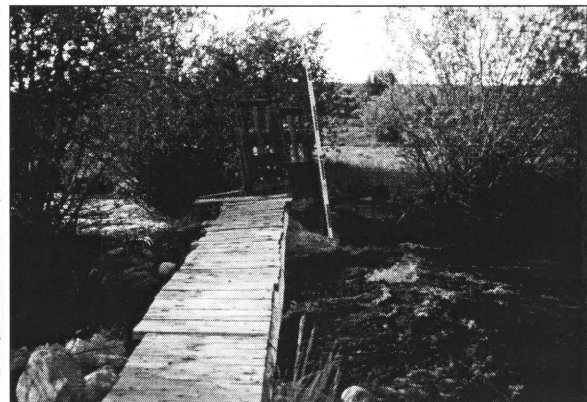
Figure 3.5 Wiant Ditch: Diversion Structure 1A.

Diversion Structure No. 1A is found on the Wiant Ditch at Station 6+50 (Figure 3.5). The structure is used by the District to control the flow in the Wiant Ditch. Any flow not diverted to the Wiant Ditch at this structure is diverted into Buffalo Gulch. The structure consists of two wooden slide gates and a pedestrian bridge over the Buffalo Gulch Return Channel. The Wiant Return Channel from Diversion Structure No. 1 on the Highline Canal enters the Wiant Ditch immediately upstream of Diversion Structure No. 1A. When the wooden slide gates are closed, they are covered in plastic to provide a seal against leakage. The gates are in fair condition and the bridge is in good condition. This structure could be replaced with a concrete headwall and a steel-gated structure to provide better control of flows at this diversion point. Debris and sediment did not appear to be a major problem at this diversion as they probably pass on through to Buffalo Gulch.

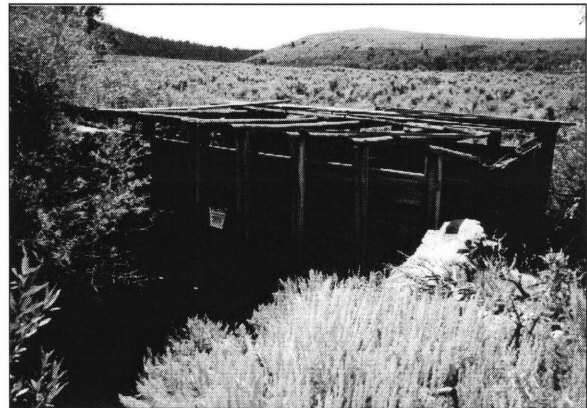
Figure 3.6 Wiant Ditch Flume.

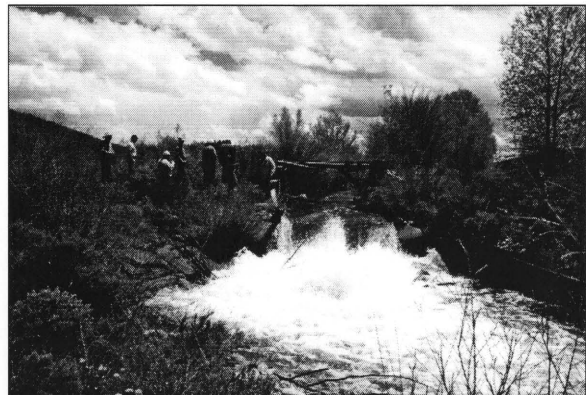
Figure 3.7 Wiant Ditch at Flume Over Highline No. 4 Ditch.

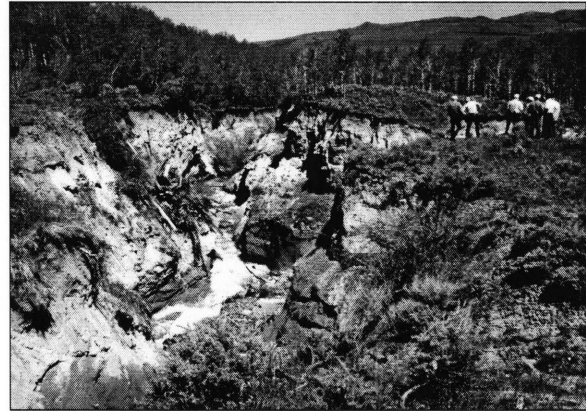
Figure 3.8 Wiant Ditch Washout (Reach 3).

(Figure 3.8). The average slope of this reach is approximately 0.055 ft/ft. Channel capacity in this reach is adequate, but the channel is highly unstable. This reach of the channel is threatening the Gross, Twin Pipes, and Ryan Foreman Pipe Crossings over the Wiant Ditch.

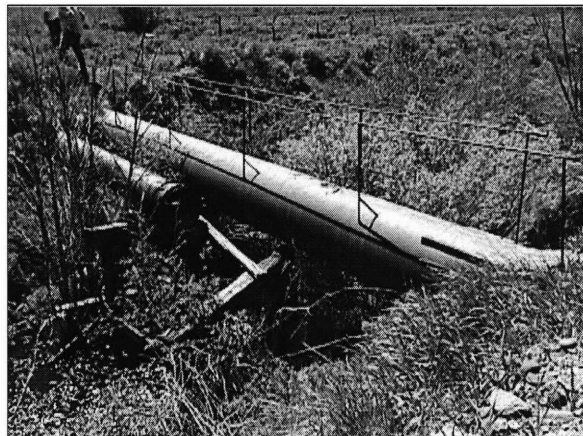
Figure 3.9 Gross Ditch Pipe Crossing Over Wiant Ditch.

The Gross Pipe Crossing consists of a 36-inch diameter steel pipe approximately 73 feet long (Figure 3.9). The pipe spans the Wiant Ditch approximately 8 feet above the invert. The pipe and the inlet and outlet structures are in good condition.

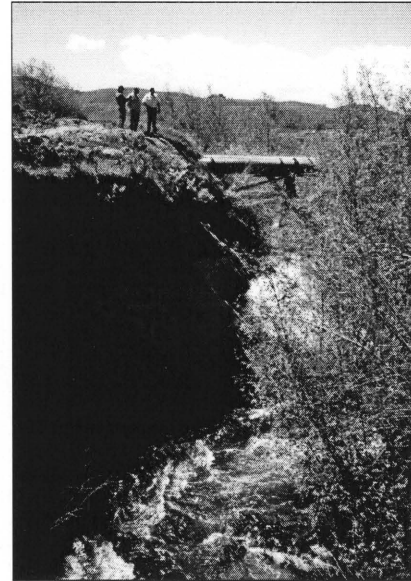
Figure 3.10 Twin Pipes Crossing Over Wiant Ditch.

The Twin Pipes Crossing (Figure 3.10) consists of two steel pipes measuring 24 inches and 36 inches in diameter. The Twin Pipes are approximately 41 feet long. The pipes and the inlet and outlet structures are in good condition. Bank instability from the Wiant Washout is currently threatening the integrity of the Twin Pipes Crossing.

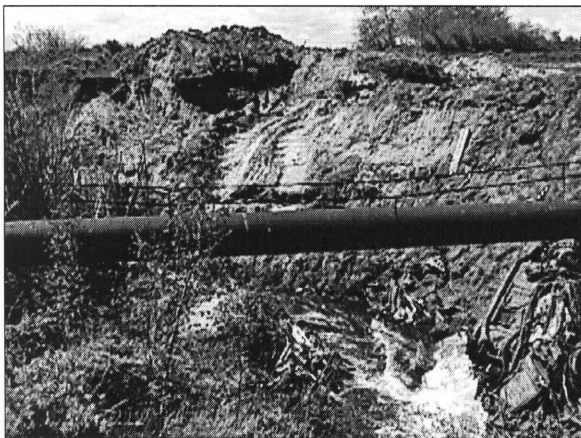
Figure 3.11 Ryan Foreman Pipe Crossing Over Wiant Ditch.

The Ryan Foreman Crossing consists of a 24-inch steel pipe (Figure 3.11). The pipe spans the Wiant Ditch approximately 20 feet above the invert. The pipe and the inlet and outlet structures are in good condition. Bank instability from the Wiant Washout is currently threatening the integrity of the Ryan Foreman Pipe Crossing. Bank protection (auto bodies) has been placed along the banks of the Wiant Ditch as a temporary bank protection measure.

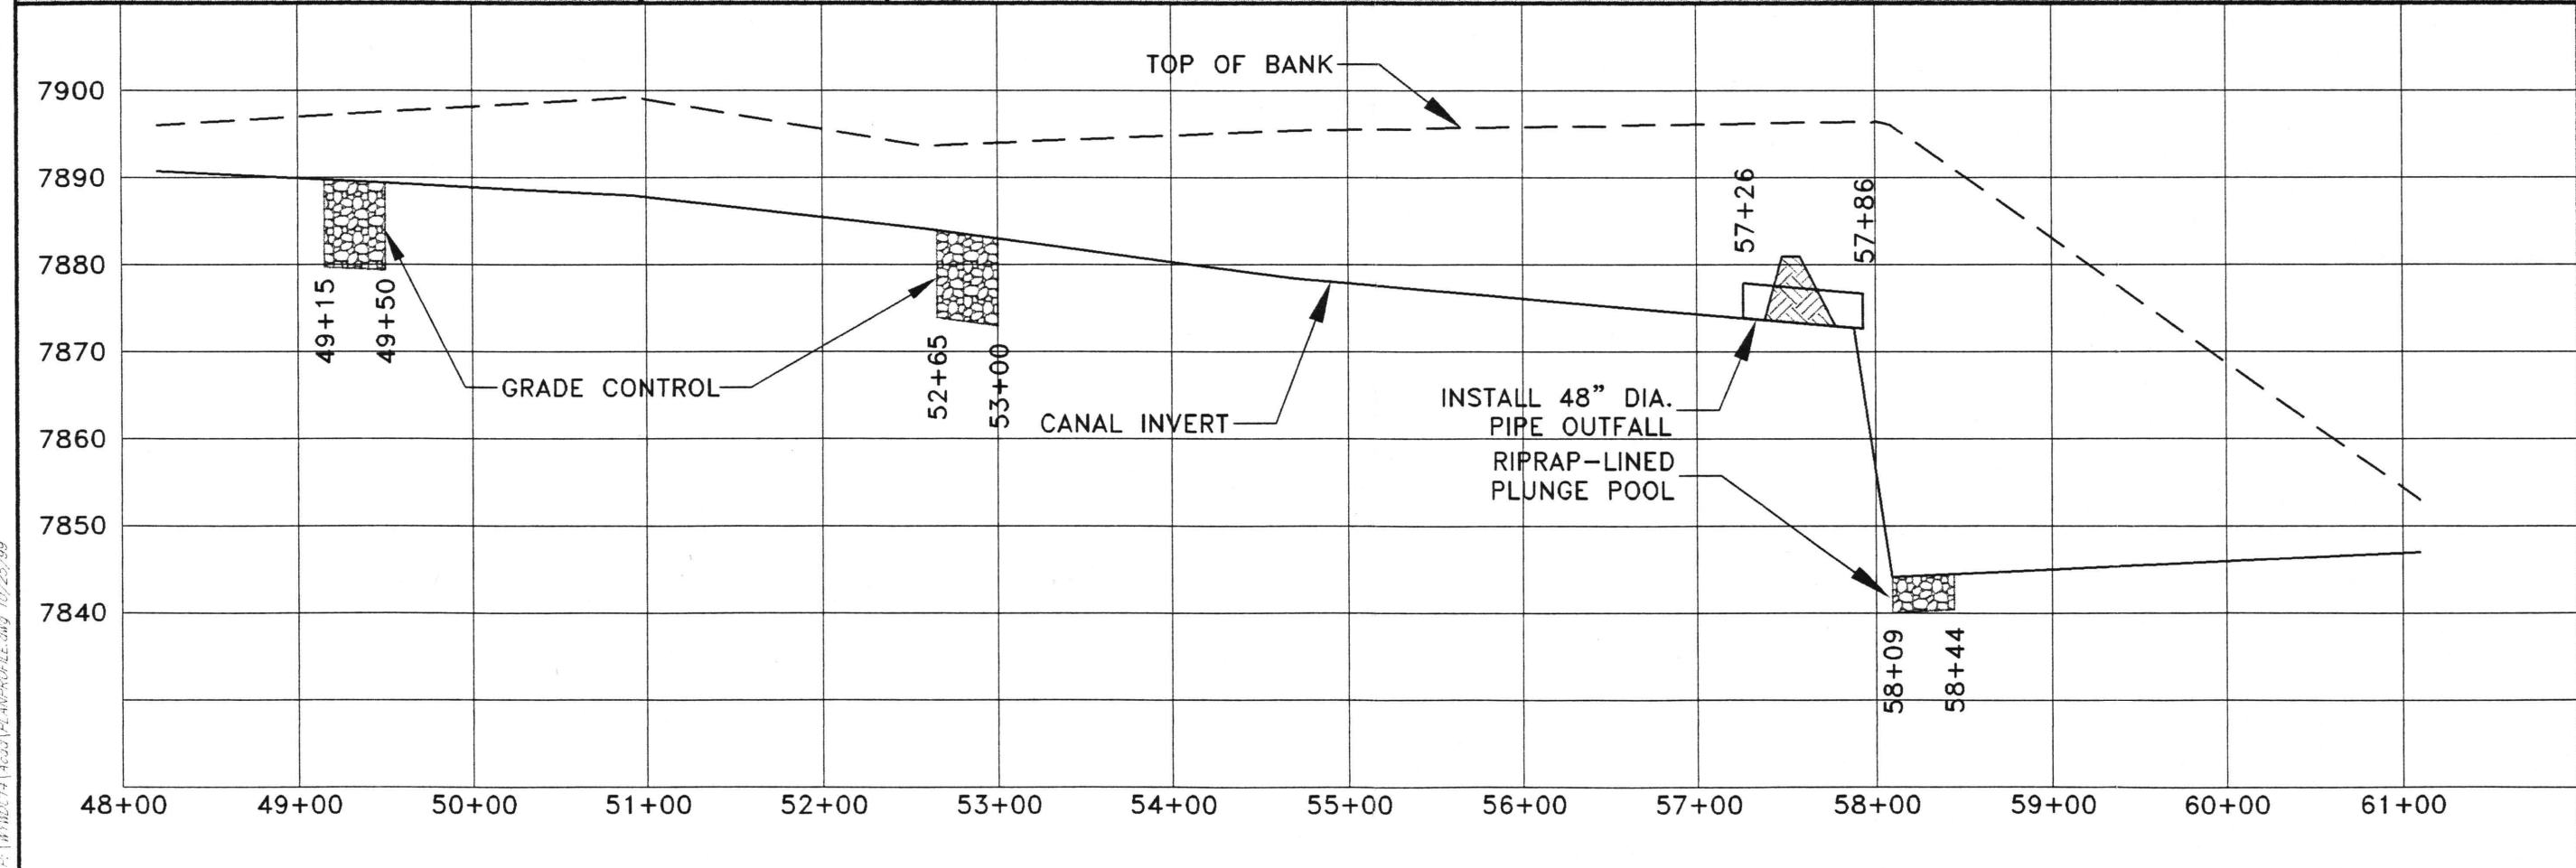
HIGHLINE WATERSHED IMPROVEMENT DISTRICT  
DITCH PROJECT LEVEL II  
CONCEPTUAL DESIGN PLAN AND PROFILE:  
HIGHLINE WASHOUT REHABILITATION ALT. D

The recommended alternative for rehabilitation of the Highline No. 4 Ditch consists of stabilization of the existing ditch as described below:

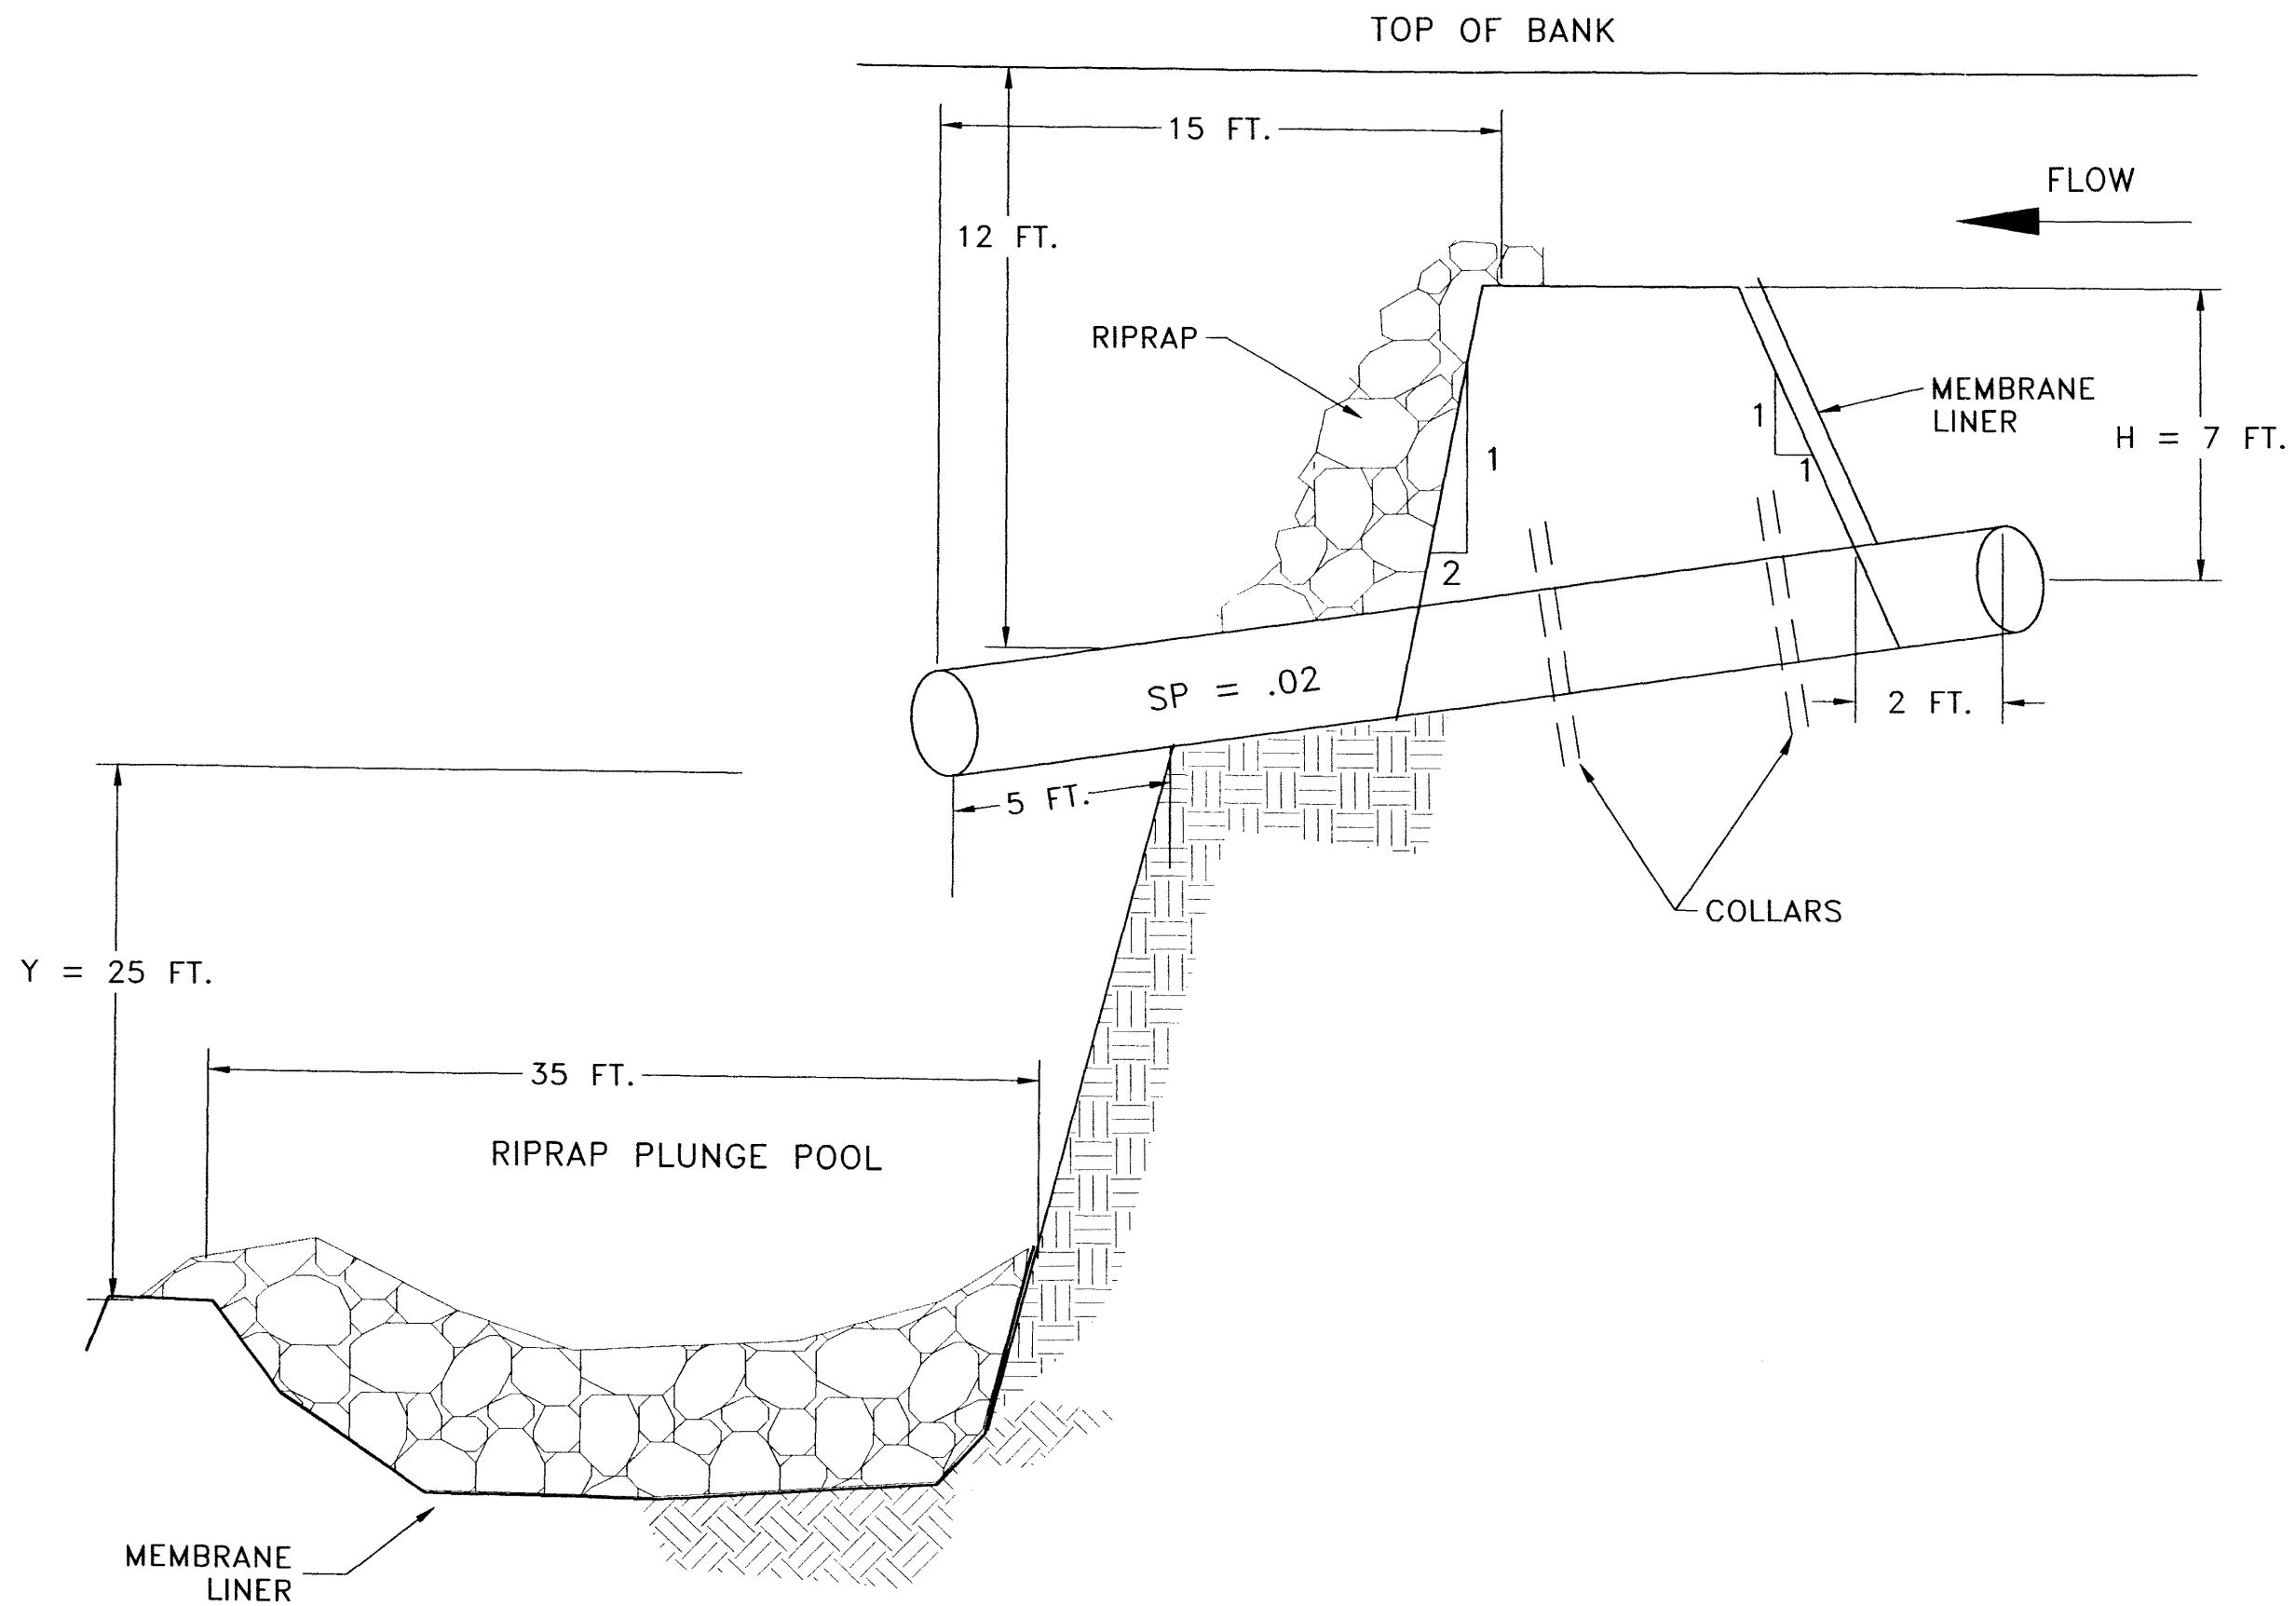
HIGHLINE No. 4 DITCH PIPE OUTFALL  
STRUCTURE PROFILE VIEW

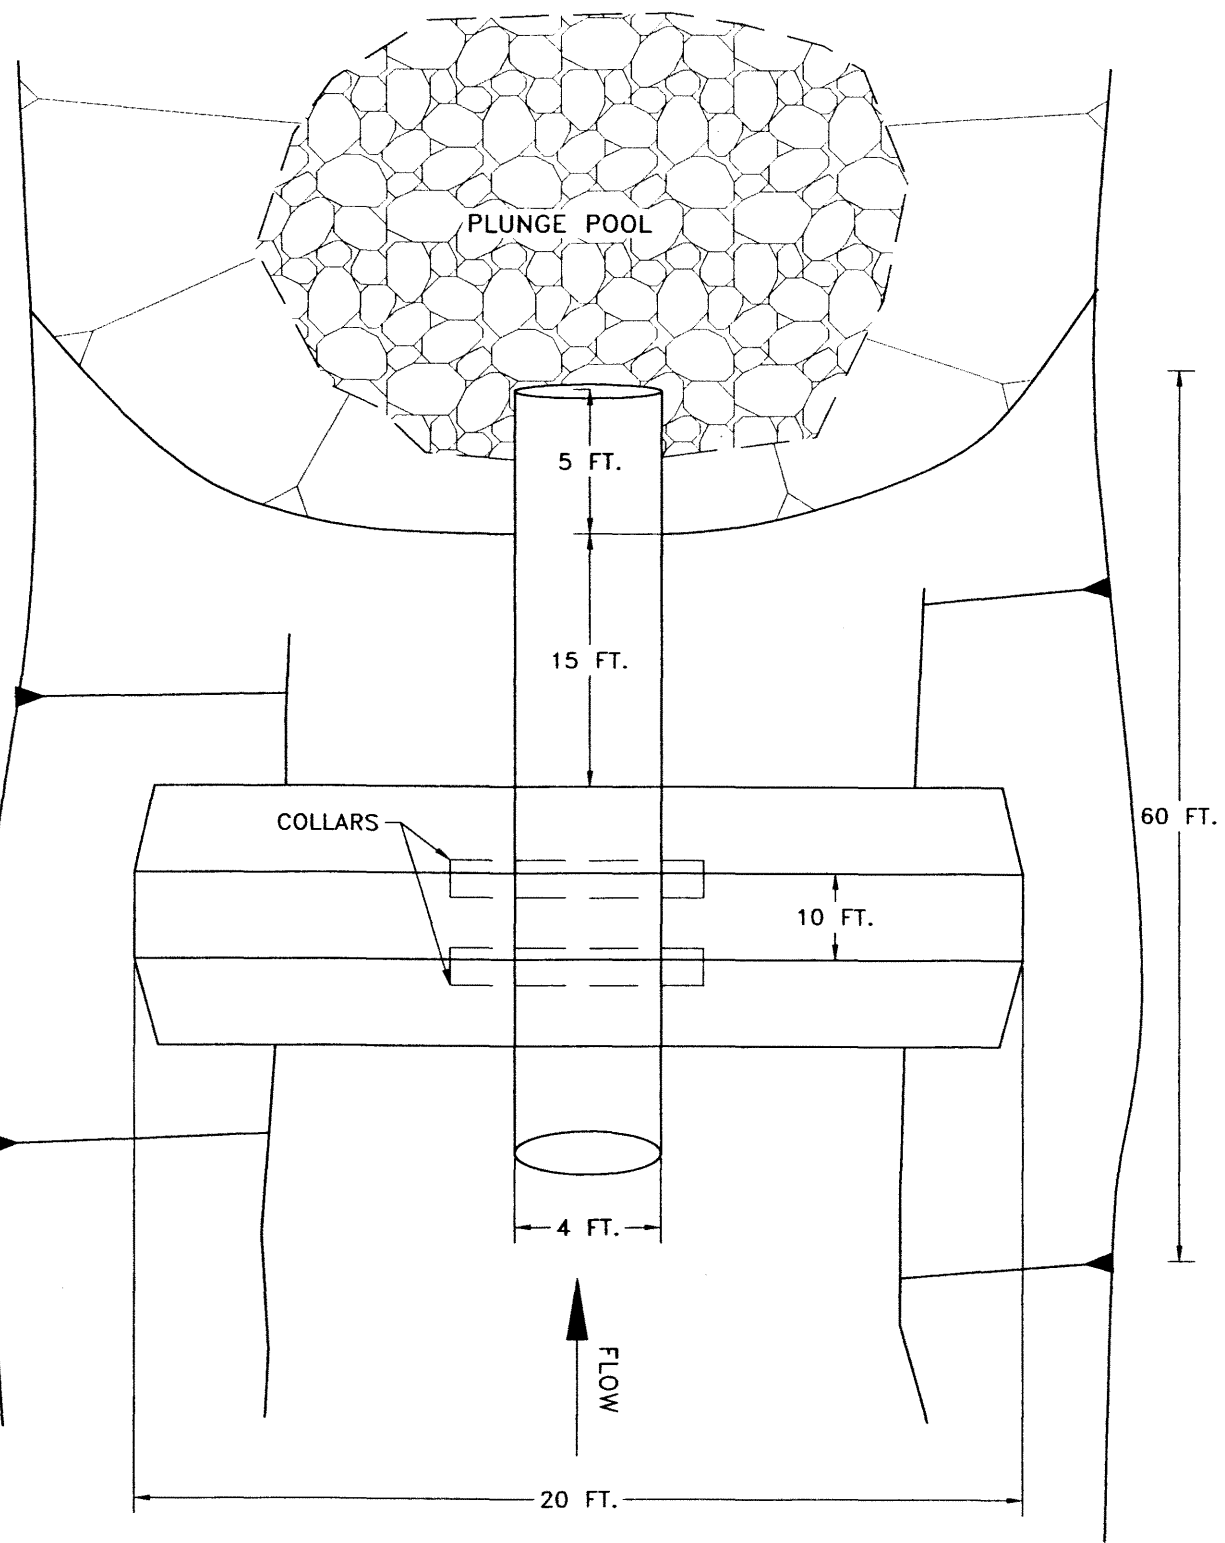
**HIGHLINE No. 4 DITCH PIPE OUTFALL  
STRUCTURE PLAN VIEW**

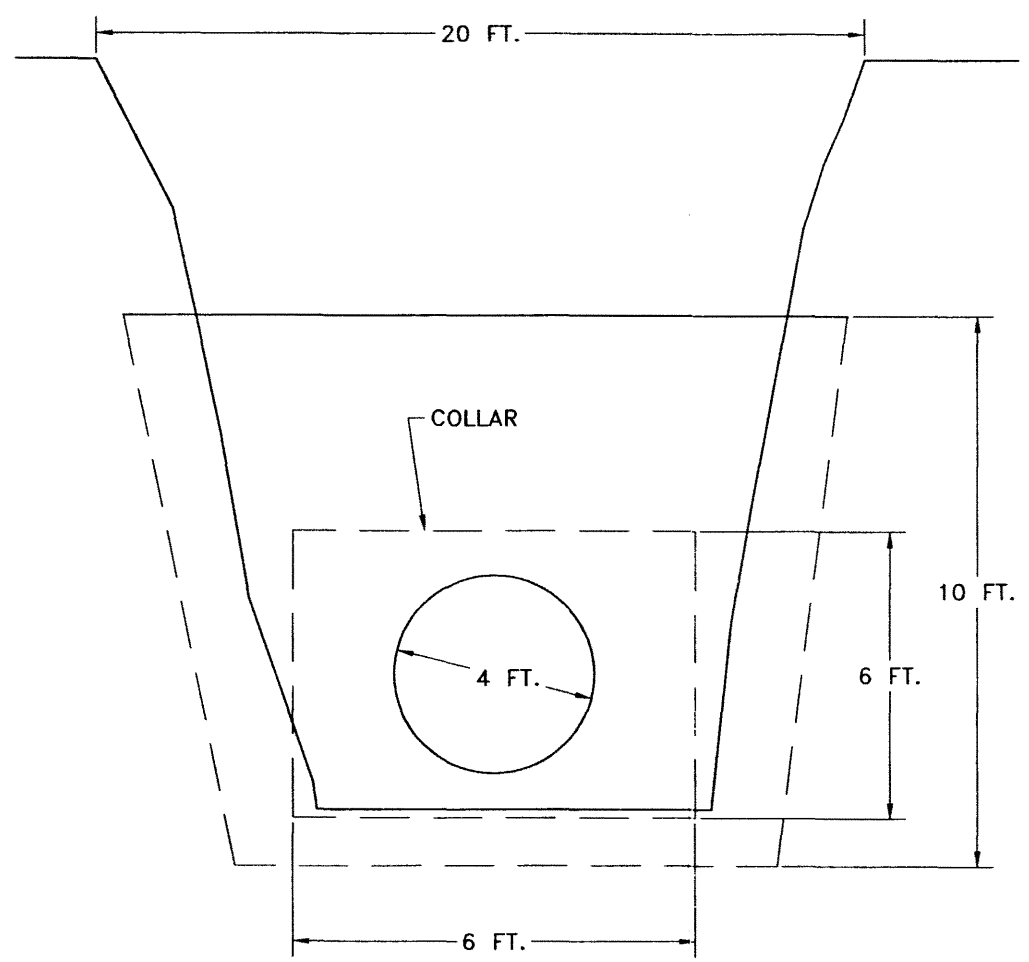
**HIGHLINE No. 4 DITCH PIPE OUTFALL STRUCTURE  
CROSS SECTION VIEW**

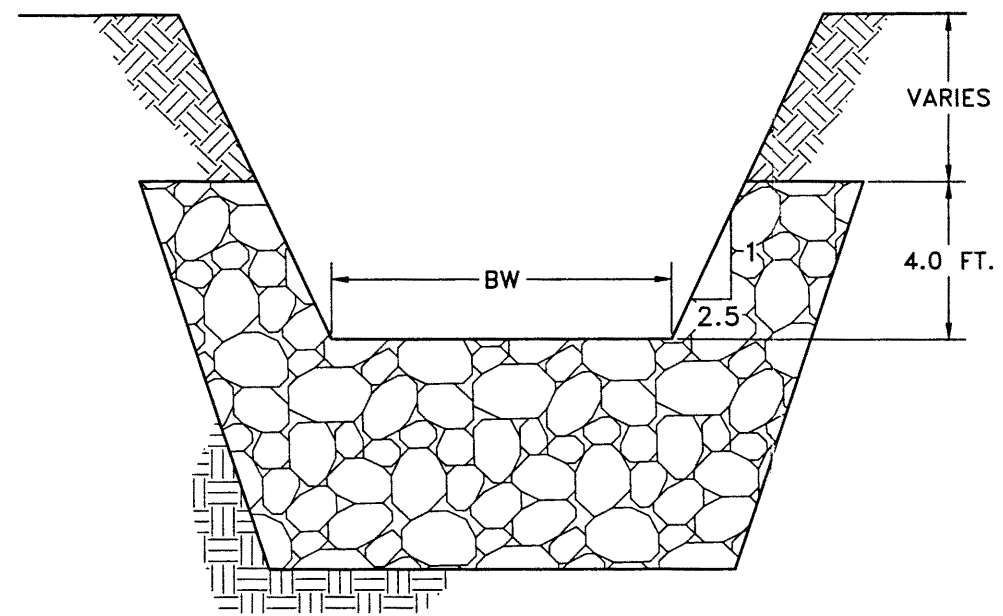
TYPICAL GRADE CONTROL STRUCTURE - CROSS SECTION VIEW  
NOT TO SCALE

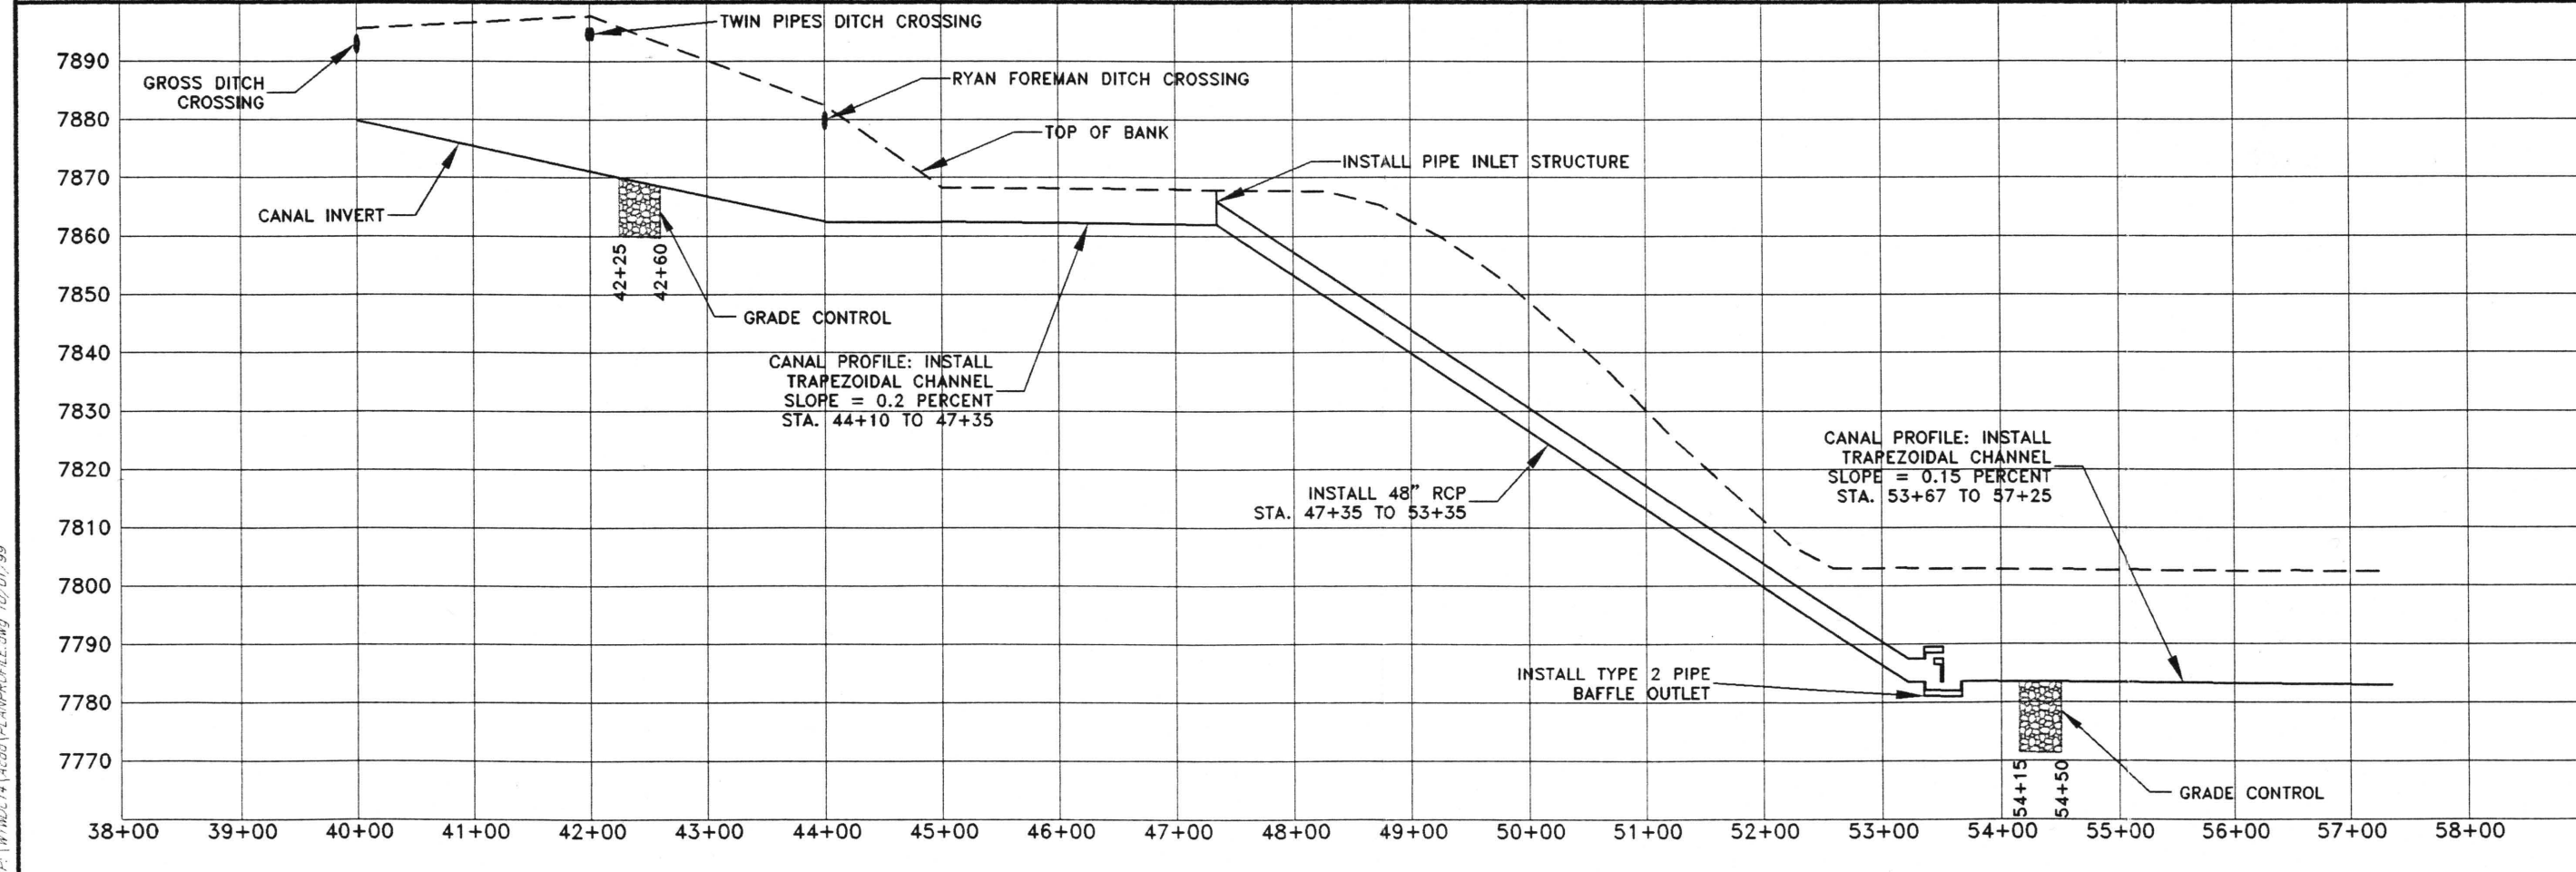
HIGHLINE WATERSHED IMPROVEMENT DISTRICT  
DITCH PROJECT LEVEL II  
CONCEPTUAL DESIGN PLAN AND PROFILE:  
WIANT WASHOUT REHABILITATION ALT. D

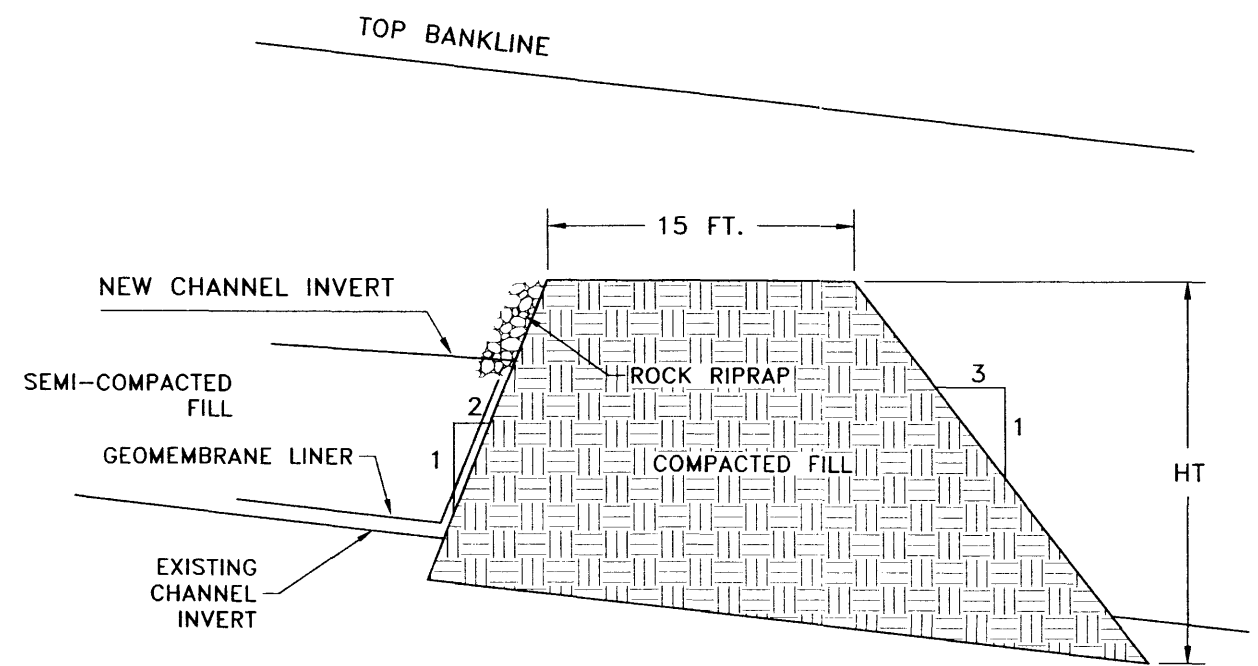
TYPICAL DIVERSION BERM - PROFILE VIEW  
NOT TO SCALE

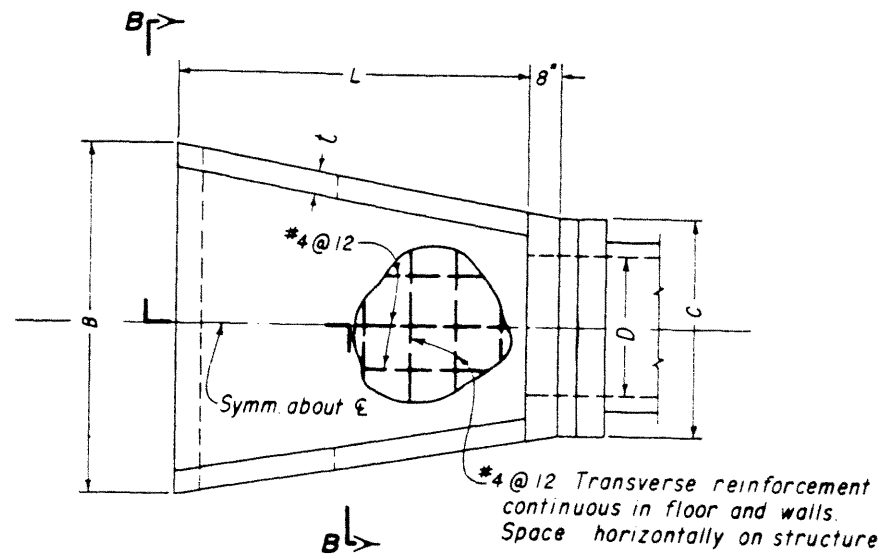
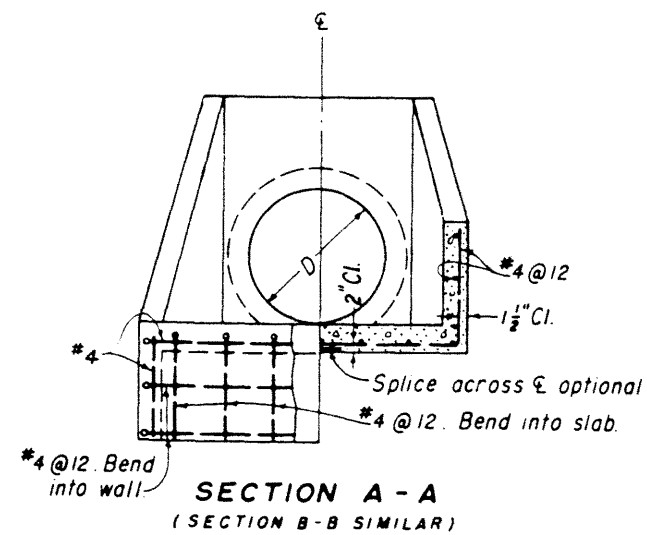
WANT DITCH REHABILITATION  
PIPE INLET DETAIL

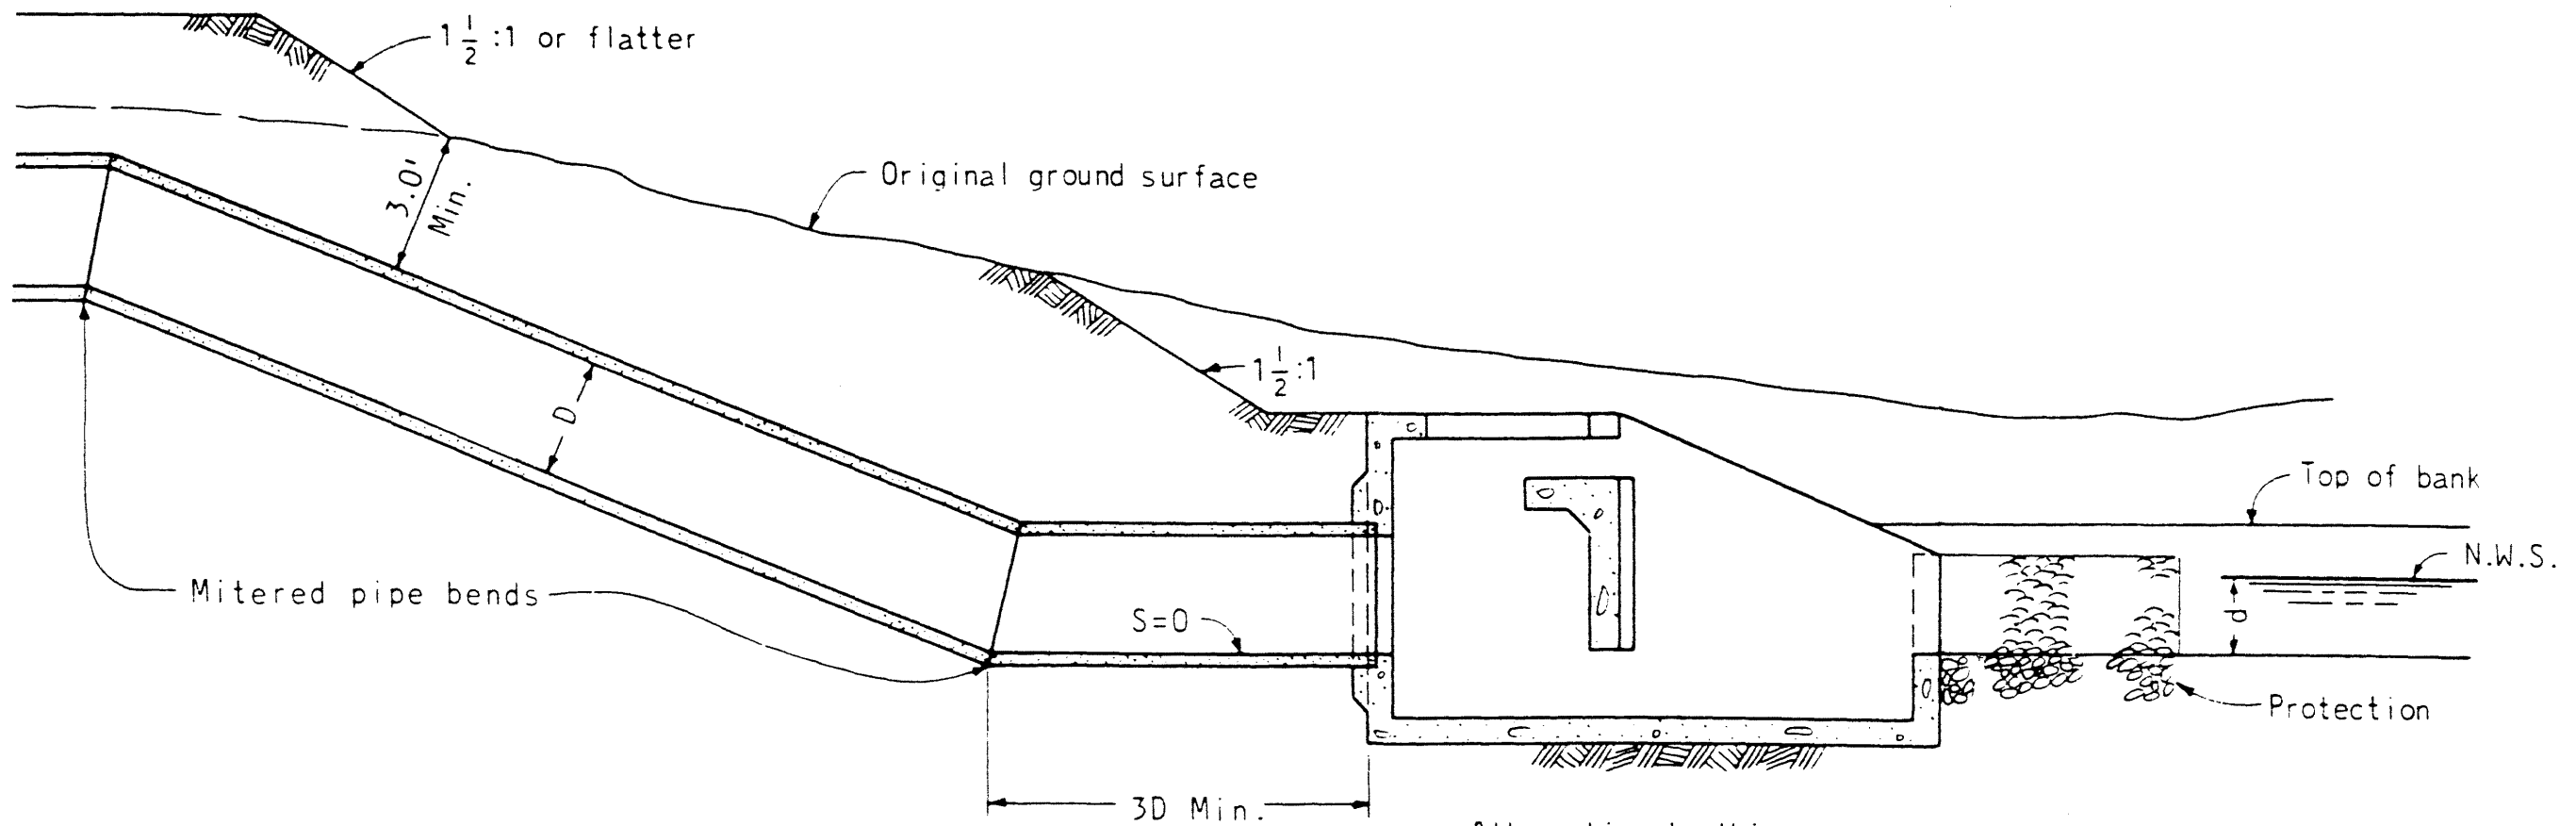
Alternative to this baffled outlet is a stilling pool.

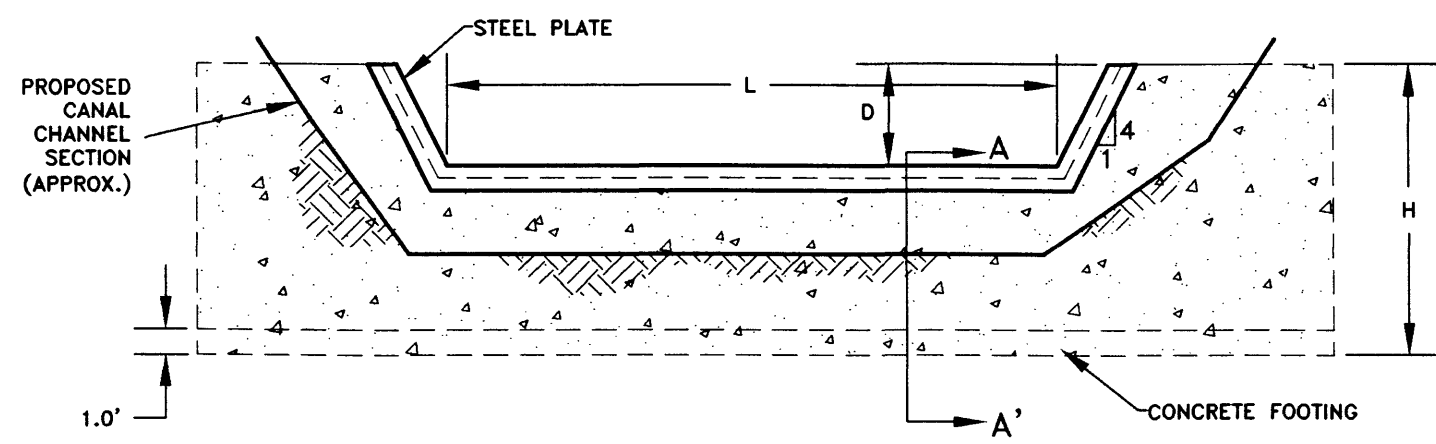
**WEIR SECTION**  
(LOOKING DOWNSTREAM)  
N.T.S.

Currently, there are no measurement structures at Diversion Structure Nos. 1, 2, or 3. This alternative involves incorporation of Cipolletti weirs on the main ditches at these locations. In

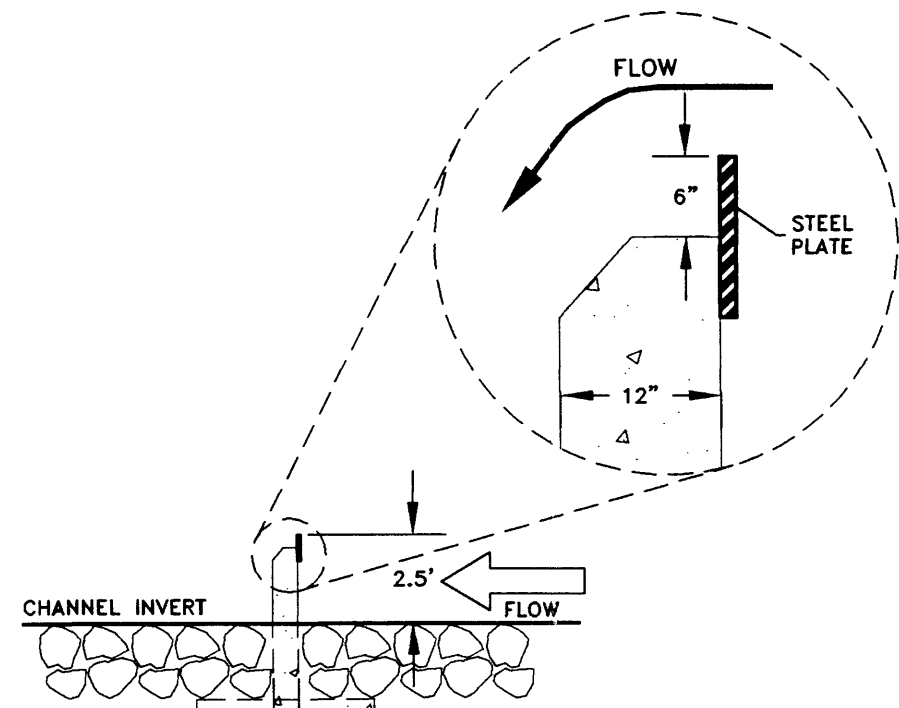
**SECTION A-A'**  
N.T.S.
