# FINAL REPORT

## Highline Watershed Improvement District Ditch Rehabilitation Project Level II

Anderson Consulting Engineers, Inc.  
2900 South College Avenue, Suite 3B  
Fort Collins, CO 80525  
(ACE Project WYWDC14)

November 1, 1999

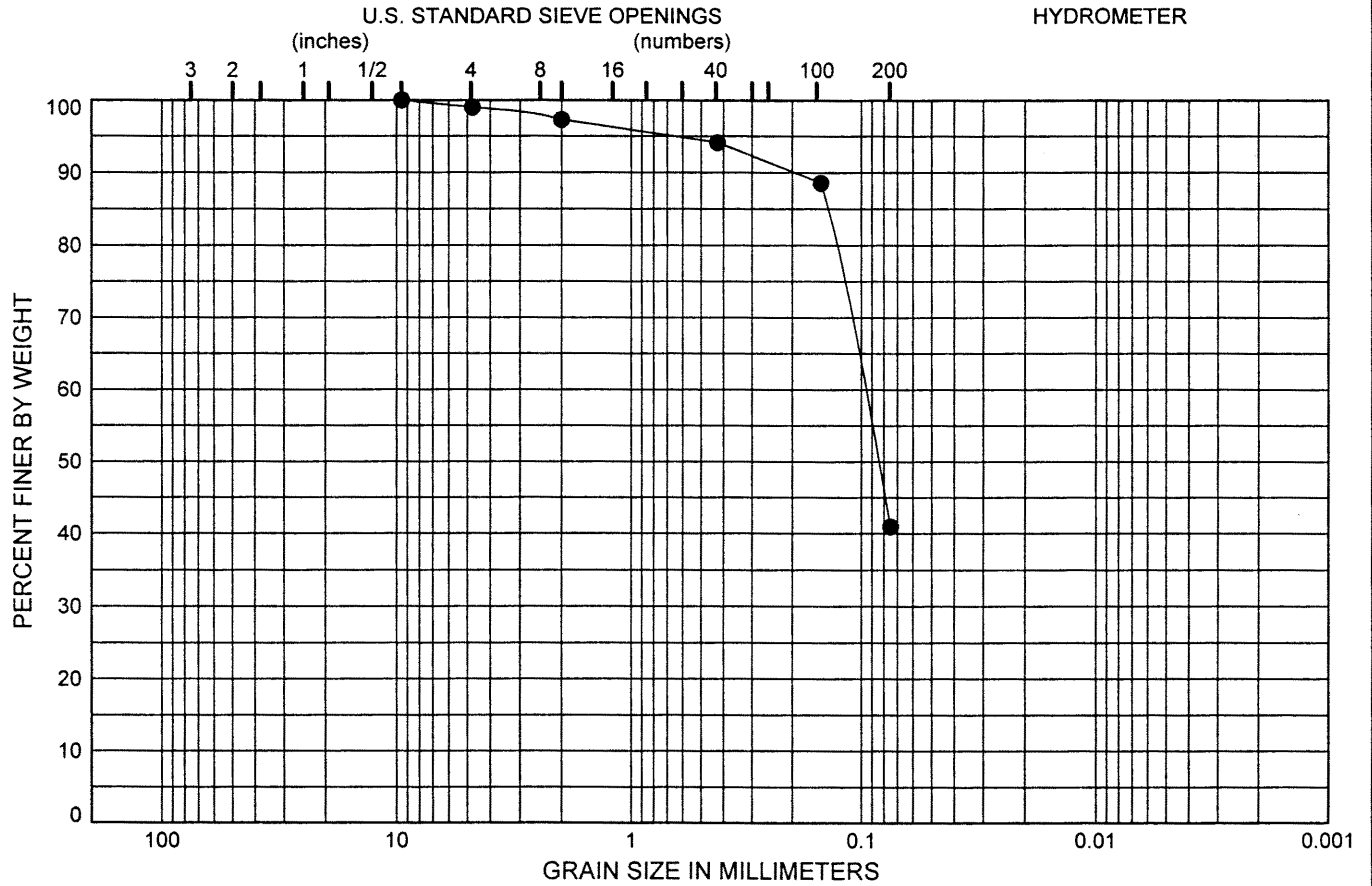
SOIL DESCRIPTION: Pale Brown, Silty Fine Sand SAMPLE NO.: S-1  
 SOURCE: Ryan Foreman Ditch DEPTH: 0  
 SAMPLED BY: SFM

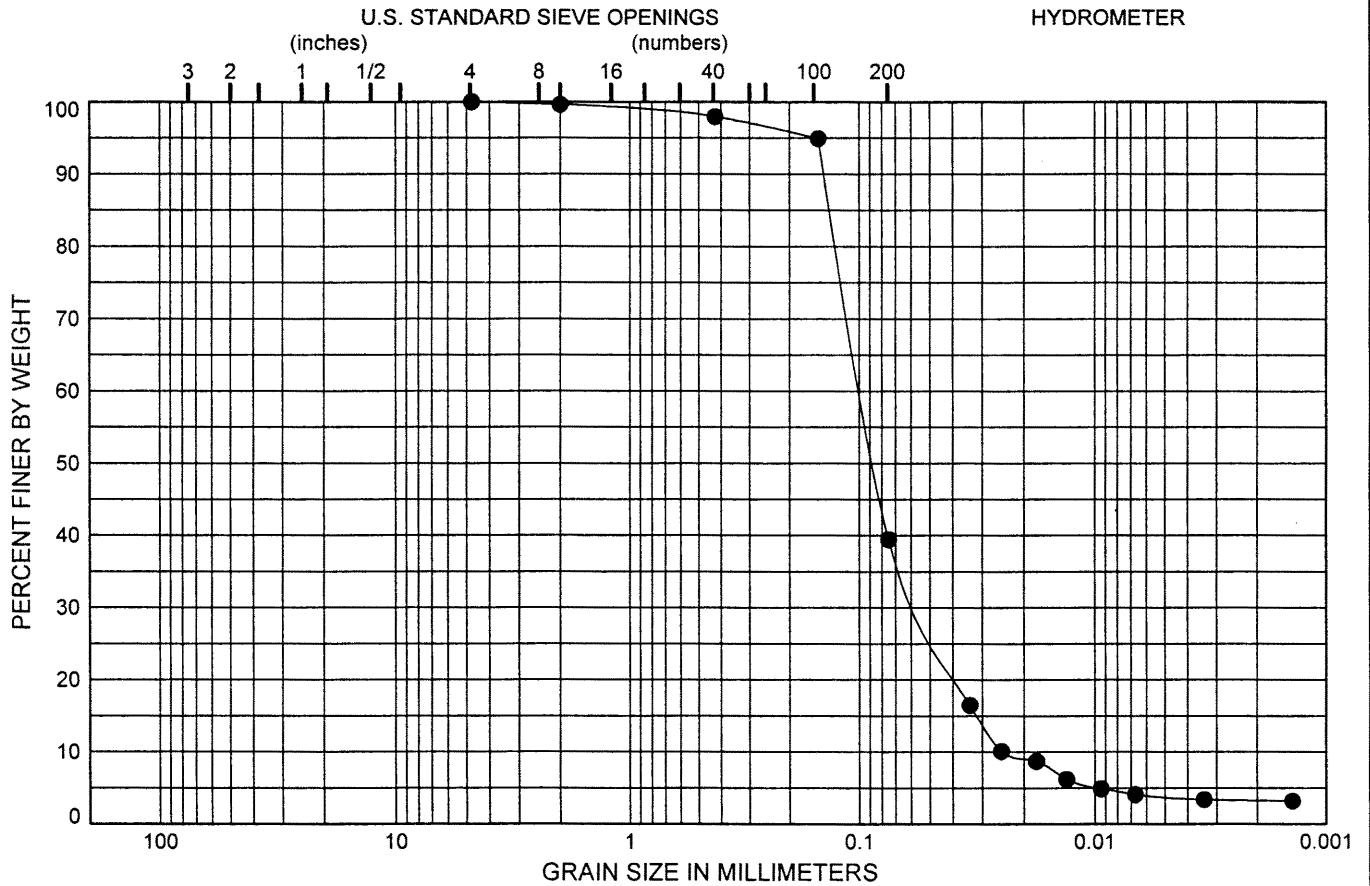
SOIL DESCRIPTION: Yellowish Brown, Silty Fine Sand SAMPLE NO.: S-3  
 SOURCE: Wiant Ditch DEPTH: 0  
 SAMPLED BY: SFM

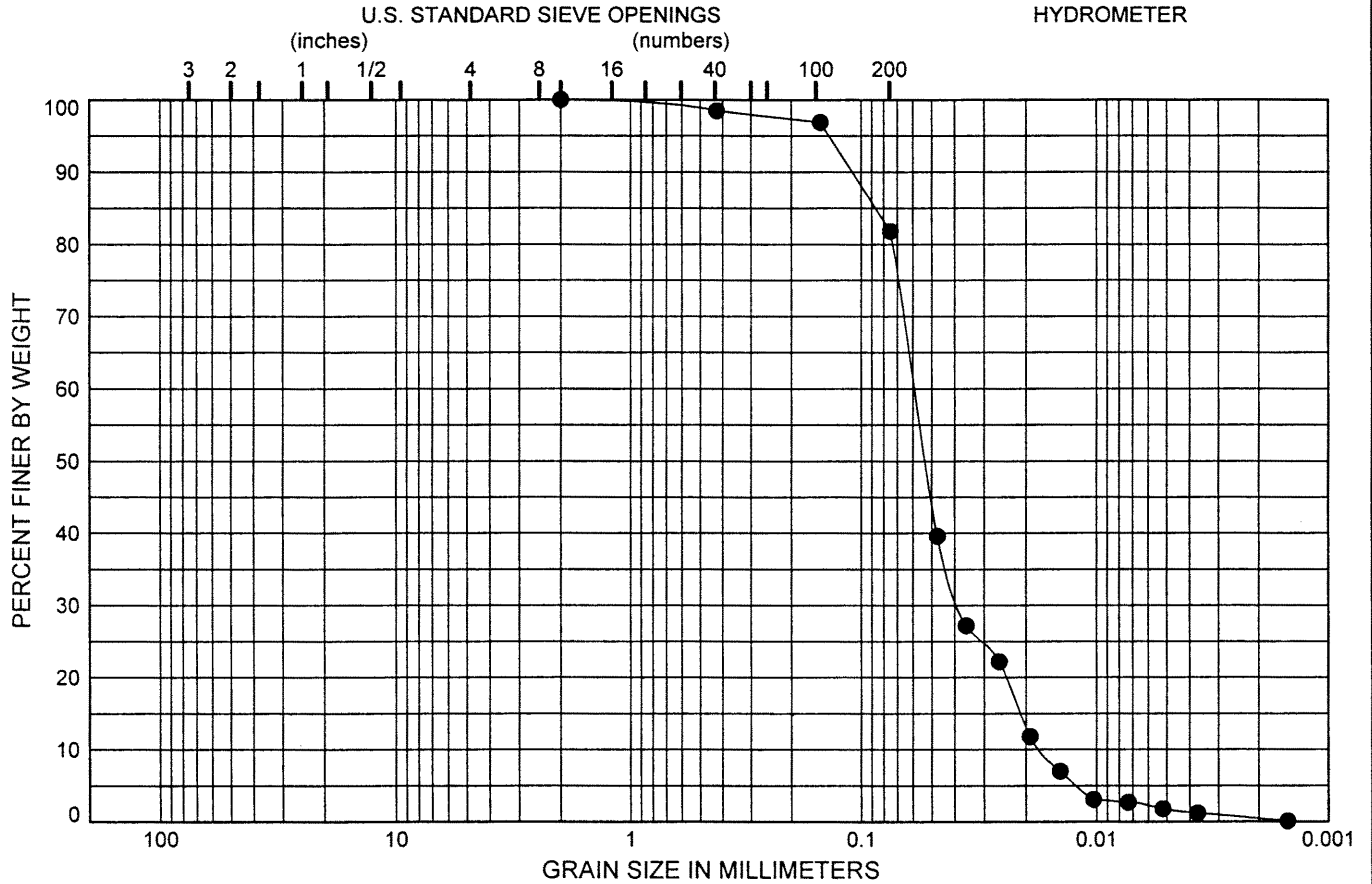
SOIL DESCRIPTION: White, Fine Sandy Silt SAMPLE NO.: S-4  
(Sandstone) SAMPLED BY: SFM  
 SOURCE: Wiant Ditch DEPTH: 0

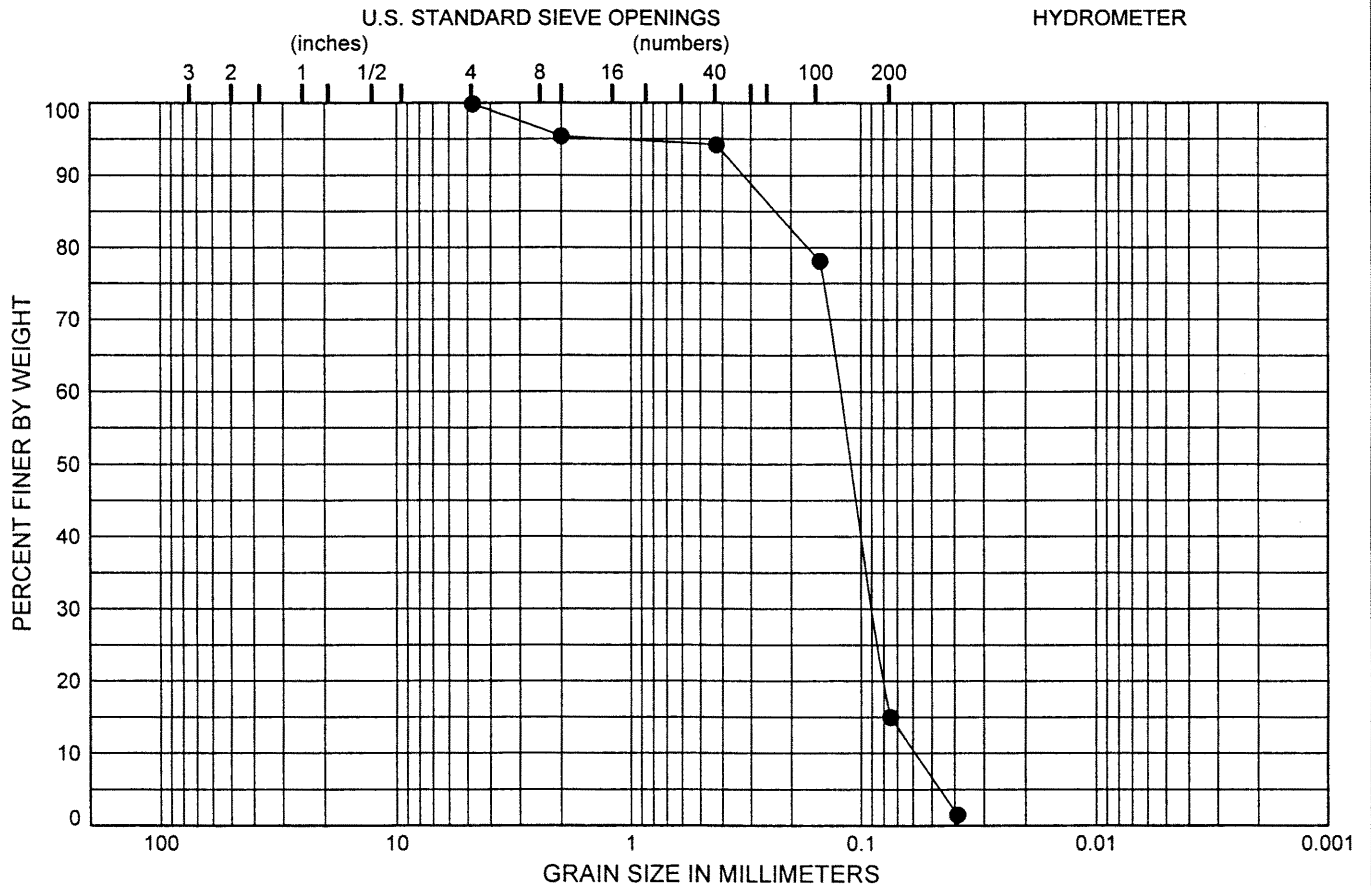
SOIL DESCRIPTION: Light Gray, Silty Fine Sand SAMPLE NO.: S-5  
 SOURCE: Highline Ditch DEPTH: 0  
 SAMPLER BY: SFM

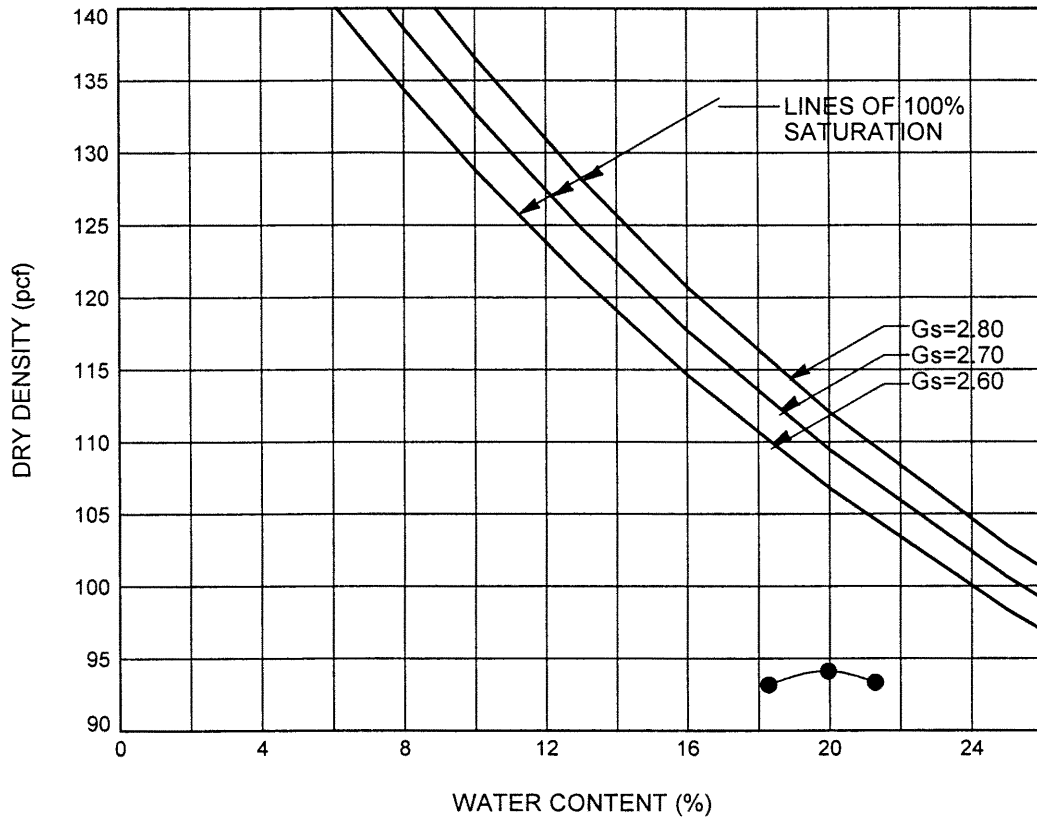
SAMPLE NO.: S-8 SOIL DESCRIPTION: Light Brown, Silty Fine Sand  
 SAMPLED BY: SFM  
 DEPTH: 0 SOURCE: Wiant Ditch
