WYOMING WATER DEVELOPMENT COMMISSION
KIRBY CREEK WATERSHED PLAN
LEVEL I STUDY

SUNRISE ENGINEERING, INC.

KIRBY CREEK WATERSHED PLAN LEVEL I STUDY

September 12, 2005

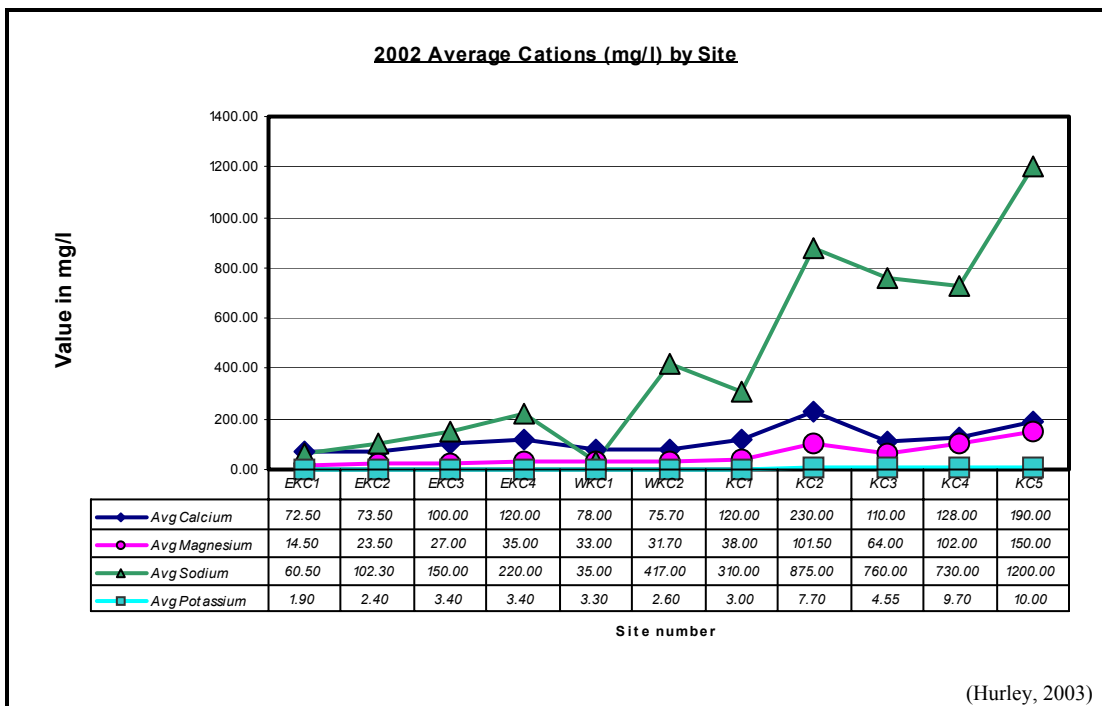
EXHIBIT 2.14.2 – AVERAGE CATIONS BY SITE

Exhibit 2.14.2 shows that the most dominant cation in the waters of Kirby Creek is sodium, followed by calcium, magnesium, and potassium. The presence of cations generally increases from upstream to down stream, with the same KC2 spike that was visible in testing for TSS and turbidity.

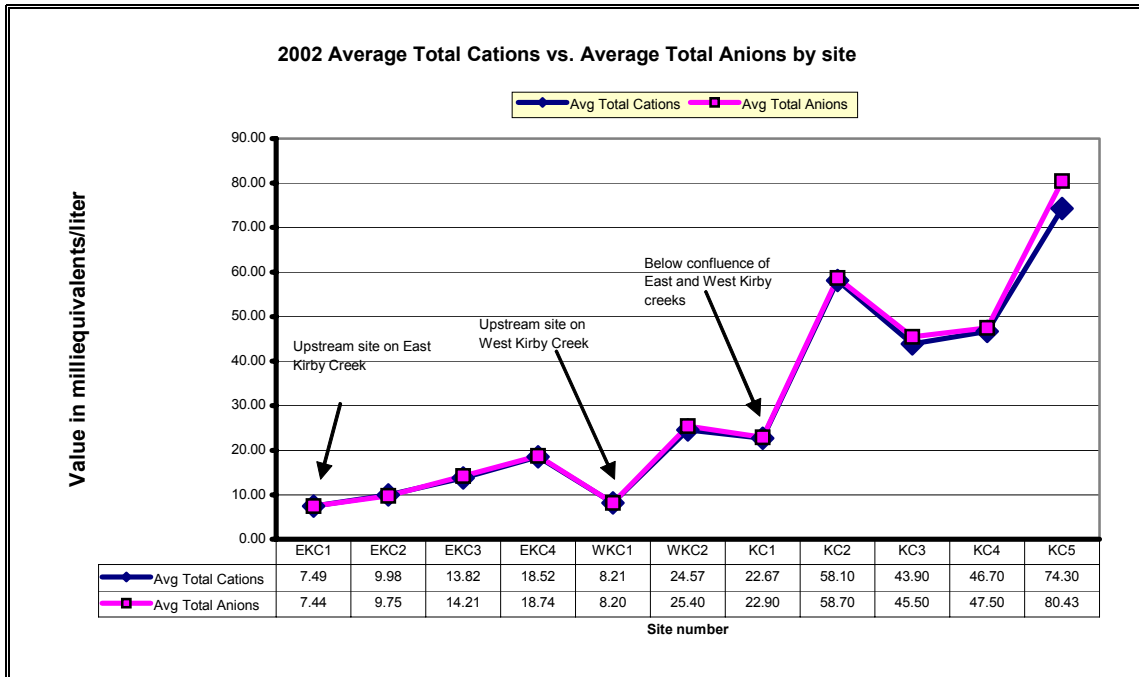
EXHIBIT 2.14.5 – AVERAGE TOTAL CATIONS/ANIONS

Exhibit 2.14.5 shows the average total cations per site vs. the average total anions per site for the sites sampled. This graph shows that the cations and anions closely match each other at each site, with a steady increase in concentration from upstream to downstream sites.

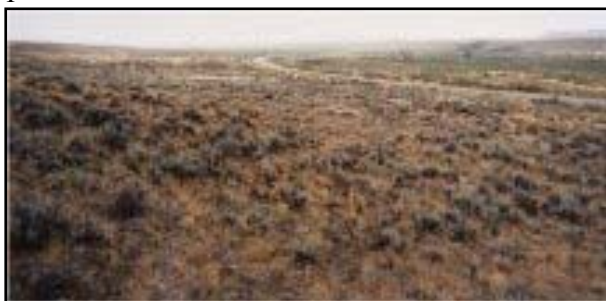
Photograph 1. View of the lower Kirby Creek Valley looking downstream towards the Big Horn River 12 miles away. The creek is to left of the road where the vegetation appears greener.

In the lower catchment, the valleys are wide (Photograph 1) and the valley slope is a modest 0.45 percent. In much of this region, the streams are gullies in various stages of erosion and deposition. In the last 2 miles as it approaches the Big Horn River, Kirby Creek is in the backwater influence of the river. Here the creek is stable and well vegetated (see Transects 1 and 4 and Geological Map).

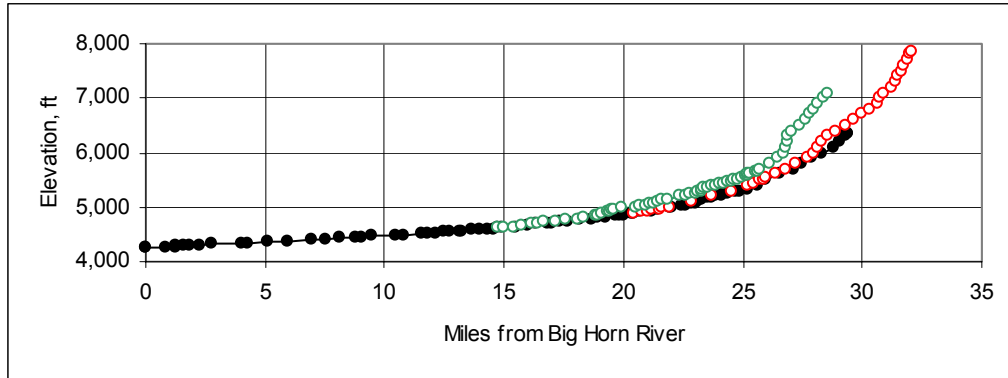
EXHIBIT 5.2.1 – VALLEY PROFILE

The valley profiles of the three creeks are very similar (Exhibit 5.2.1). Stationing begins at the Black Mountain Road Bridge over the Big Horn River (Mile 0.0). From the Big Horn River to the confluence of Alkali Creek, Kirby Creek is slight sinuous, running in a broad alluvial valley (Photograph 1) filled with sediment from past geological erosion periods.

Valley profile of Kirby Creek (black), West Kirby Creek (red) and Alkali Creek (green). The Alkali confluence is at Mile 14.7; the West Kirby is at Mile 20.5. The contour interval on the 1-to-24,000 scale topographic maps used here is 20 feet.

From the confluence of Kirby and Alkali Creeks to the Big Horn the valley slope is 0.45 percent. The Alkali confluence is 14.7 miles upstream. Between Alkali and West Kirby, the Kirby Creek valley narrows up and the slope doubles to 0.9 percent. The West Kirby Creek confluence is 20.5 miles upstream from the Big Horn. In the headwaters, all three creeks have valley slopes of approximately 15 percent.

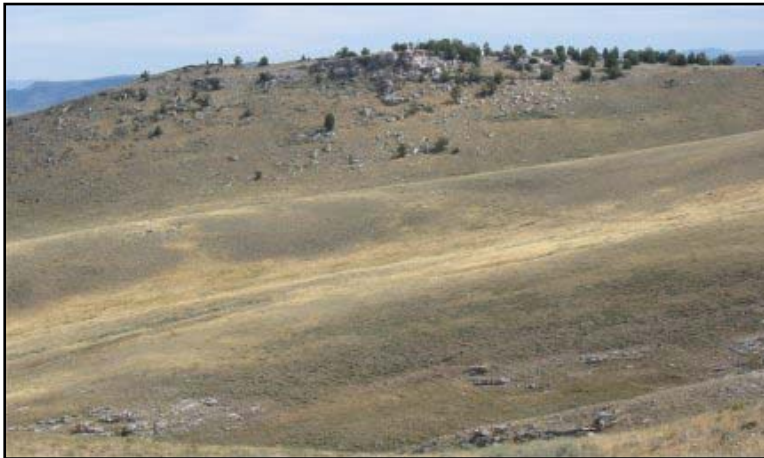
The smallest drainages are grassed swales (Photograph 2 and Transects 70 and 75), the yellow part of the waterway in the center of the photo. In the lower part, the vegetation is green; perhaps sedge as seepage water appears. Here the divide is capped by hard rocks, some of which have rolled down the slope. Otherwise, most everywhere there is a layer of soil.

Photograph 2. Grassy swales are the lowest order of streams in the upper catchment. This is not a stream type in the Rosgen classification.

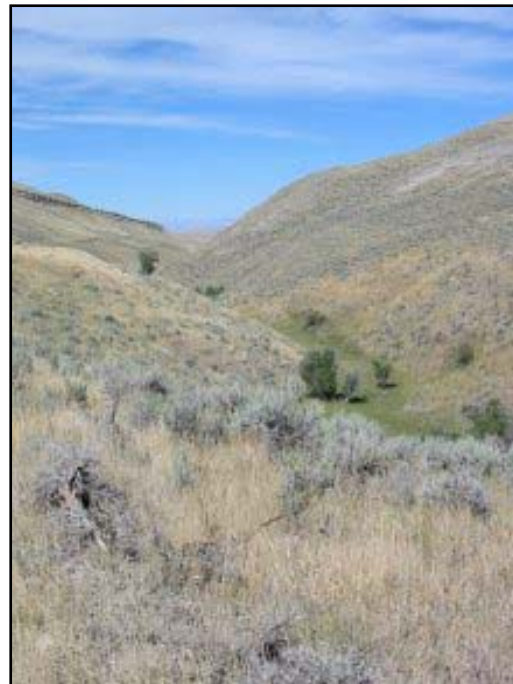
Grassy swales turn into narrow defined waterways with grassed bottoms and a few small trees (Photograph 3). Off to the sides there is brush. As the stream order increases, there is more variability to the stream character.

Photograph 3. A small stream in the upper catchment.

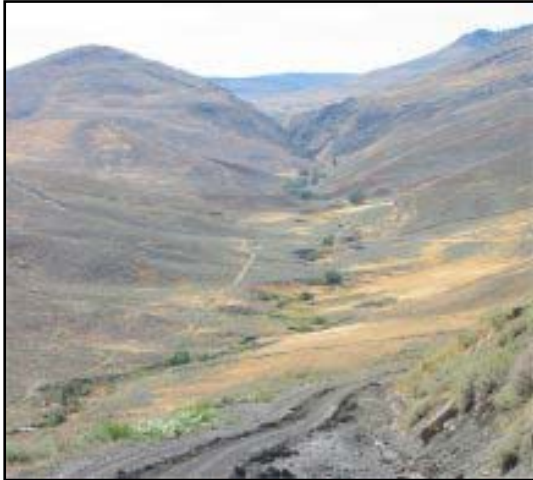
Photograph 4 is of West Kirby Creek eroding a canyon through hard rock and then winding down a broader valley. In this reach, the creek bottom is grassed in most places. It is joined by a grassy swale on the right. The scar on the left side is the pipeline right-of-way.

Photograph 4. West Kirby Creek in the upper catchment.

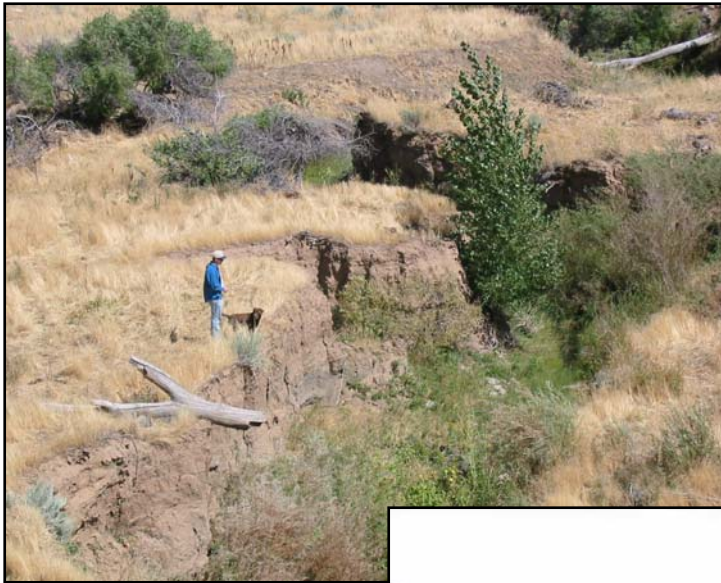
Transect 47 is a Rosgen G6 type Level II stream. The wetland upstream from the headcut is in a very flat reach and has a very small E6 stream.

Photograph 5. Looking downstream at a deep and narrow gully Type G6 in West Kirby Creek.

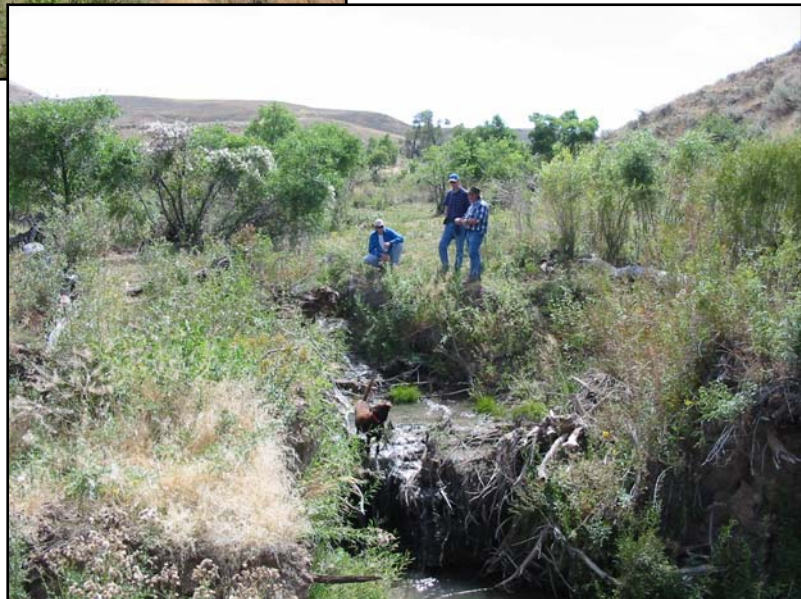
Photograph 6. Looking upstream at the two headcuts in a West Kirby Creek gully.

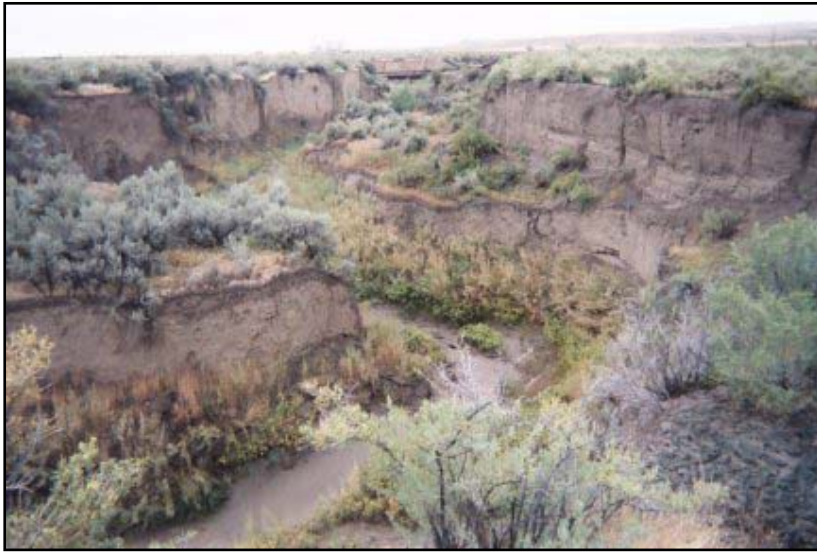
Red Hole Road 1426 branches off the Black Mountain Road approximately 6.7 miles upstream from the Big Horn River. Kirby Creek used to pass through a culvert under Red Hole Road. This culvert was washed out and replaced by a single span bridge. In destroying the culvert, Kirby Creek began headcutting upstream, entrenching itself again in its old gully. Photograph 7 is a view of the present conditions. The floor of the previous gully is now a terrace with a growth of brush. The banks of both the new and old incisions are nearly vertical and bare. At the base of the new downcutting, vegetation has been established, narrowing the base flow of the creek. Transect 87 is in this reach, a Level II Rosgen Type G6 stream, gullied twice or a gulley within a gulley.

Photograph 7. View looking downstream at Kirby Creek incising itself upstream from the Red Hole Road. The bridge is visible as the dark object in the upper center of the photo. This stream is a Rosgen Type E.

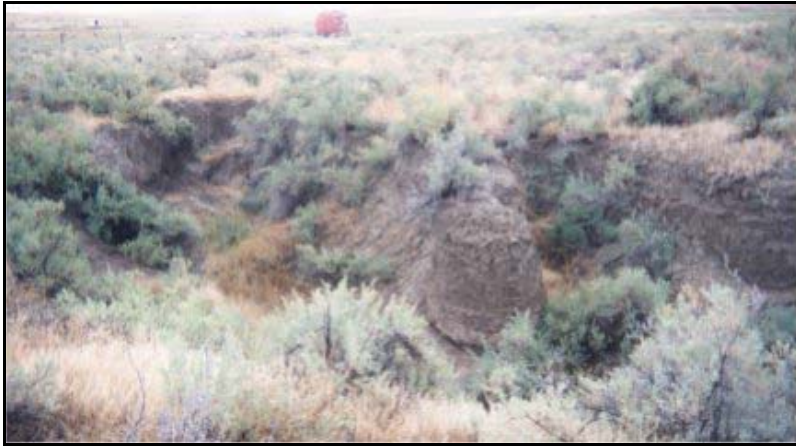
Photograph 9. Two headcuts in a small tributary to Kirby Creek near Red Hole Road.

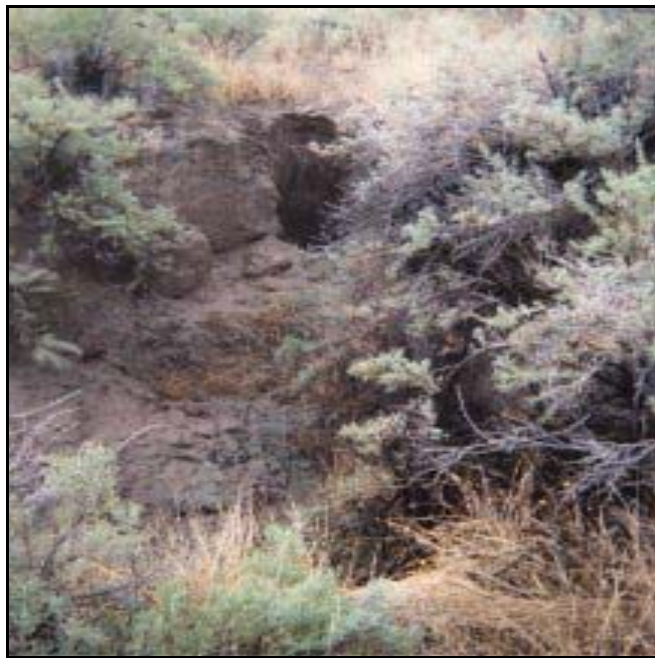
Photograph 10. Water from the tributary enters the Kirby Creek gully through the ‘pipe,’ the black hole in the ground (upper center of photo) from the tributary bed level to the vertical bank of the creek

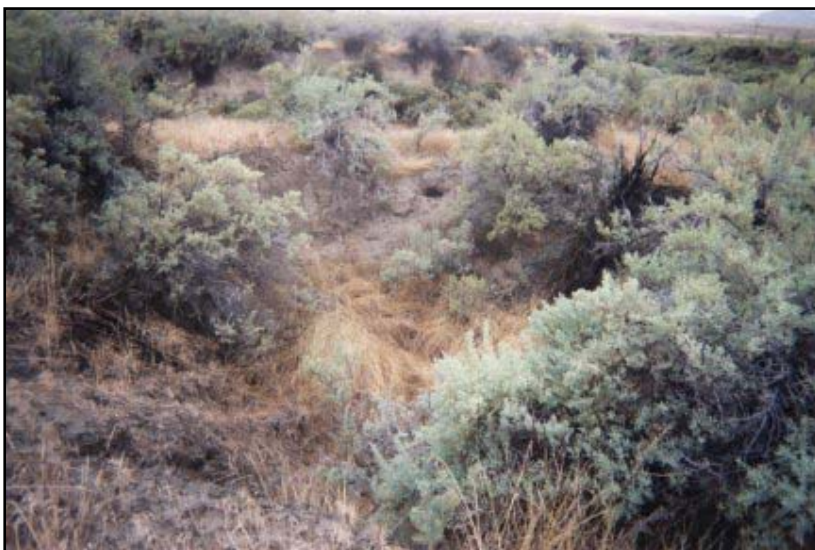
Photograph 11. A small tributary (foreground) flowing down towards a gully (background) entering through a ‘pipe’ in the ground. The entrance to the pipe is the small black hole in the upper center of the photo.

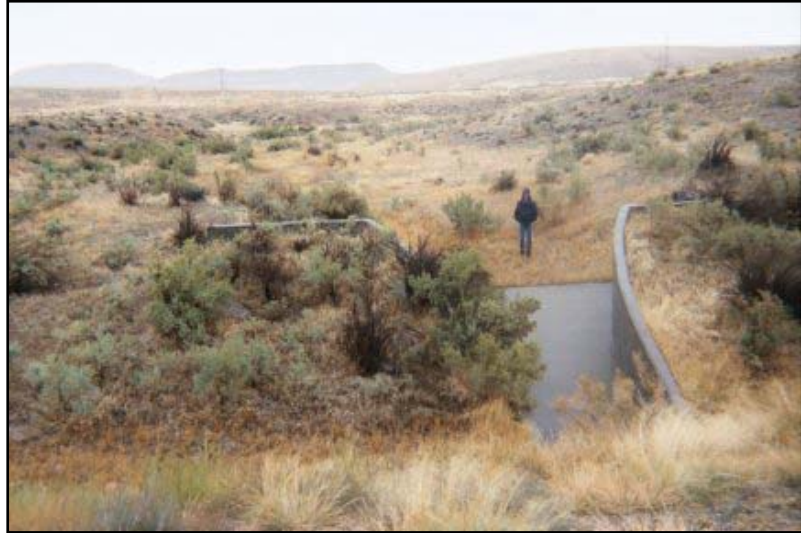
Photograph 12. Curved inlet to box culvert under Black Mountain road. Upstream, there is no channel, only a grassy swale in may have been a gully in the past.

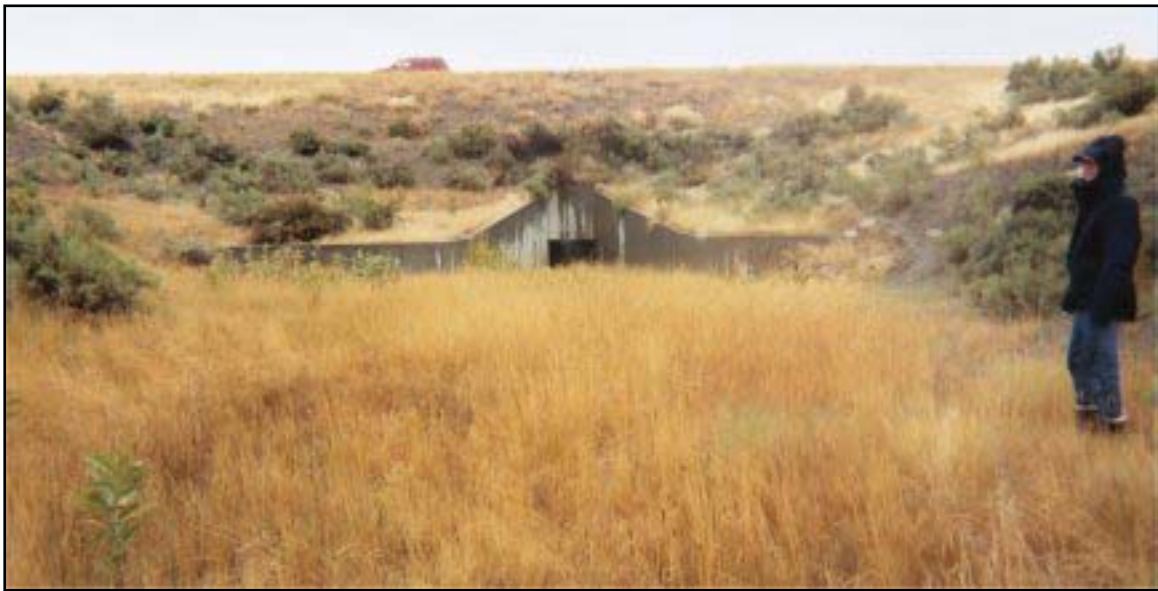
On the downstream side conditions are different (Photograph 13). There is an old gully here with a newly deposited flat bed of clay covered with grass. The tops of the gully banks are still raw and vertical. There has been bank slumping so that the bottom is sloped and supporting vegetation.

Photograph 13. Outlet of the box culvert under Black Mountain Road. The stream bed is recently deposited sediment with large drying cracks and a dense growth of grass.

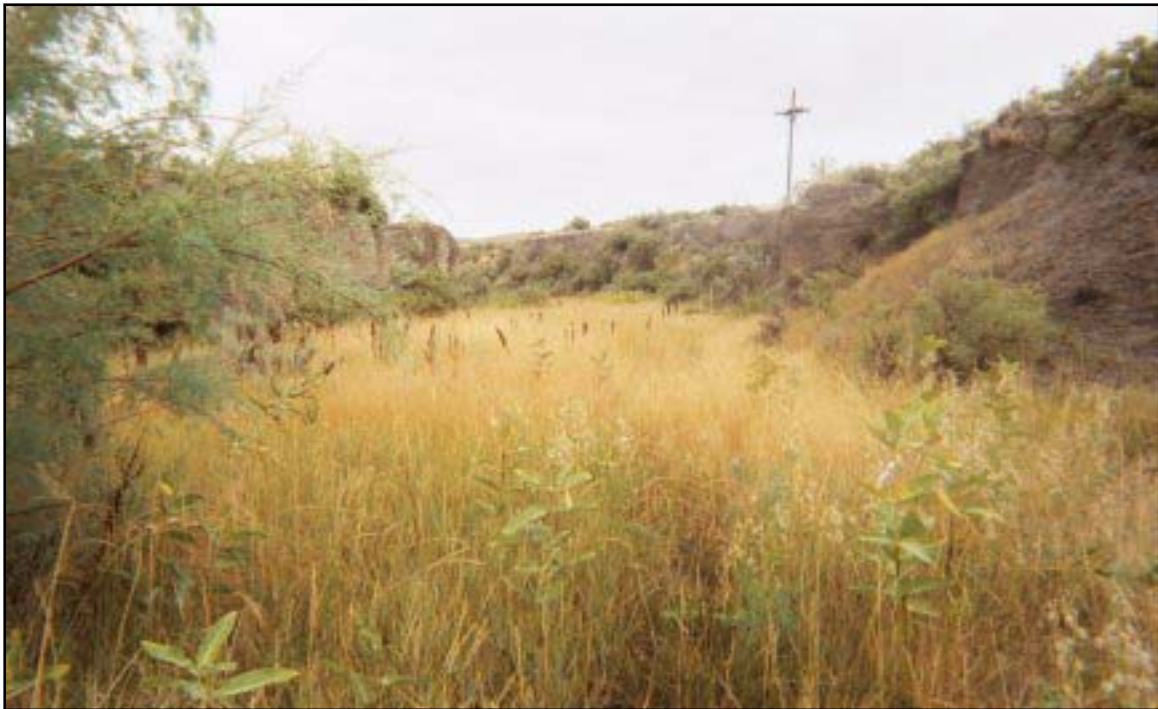
Photograph 14. Looking upstream in a tributary gully to Kirby Creek. The gully is downstream from the box culvert under Black Mountain Road. The tree on the left side is a tamarisk.

Where this tributary enters Kirby Creek, the creek is a wide gully formed in the past and now heavily infested with the trees, brush, plants and grasses. A small incised inner channel carries the lower flows. The tributary flows into the creek at the terrace level.

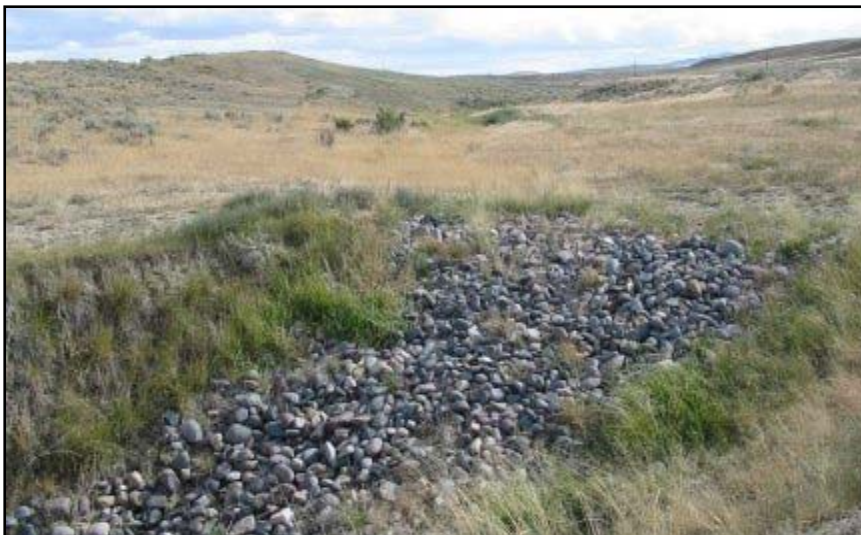
This gully headcut has been arrested by grading the cut and covering it with riprap (Photograph 15). The headcut was repaired in 1998. The gully had been excavating itself in a wide shallow grassy swale with no defined channel. The drainage way is a tributary to Kirby Creek.

Photograph 15. Headcut with grading and rip-rap on a tributary to Kirby Creek.

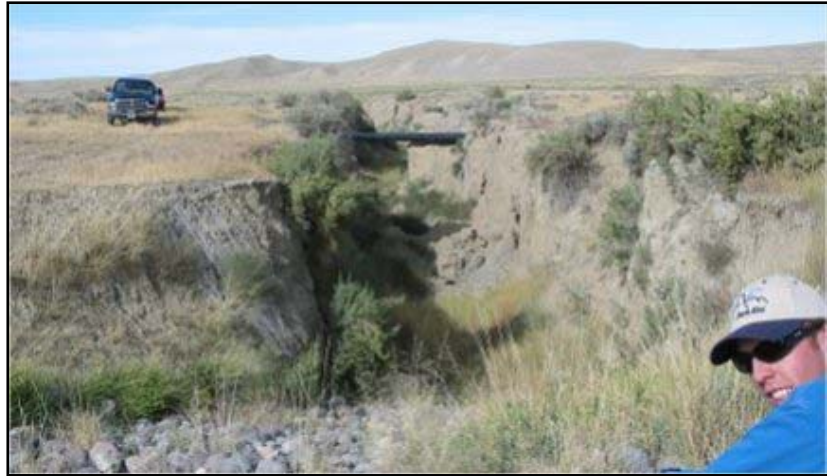
Photograph 16 is a view downstream at the most recent gullying. There are fresh soil falls from the raw vertical banks. A Marathon oil pipeline constructed in 1954, suspended across the gully, is visible. It is presumed that the pipeline was constructed before the gully formed.

Photograph 16. View of gully looking downstream. There is an oil pipeline suspended across the gully. This is another Rosgen Type G stream for a short ways downstream.

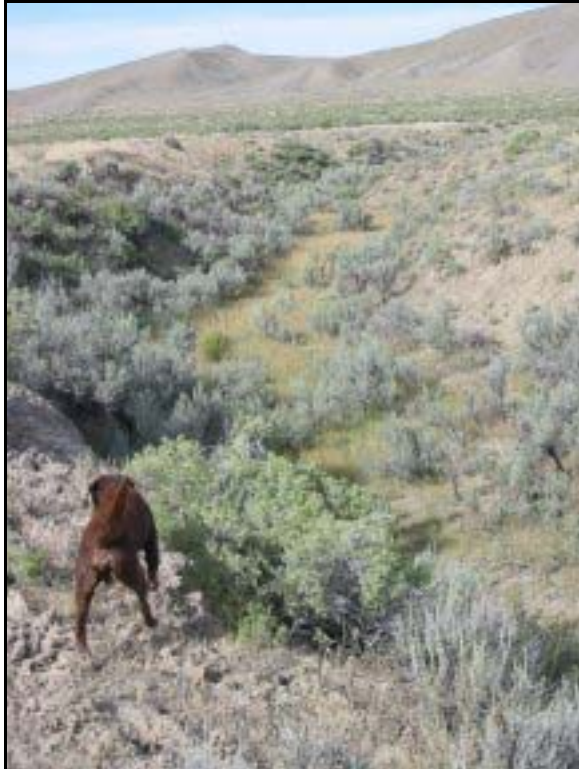
Farther downstream time has healed the gully scars (Photograph 17). The banks have slumped inward and are now stable and covered with vegetation. There is no more erosion of the bottom. One sagebrush in the bottom just downstream from the pipeline was estimated to be 13 years old.

Photograph 17. Farther downstream from the pipeline, the gully has become stabilized with vegetated banks and channel bed.

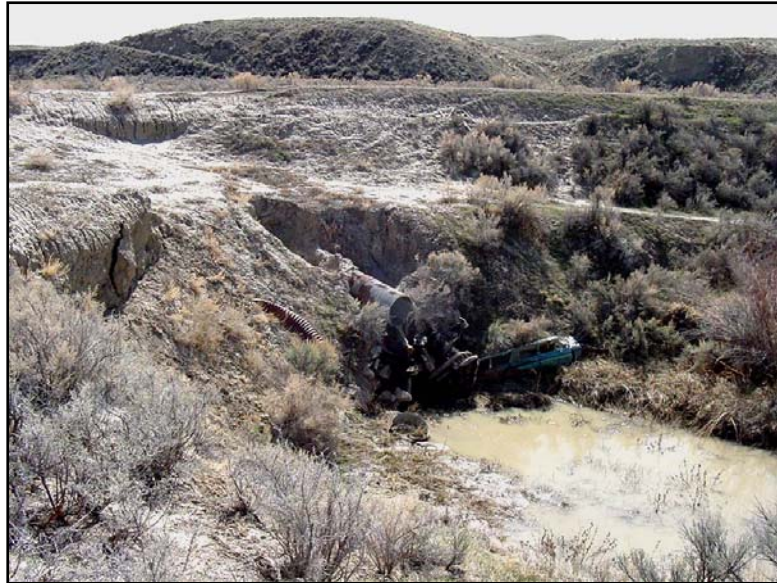
Photograph 18. Spillway of the Jones Dam

In addition to irrigation diversions, there is a dam located on Kirby Creek on the Jones Ranch. It is privately owned, produces a reservoir used for stock watering and irrigation, but the dam is in need of repair. It is approximately 670 feet wide and produces a reservoir 2,700 feet long and has 70 acre-ft. of water right. There are also 62 stock reservoirs and 2 detention basins in the watershed as shown in **Figure II-7**. A data base of these reservoirs is in **Appendix A**. Some reservoirs appear to be in good working condition, while several others are in need of repair.

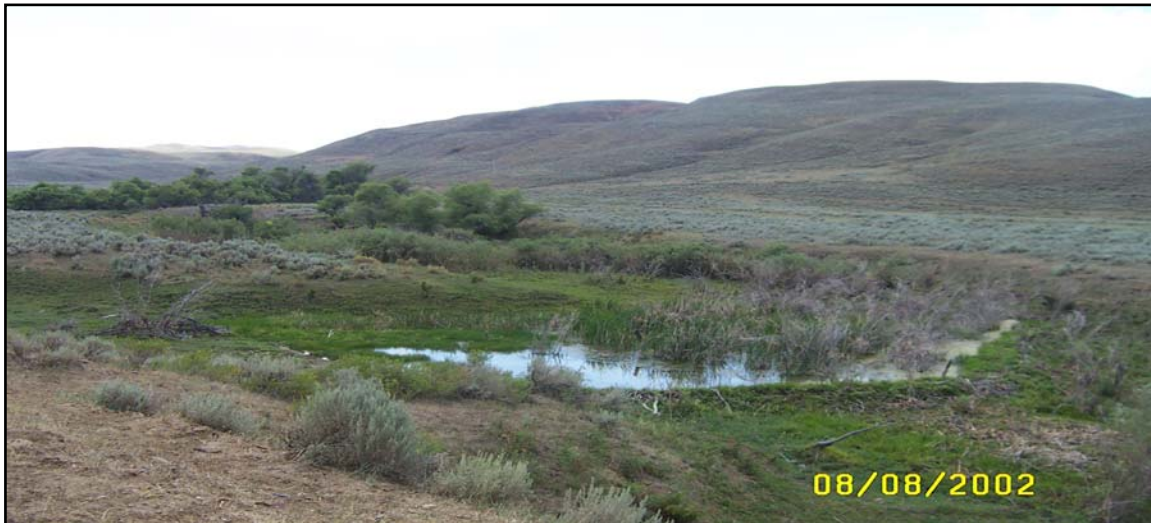
As was mentioned in Section 2, there is currently a beaver population in existence on East Kirby Creek as can be seen in the photo shown below.

Beavers can provide a cost effective way to slow erosion and develop riparian areas.
