FINAL REPORT FOR THE SWEETWATER RIVER WATERSHED STUDY PHASE II MUDDY CREEK AND HORSE CREEK WATERSHED MANAGEMENT PLAN

Anderson Consulting Engineers, Inc. 375 E. Horsetooth Rd. Bldg. 5 Fort Collins, CO 80525 (ACE Project No. WYWDC26)

April 20, 2012

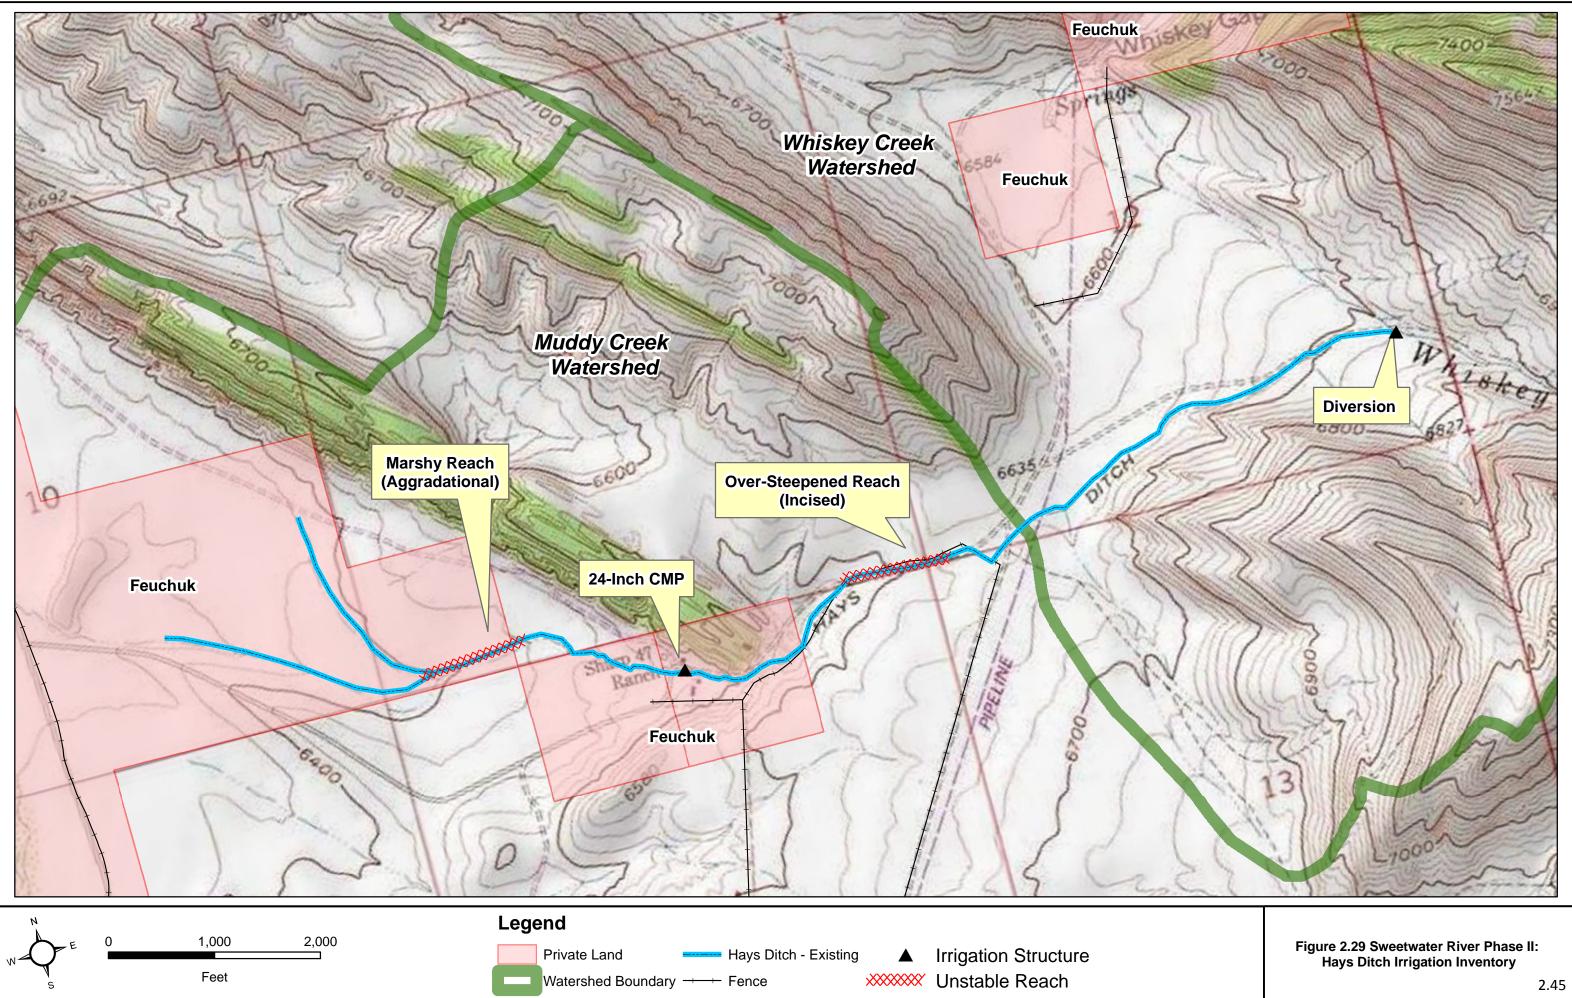
The ditch is entirely earthen; there are no lined or piped sections. It initially is aligned along the contour and appears to be relatively stable. Approximately 0.8 miles downstream of the diversion, the ditch slope increases where it joins a native drainage. This reach appears to be incising, however, considering the age of the ditch (>100 years), the incision does not appear severe (Figure 2.31).

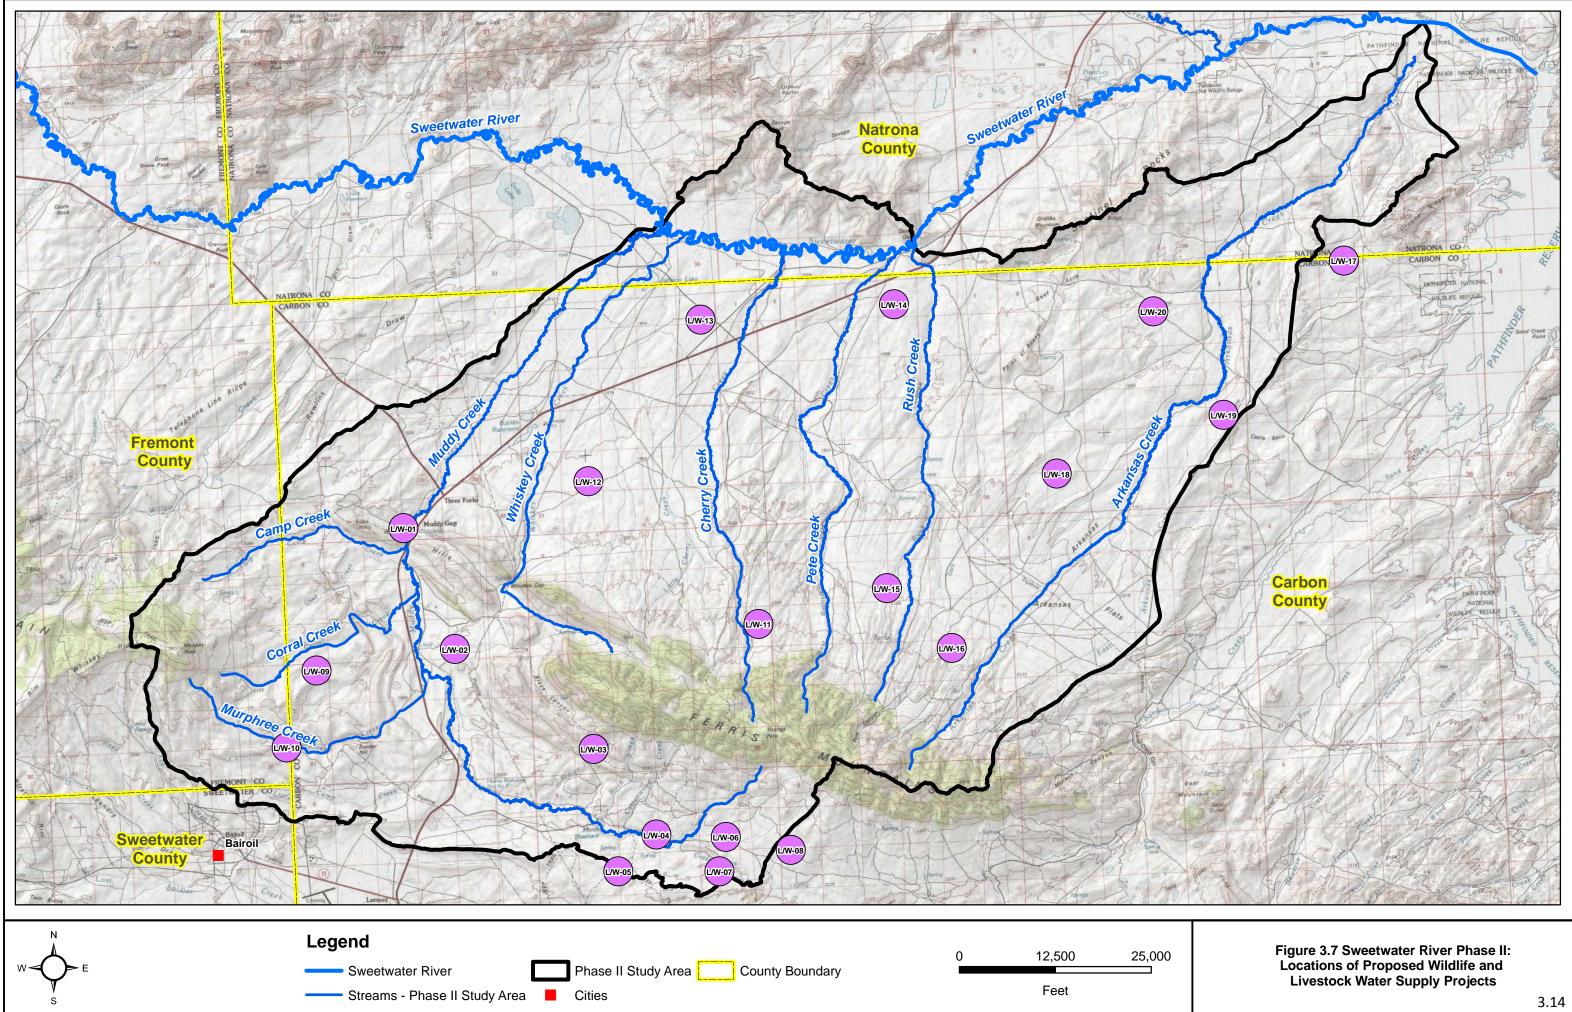
side of the highway. This project lies within the Cherry Creek Allotment. Figure 3.8 displays the general configuration of this alternative.
