**FINAL REPORT  
FOR THE  
SWEETWATER RIVER WATERSHED STUDY PHASE IV  
WILLOW CREEK / SAGE HEN CREEK / DRY CREEK  
WATERSHED MANAGEMENT PLAN**

**Anderson Consulting Engineers, Inc.  
375 E. Horsetooth Rd. Bldg. 5  
Fort Collins, CO 80525  
(ACE Project No. WYWDC26)**

**April 20, 2012**

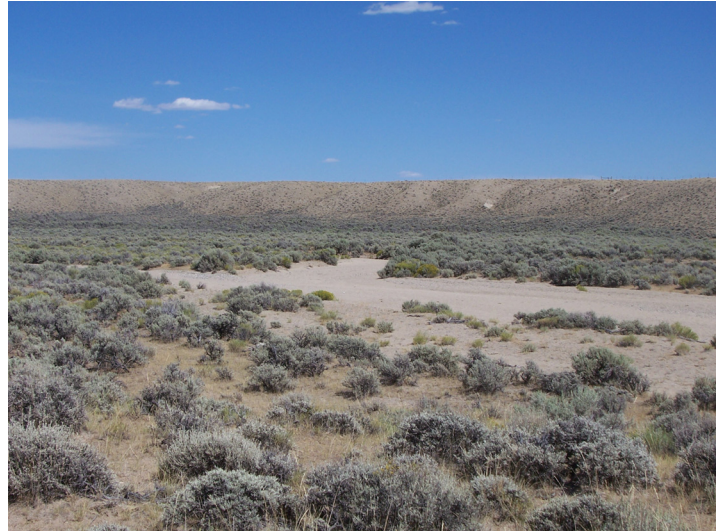
Figure 2.18 Example Type C Channel: Lower Sage Hen Creek.

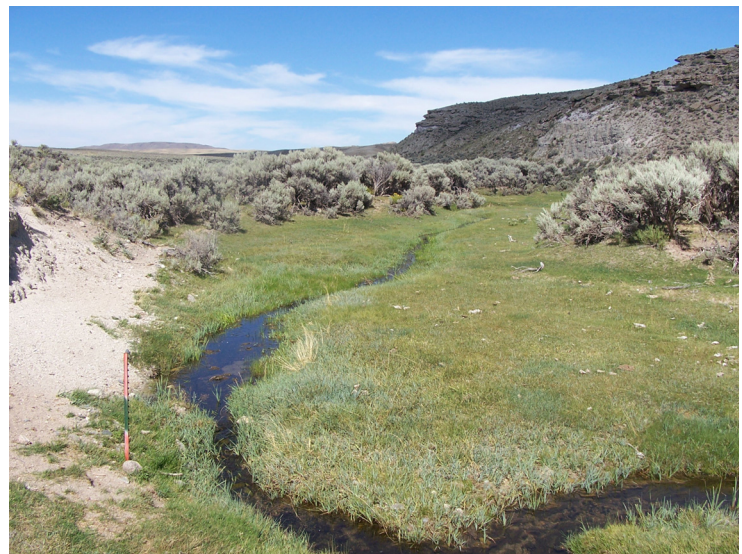
Figure 2.19 Example E-Type Channel: Upper Sage Hen Creek.

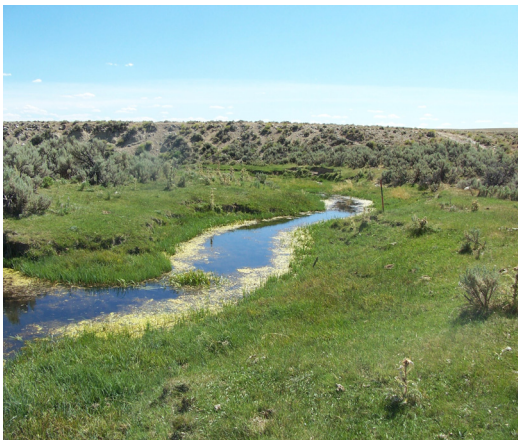
Figure 2.21 Loss of Riparian Vegetation and Habitat on Sage Hen Creek.

- Riparian Vegetation Degradation: Impaired riparian condition and habitat. Figure 2.21 displays a geomorphically stable portion of Sage Hen Creek exhibiting a lack of riparian vegetation and habitat.
- Riparian Degradation: Generally bank erosion and physical disturbance of stream banks. Figure 2.22 displays a photo of Dry Creek where stream banks have been disturbed by wildlife and livestock utilization. Figure 2.23 displays a photo of Lower Dry Creek where channel incision has resulted in over-steepened and unstable stream banks.

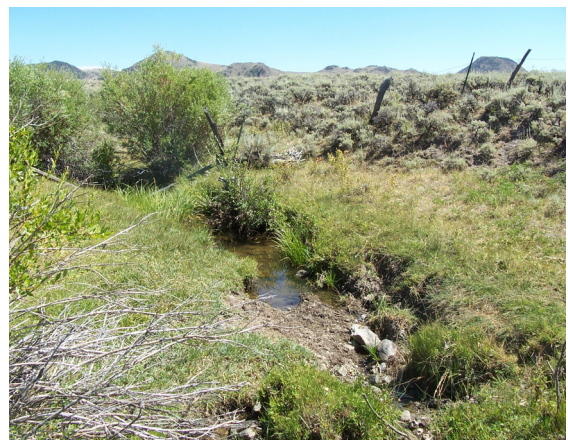
Figure 2.22 Stream Bank Disturbance On Upper Dry Creek.

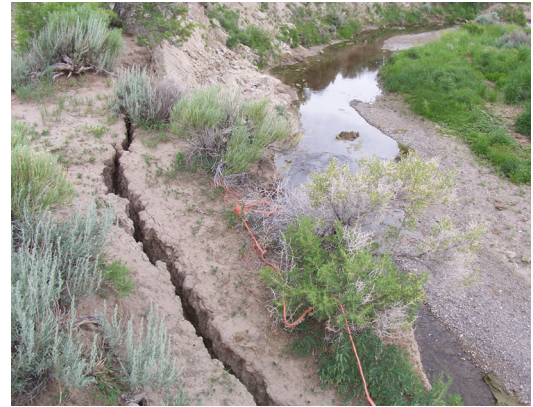
**Figure 2.23 Stream Bank Instability on Lower Dry Creek.**

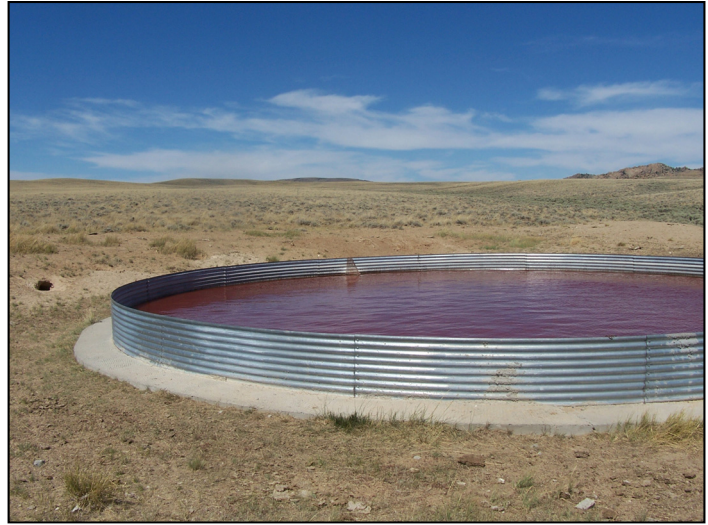
**Figure 2.30 30-Foot Diameter Concrete Bottomless Stock Tank.**

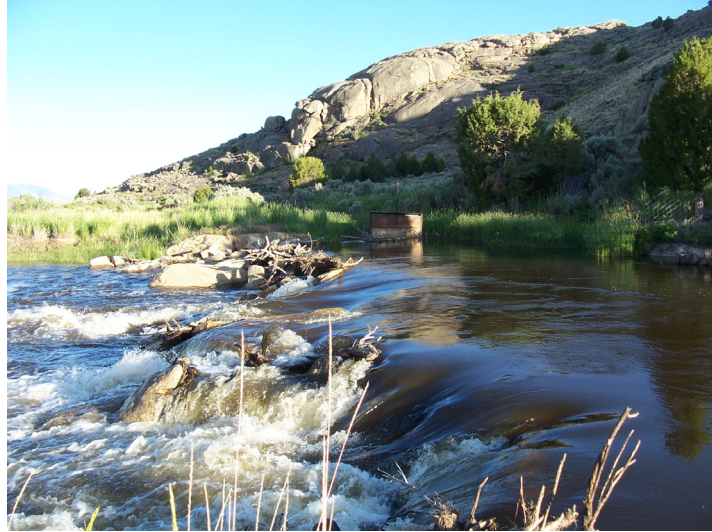
**Figure 2.33 McIntosh Ditch Diversion Structure on the Sweetwater River.**

- The structure consists of a large boulders placed across the river to provide the water surface elevation necessary to divert water through the ditch headgate.
- Two 36-inch diameter culverts have been placed within the structure to consolidate flow during low flow periods. Based upon an interview with the ditch owner, it is our understanding that the culverts are in good condition although they were not visible due to high flow conditions.

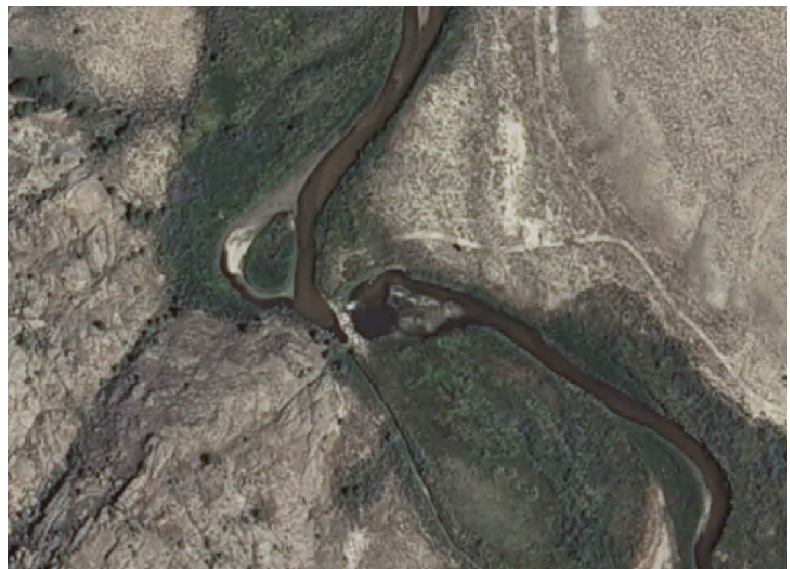
**Figure 2.34 Overview of the McIntosh Ditch Diversion Structure.**

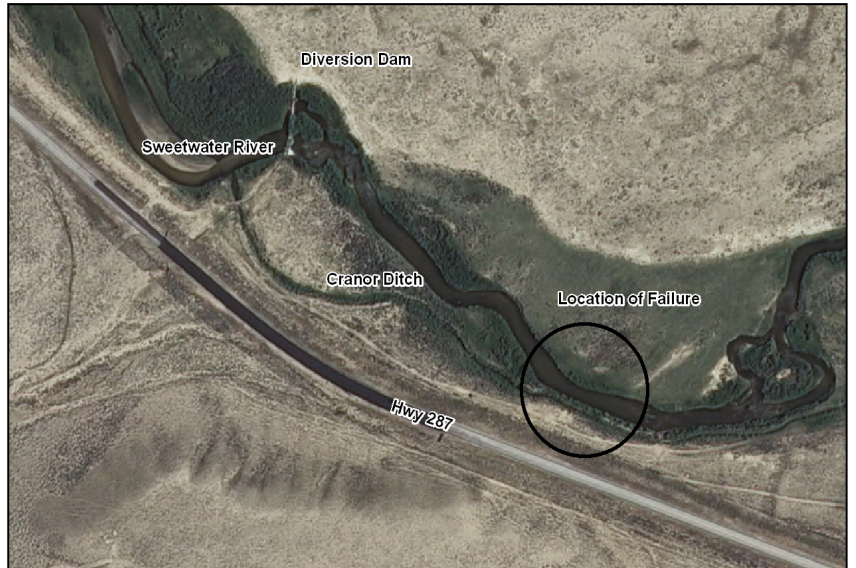
Figure 2.35 Overview of the Cranor Ditch Diversion and Failure Location.

The Cranor ditch provides irrigation water to approximately 50 acres in the vicinity of the Split Rock Ranch. Approximately 1,350 feet downstream of the ditch headgate on the Sweetwater River, the ditch is aligned immediately adjacent to the river (Figure 2.35). In early 2011, bank failure resulted in loss of the ditch through a length of approximately 150 feet (Figure 2.36). Due to the failure, conveyance of irrigation water in the ditch is impossible.

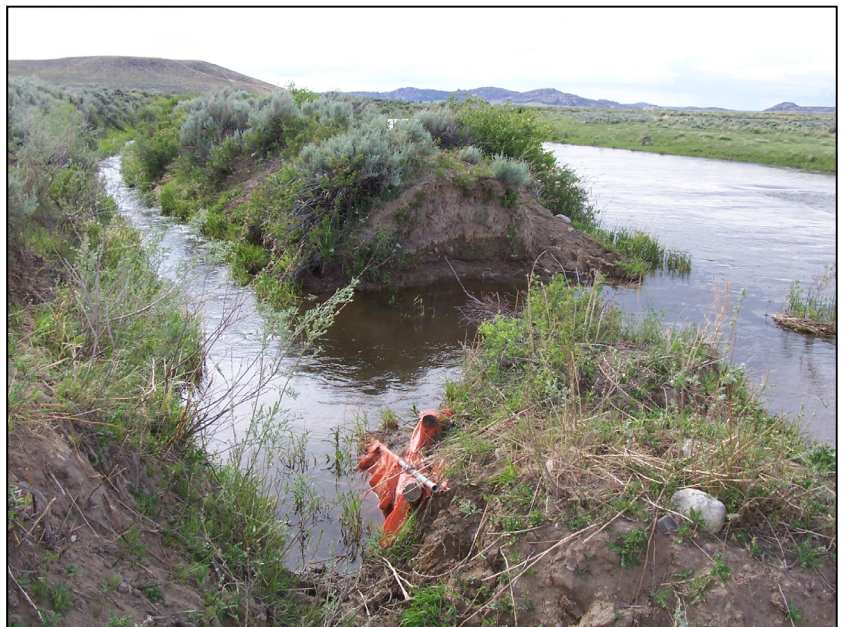
Figure 2.36 Cranor Ditch Failure on the Sweetwater River.

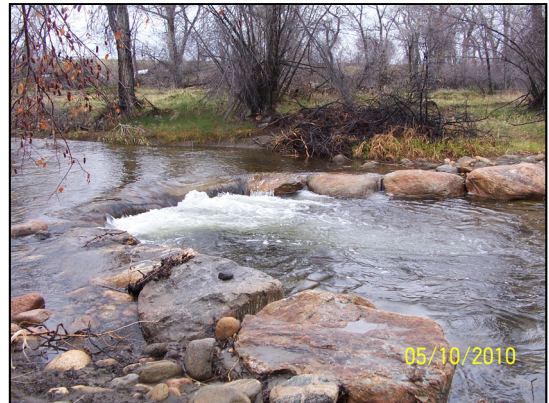
Figure 3.2 Stream Stabilization Structure: Rock Vortex Weir.

For instance, methods of restoring incised channels may include construction of gradient restoration facilities (i.e., drop structures, check structures) within the incised channel. Figure 3.1 displays a diagram of a typical stream channel stabilization strategy for a small channel experiencing minor downcutting or bank erosion. A vortex weir can be placed within a problematic reach to serve as a grade control structure as well as directing and centralizing streamflow. Weir configuration can be varied to provide additional functions such as facilitating irrigation diversions. Figure 3.2 displays a photograph of a typical installation.

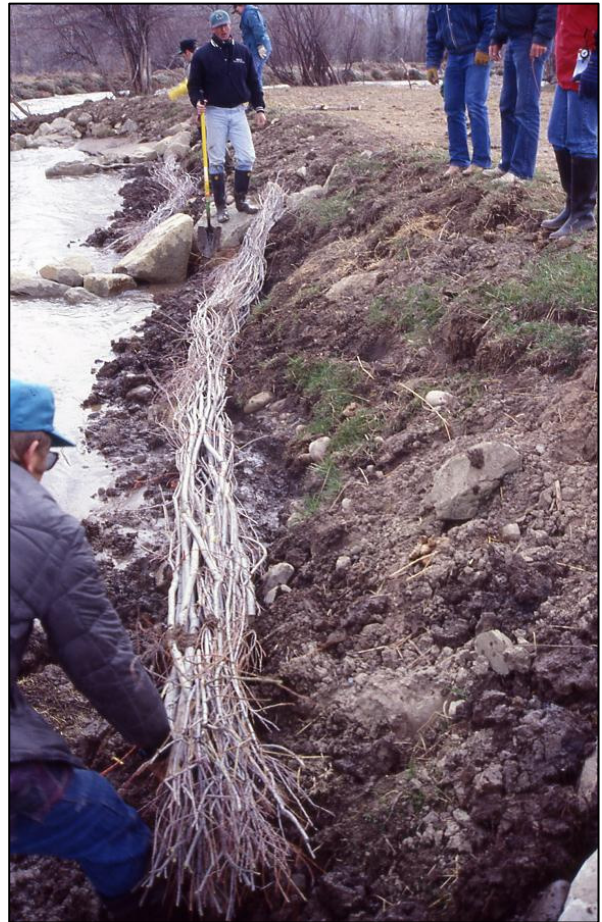
**Figure 3.3 Stream Stabilization Measure: Willow Fascine Installation.**

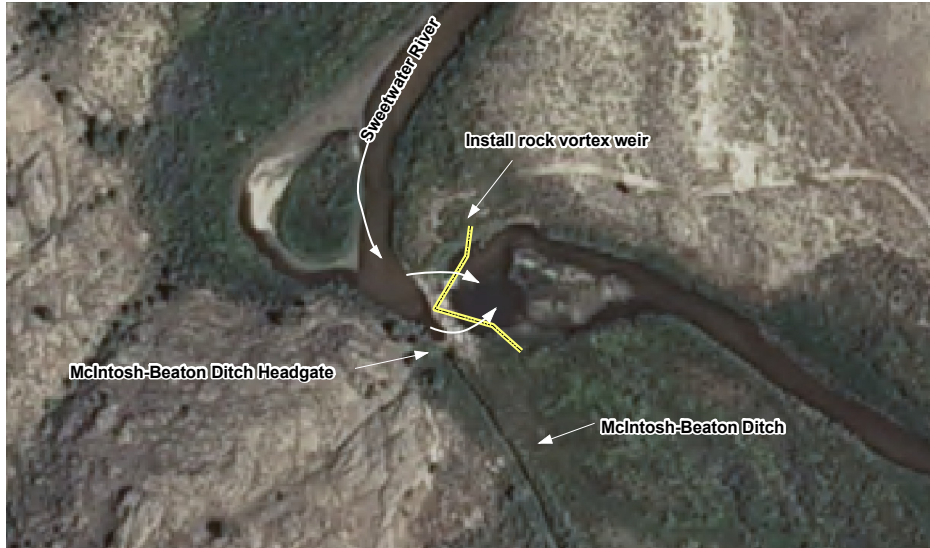
**Figure 3.4 McIntosh-Beaton Ditch Rehabilitation.**

Rehabilitation Item Number	Description	Priority
I-1	Reconfigure/rehabilitate Existing Diversion Dam	2
I-2	Install measurement device on McIntosh-Beaton Ditch	3

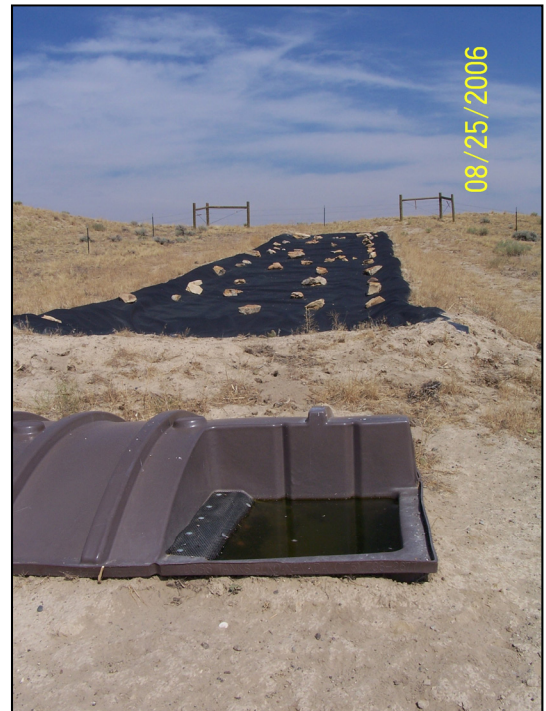
**Figure 3.13 Wildlife Guzzler.**

These guzzlers would be installed at locations to be determined. The guzzler operates by intercepting direct rainfall or snowmelt on the catchment, routing the captured water via a pipe
