HEART MOUNTAIN CANAL REHABILITATION LEVEL II STUDY

EXECUTIVE SUMMARY

Wyoming Water Development Commission (WWDC) contracted with Engineering Associates (EA) in June 2015 to complete a study for Heart Mountain Irrigation District for the Canal Liner directly downstream of the Rattlesnake Mountain Tunnel.

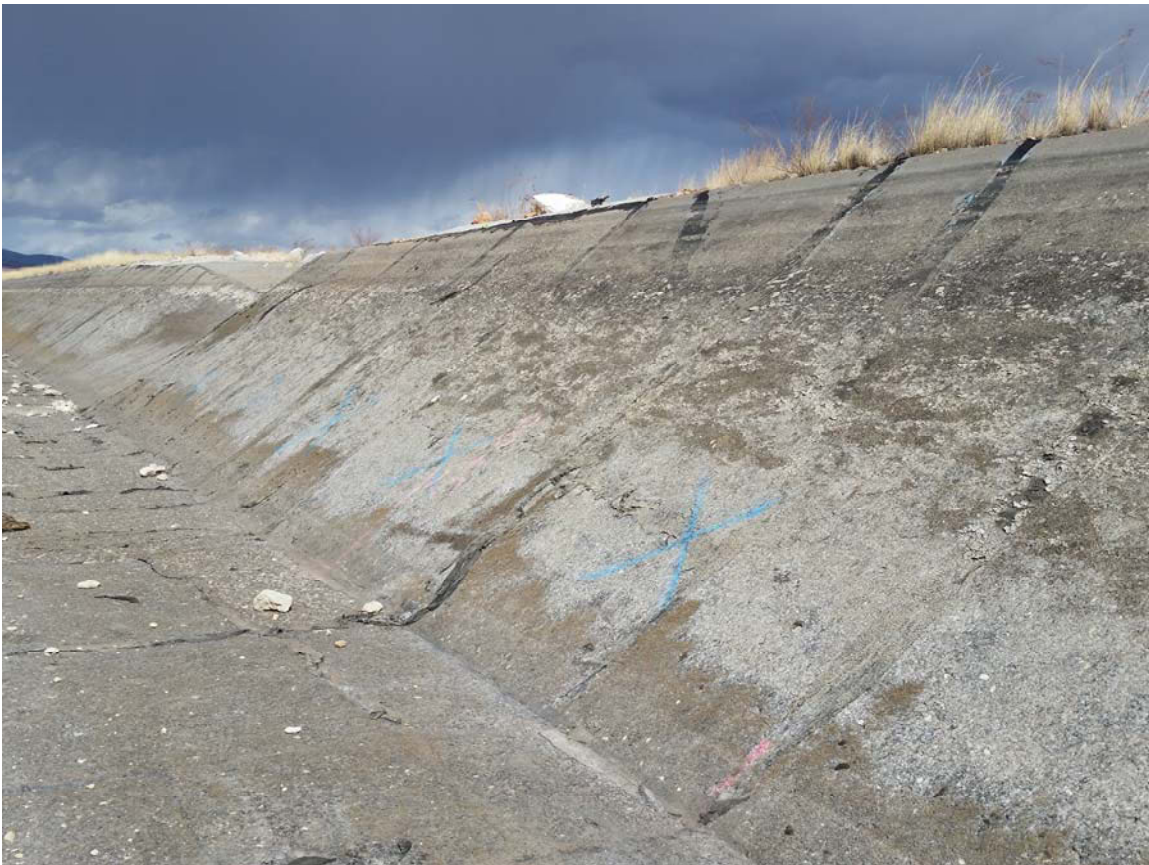
Figure 2

The concrete lined section of the HMID canal was visually inspected in dry condition from November, 2015 to March, 2016 and during the irrigation season from July, 2015 to September, 2015. During the dry inspection, large cracks, exposed rebar, and deteriorating concrete were located at numerous locations. 95 concrete panels on the west side of the liner and 87 concrete panels on the east side of the liner have extensive cracking.

With the amount of cracking, poor subgrade, and overall age of the existing liner, another major failure is definitely likely. It is the recommendation of this study that the existing liner should be completely removed and replaced. Trying to “Band-Aid” the existing liner will only postpone the inevitable replacement.

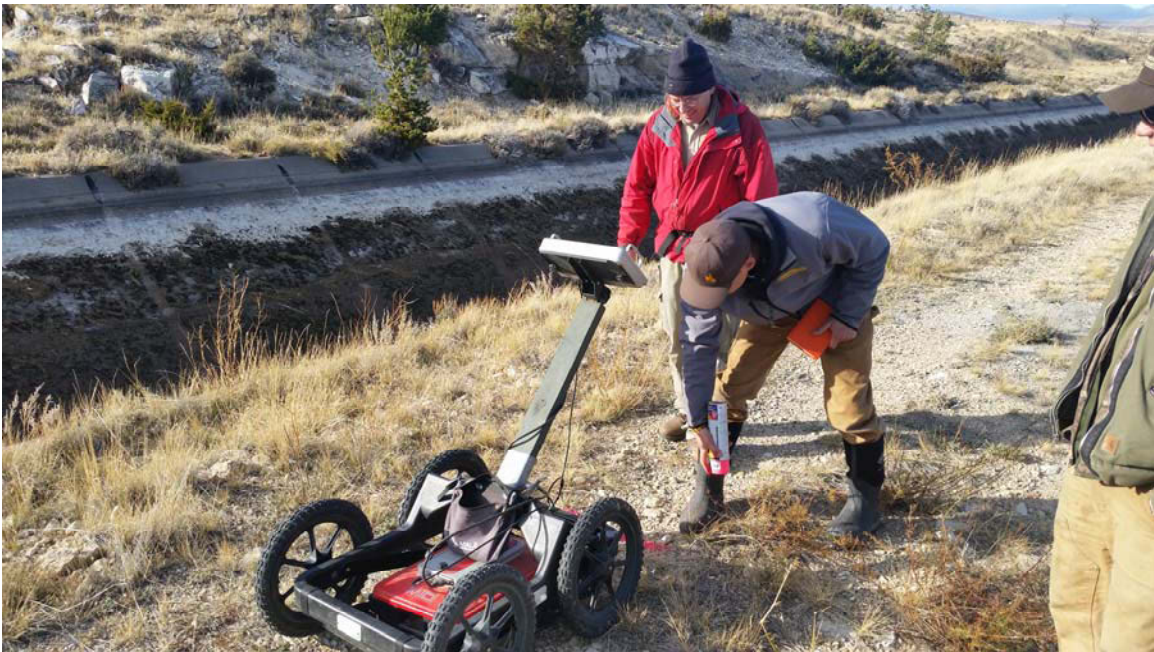
Figure 3

When using the GPR, any anomaly found was marked in the field with spray paint and then surveyed and recorded with GPS. During this mapping with the GPR, the bedding planes of the bedrock were visible in multiple locations. See the report found in Appendix A of the Final Report for the complete information on the GPR investigation.

A total of nine possible void areas were identified by correlation with other investigation efforts. Other anomalies that were not identified as possible void areas could be the result of large boulders, small voids, reflection of rebar, change in material composition, or change in material moisture content.

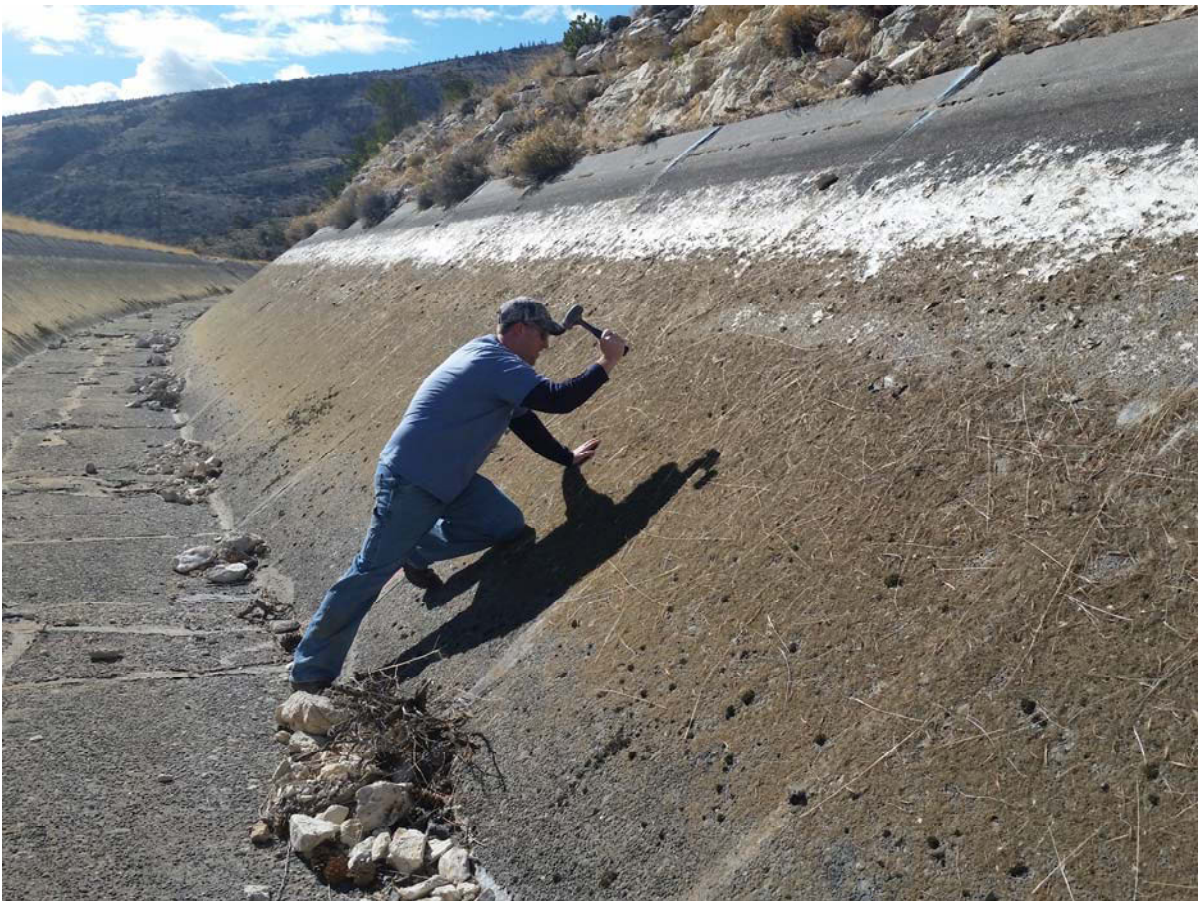
Figure 4

After using the ground penetrating radar method, EA decided to use another non-destructive exploration approach to evaluate the current physical conditions of the canal liner. This method used a 4-pound sledge hammer and a chain to conduct sounding tests. Sounding involves striking the concrete surface and interpreting the sound produced. Solid concrete will produce a ringing sound, while concrete that is delaminated, spalled, or has separation from the base material will produce a flat or hollow sound. Subgrade voids will also produce a flat or hollow sound. Sounding of vertical areas is best achieved by using a hammer or steel rod. A steel chain was drugged over the floor of the canal. Results from the hammer and chain tests located twenty-nine sections of the wall and floor of the liner with suspected hollow areas.
