CRAZY WOMAN WATERSHED PROJECT - LEVEL II

PHASE I
REHABILITATION PLAN
AND
PHASE II
CONCEPTUAL DESIGN AND COST ESTIMATES
FINAL REPORT

HKM ASSOCIATES
1842 Sugarland Drive, Suite 103
Sheridan, Wyoming 82801
307-672-9006

November 6, 1991

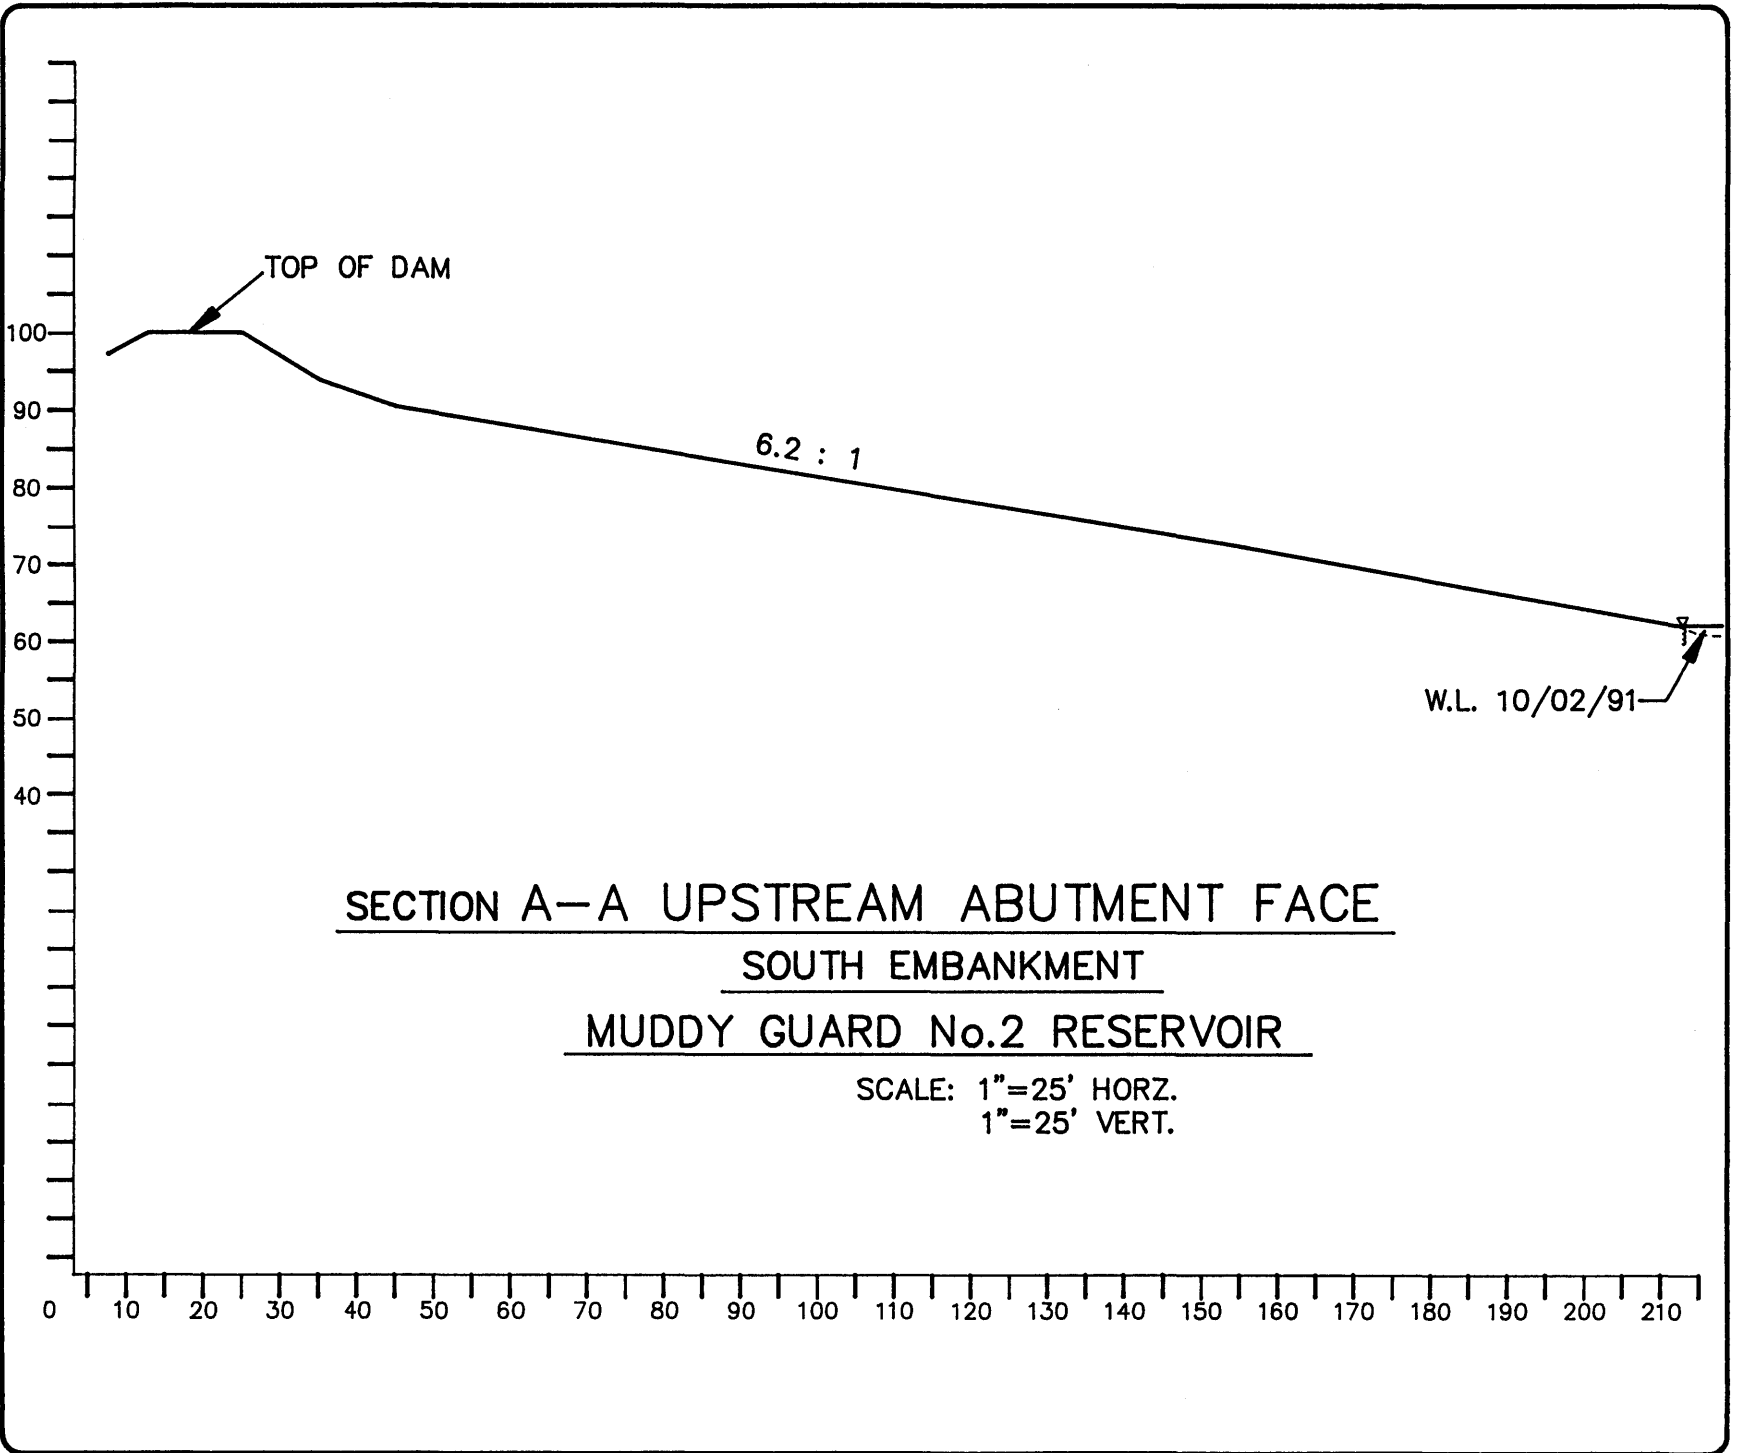
FIGURE 12

Two conditions appear to exist in the left abutment area. First, there appears to be some riprap shifting and erosion due to wave action as the water fluctuates from high water to low level. Bare areas are present and some benches are forming. Generally, the erosion is minor and the slope of the 3.1:1 face is approximately the same as the designed 3:1 slope. (See Figure 11 and 12). Secondly, it appears that the south embankment was the final area to receive riprap in the original construction. The top 15 to 20 feet of embankment appears to be adequately covered with large 12 to 30 inch rock. Below the 15 to 20 foot level the amount of large rock varies and there is significant small rock in the 3 to 12 inch range.

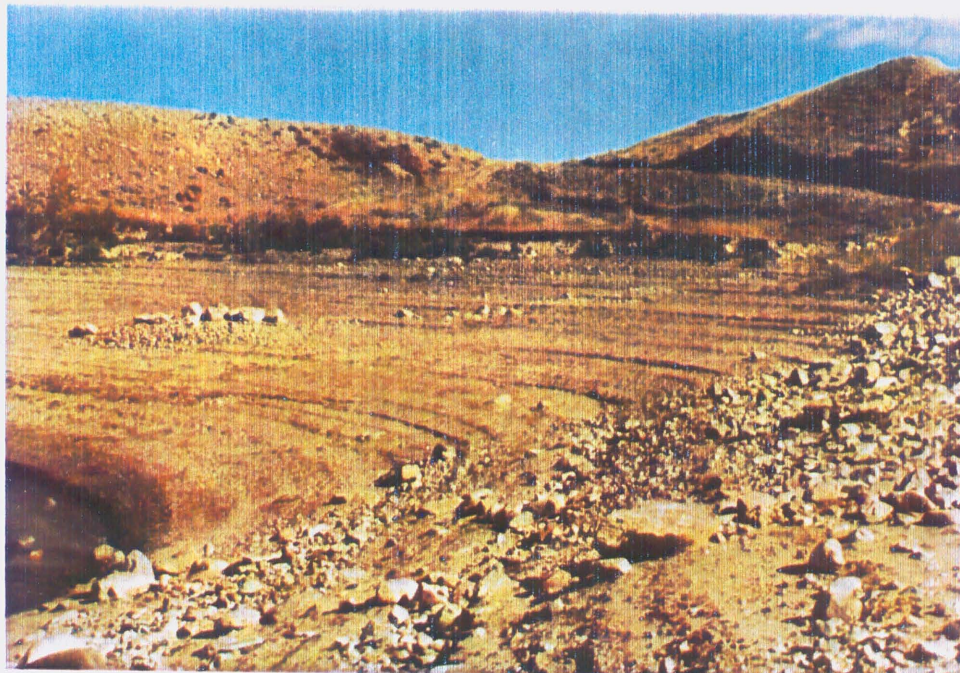
SECOND PHOTO

LEFT (EAST) ABUTMENT RIPRAP - SOUTH EMBANKMENT
MUDDY GUARD NO. 2 RESERVOIR
PROJECT NO. 7

The plan view shown on Figure 13 identifies three areas near the left (east) abutment where the placement of additional riprap is recommended. Area A is at the abutment and consists of 670 square yards, Area B consists of 1,800 square yards and Area C consists of 1,000 square yards. It is estimated that riprap in these areas is deficient by 100%, 50%, and 30% respectively. Assuming an average rock diameter of 16 inches results in a total riprap quantity of 935 cubic yards. It has been assumed that 1,000 cubic yards of riprap will be required.

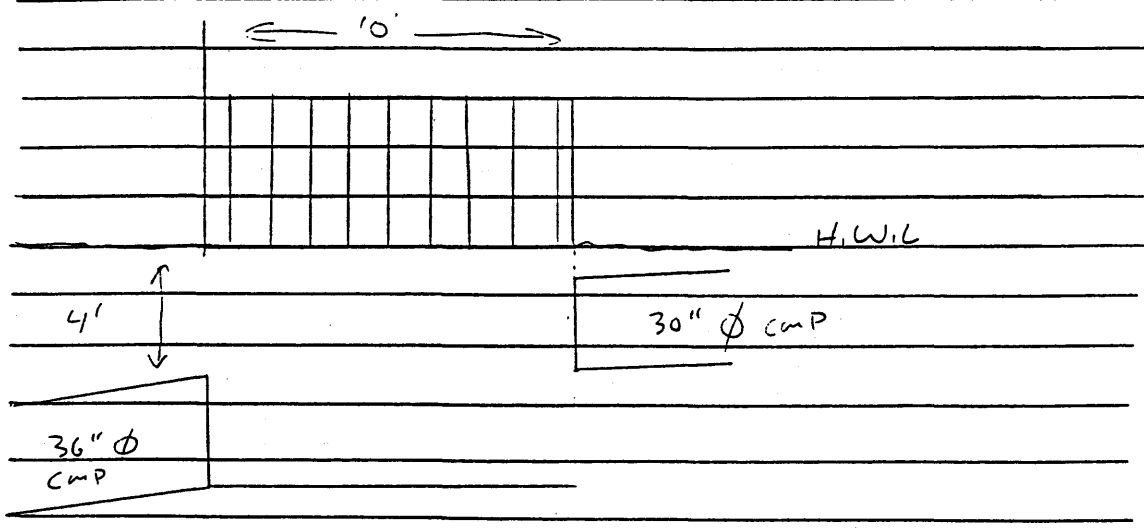
Sketch of Seepage Areas Below South Dam

SKETCH (Use to show problem areas with dam or related facilities):
