FINAL REPORT
POPO AGIE RIVER
WATERSHED STUDY, LEVEL I

Anderson Consulting Engineers, Inc.
772 Whalers Way, Suite 200
Fort Collins, CO 80525
(ACE Project No. WYWDC17)

July 9, 2003

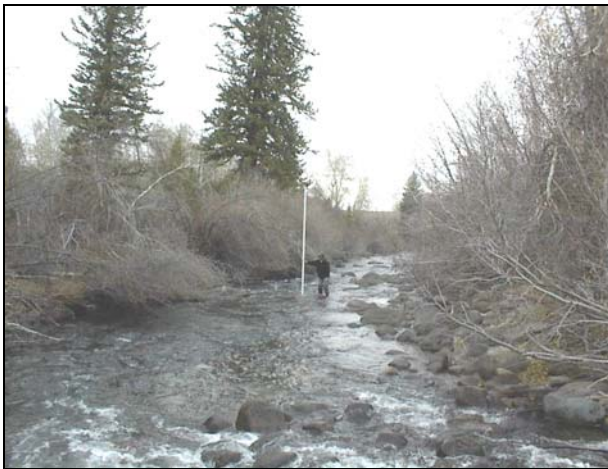
Figure 4.12 Site NPA-1: Type B2 Channel.

The upper reaches of the North Popo Agie River are confined within a bedrock canyon as it flows off of the flanks of the Wind River Range. From the mouth of the canyon near the USFS boundary to approximately the confluence of Surrell Creek, the North Popo Agie River is a B-type channel, with steep slopes, little floodplain access, and a coarse cobble/boulder substrate (Figure 4.12). Downstream of the Surrell Creek confluence, the lateral confinement, entrenchment, and channel slope all drop markedly, and the channel transitions into a C-type channel, maintaining the fundamental characteristics of a C-type channel to its mouth (Figure 4.13).

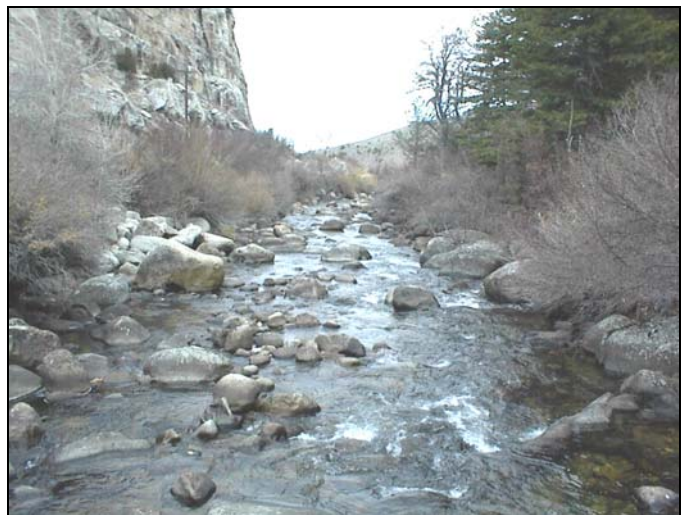
Figure 4.15 Site MPA-3: Type-A2 Channel.

The upstream portion of the study reach of the Middle Popo Agie River flows through Sinks Canyon, which is a narrow bedrock canyon. At narrow portions of the canyon, such as at the Sinks Canyon Gaging Station (Figure 4.15), the channel is very steep and entrenched, and is an A-type channel. Where the canyon locally widens out, the channel slope tends to drop, the entrenchment is reduced, and the channel has B-type characteristics. As the river leaves the canyon, it flows through a semi-confined valley as a

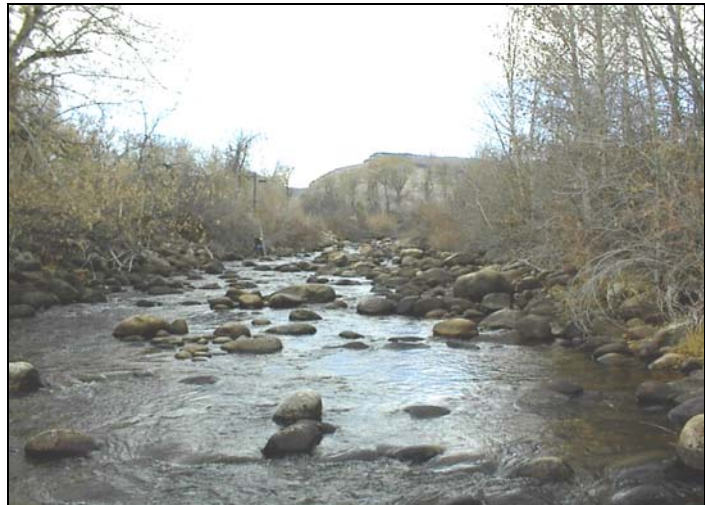
Figure 4.16 Site MPA-2: Type-B2c Channel.

B-type channel past Central Wyoming College Field Station (Figure 4.16). Further downstream, as the lateral confinement and slope are both reduced, the river transitions into a C channel type (Cross Section MPA-1, Figure 4.10), until it reaches the City of Lander, where flood control engineering has resulted in a deeply entrenched B channel (Cross Section MPA-4, Figure 4.10). Downstream of Lander, the river transitions back to a C-type channel, and maintains this form to its mouth.

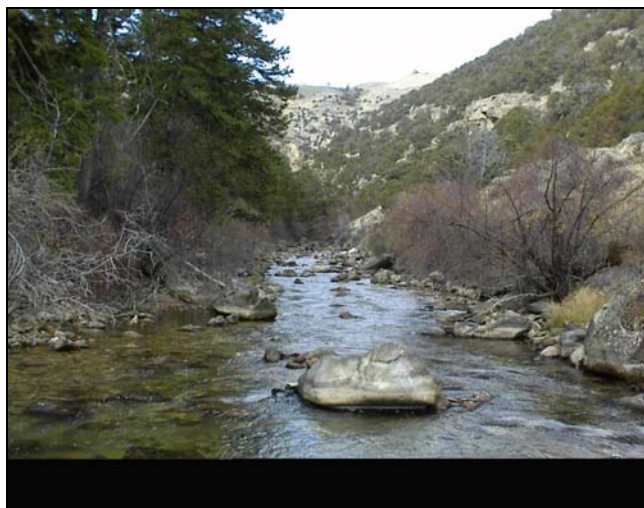
Figure 4.18 Little Popo Agie River at Mouth of Canyon (Type-B Channel).

The Little Popo Agie River emerges from the mountains as a relatively confined, entrenched, B-type channel (Figure 4.18). As the confinement and slope are reduced in the downstream direction, the channel transitions into more of a typical, meandering gravel bed stream near Highway 28 (Figure 4.18). At the Twin Creek confluence, which is on the upstream end of Dallas Dome, a broad alluvial fan crosses the Little Popo Agie River valley. This large deposit of relatively fine-grained sediment

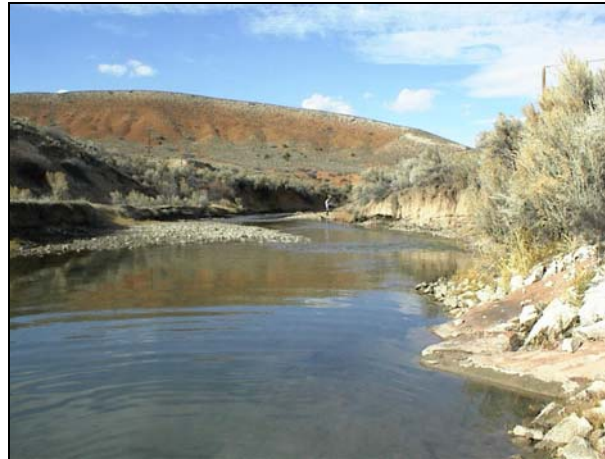
Figure 4.19 Little Popo Agie River at Dallas Dome (Type-B4c Channel).

indicates that Twin Creek has historically contributed large volumes of sediment to the Little Popo Agie River system. At the confluence, the Little Popo Agie River transitions abruptly from a meandering, unconfined C-type channel upstream, to an entrenched, confined B-type channel through the fan (Figure 4.19). Downstream of the fan, the river flows through Dallas Dome, where extremely shallow oil reservoir depths are evidenced by active oil seeps in the toe of the riverbank. Through the Dallas Dome field, bedrock valley walls narrowly confine the Little Popo Agie River valley. The channel is entrenched within terraces, and is a B-type channel. Downstream, the channel emerges into Lyons Valley.

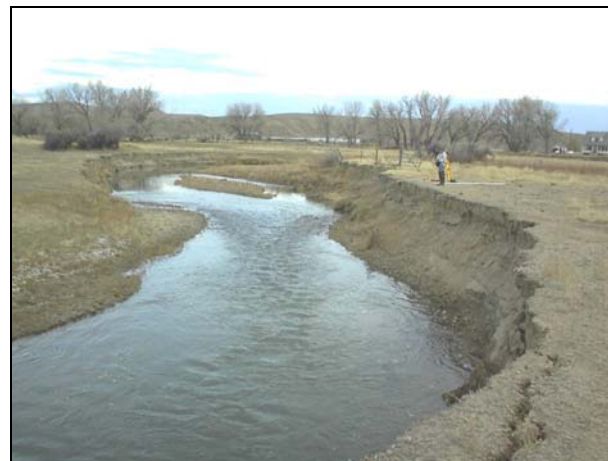
Figure 4.20 Little Popo Agie River near Mouth (Type-F Channel).

Lyons Valley contains an extensive length of F-type channels, which are deeply entrenched meandering channels that are typically unstable due to channel downcutting (Figure 4.20).

The consequences of the incised channel evolution process can be severe. Large-scale bank instability results in extensive bank failure and sediment production. As the groundwater table drops with the channel bed, the depth to groundwater from the original floodplain surface increases, commonly to the point where pre-incision vegetation patterns are not sustainable. Eventually, however, a new equilibrium condition will be achieved, as the channel develops a new equilibrium profile, and flood energies are dispersed on the new incised floodplain surface.

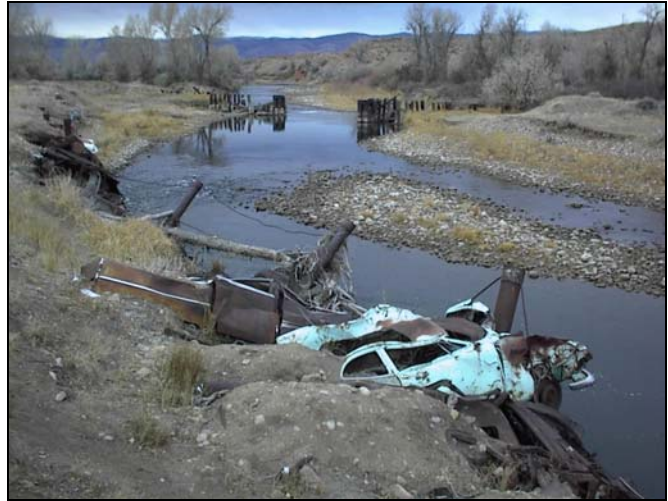
some aggressive bank protection efforts (Figure 4.22). Additionally, riparian clearing and bank grading have damaged the riparian corridor (Cross Sections PA-1 and PA-2, Figure 4.10). Levees are locally present on both sides of the channel, and the channel received a Level III rating of “fair” (Cross Section PA-3, Figure 4.10).

The impairments to the project reach of the Popo Agie River relate largely to riparian clearing, bank grading, bankline erosion control, and levee construction. Each of these impacts serves to limit riparian reinforcement of banks, and general riparian succession. Means of reducing these impacts may include floodplain/bankline revegetation; relocation of levees to a “setback” position so that less floodplain area is isolated from the channel; migration corridor delineation; and application of alternative bank protection methods that incorporate upper bank vegetation.

Figure 4.22 Bank Stabilization Efforts on the Popo Agie River (Site PA-3: Type-C3 Channel).

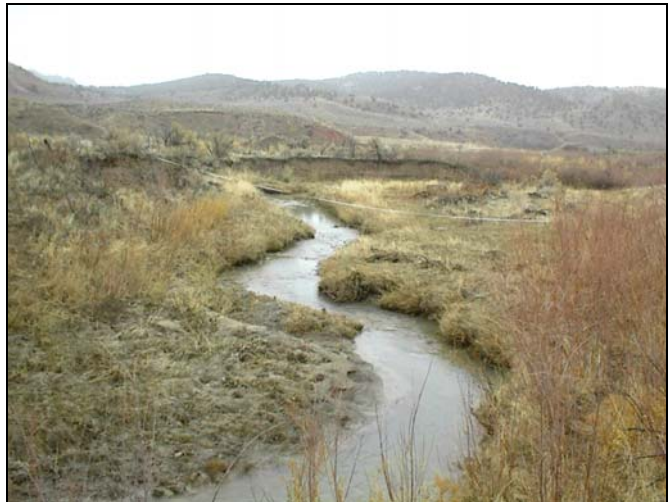
Figure 4.23 Twin Creek at TC-1: Type E4 Channel.

Twin Creek is classified as an E-type channel along its entire mapped length, indicating that the channel has a low width-depth ratio, moderate slope, and stable planform. The lower reaches of Twin Creek have historically downcut, such that the channel configuration is nested within terraces (Figure 4.23). Upstream of Carr Reservoir, the channel is still an E-type channel, although local bank instability may be reflective of some level of active downcutting (Cross Section TC-2, Figure 4.10).

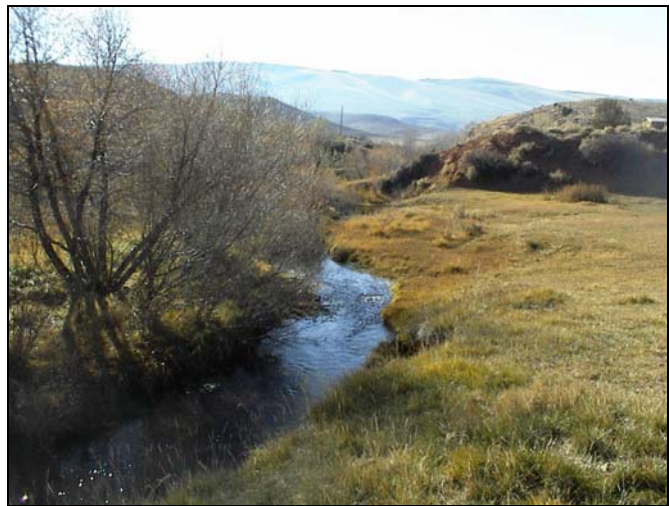
Figure 4.24 Baldwin Creek in Restored Reach (Type E3 Channel).

From its headwaters to a point just south of Red Butte, Baldwin Creek is a steep, confined, bedrock-controlled, A-type channel. As the creek flows northeastward, the confinement is reduced, and the channel transitions into an entrenched, B-type channel. This entrenchment is greatly reduced in the downstream transition, and Baldwin Creek transitions to an E-type channel approximately 2.5 miles upstream of Highway 287 (Figure 4.24).

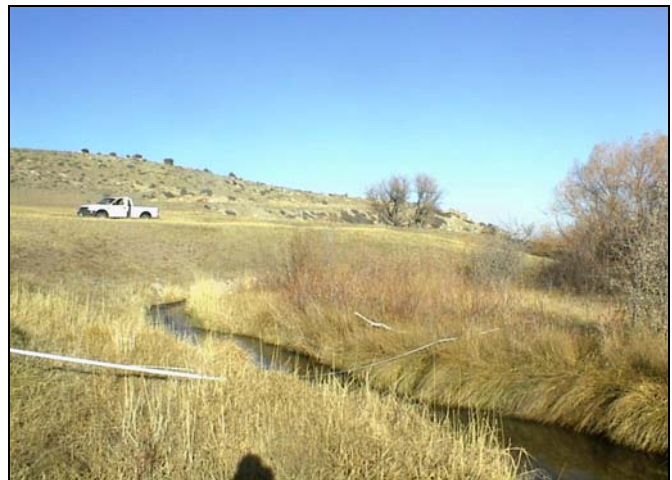
Figure 4.25 Squaw Creek at Site SQ-1 in Restored Reach (Type-E4 Channel).

Squaw Creek flows out of the Wind River Range as a steep, canyon-bound A-type channel. Approximately 1 mile upstream of the confluence with Grimmetts Gulch, the channel emerges from the canyon and transitions into an E-type channel, as it is relatively narrow and deep, and is bound by a substantial floodplain surface that is accessible to channel overflows. Along its course, the channel banks tend to be thickly vegetated with grasses and limited woody vegetation (Figure 4.25).

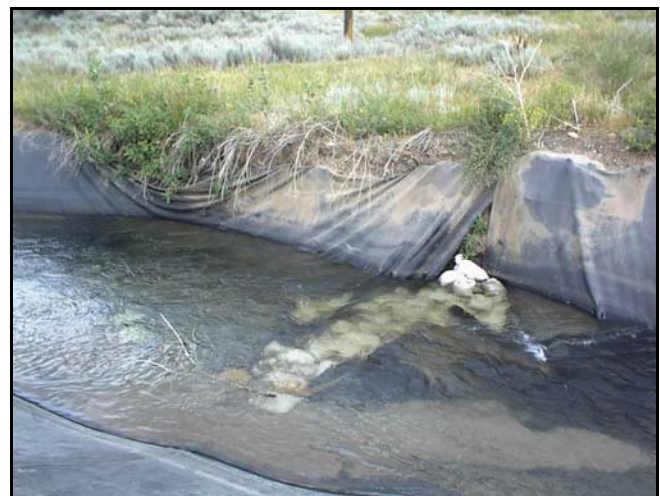
- A geotextile liner has been utilized in the reach of the ditch that crosses the City Golf Course. The inlet end of the material appears to be improperly installed and failure may occur. The bed and banks of the ditch may not have been properly cleared of vegetation and protruding rocks prior to its installation. Consequently, the fabric hangs loosely and may be prone to tearing (Figure 5.10).

Figure 5.10 Installation of Geomembrane on the Dutch Flat/Taylor Ditch.

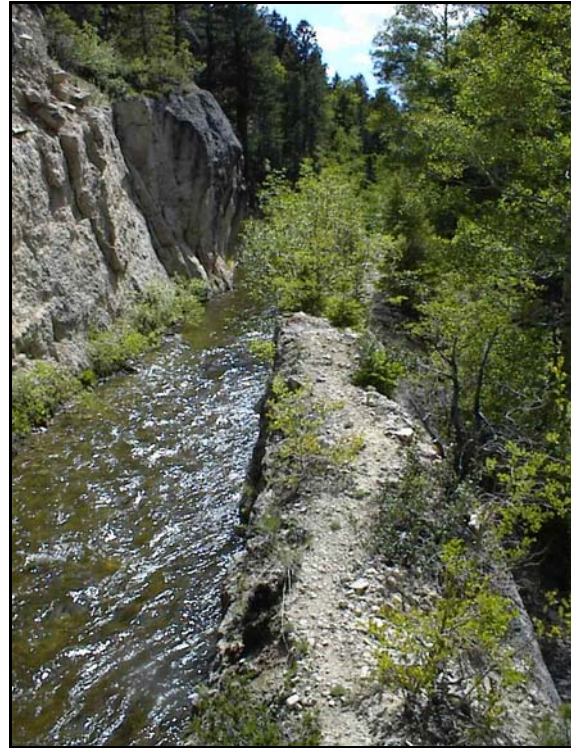
Figure 5.11 Rock Cut Segment of the Enterprise Ditch between Sawmill Creek and Crooked Creek.

A diversion from Sawmill Creek diverts flow into a 2.6-mile ditch conveying water across the basin divide to Crooked Creek. This reach of the ditch is perched high on a steep hillslope and is cut through native shales and sandstones (Figure 5.11). Flows are diverted from Crooked Creek into another earthen ditch

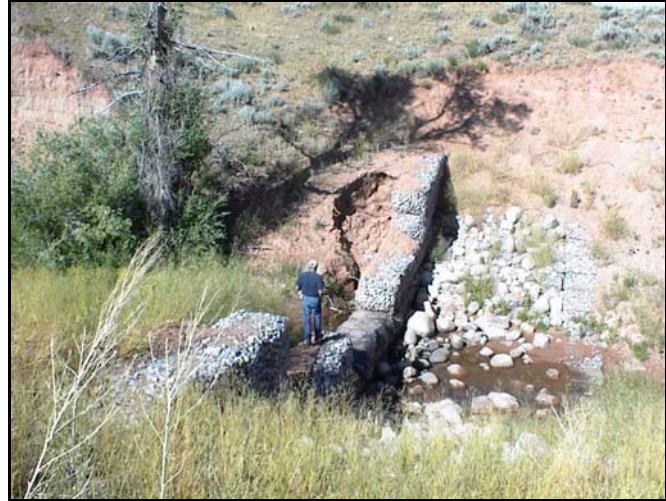
of the erosion in the channel bed; however, they appear to be in need of repair and remediation (Figure 5.13).

Figure 5. 13 One of Five Rock Gabion Drop Structures Located on Beason Creek.

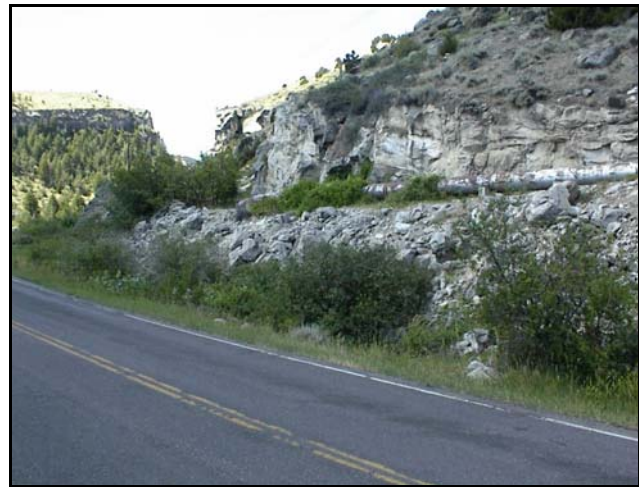
Figure 5.16 Gaylor Warnock Pipeline along CR 131.

- Approximately 250 linear feet of the ditch conveyance facilities consist of a 30-inch diameter steel pipe. The pipe is located above County Road 131 (Sinks Highway). It is our understanding that proposed road improvements will necessitate reconstruction of this portion of the ditch (Figure 5.16).

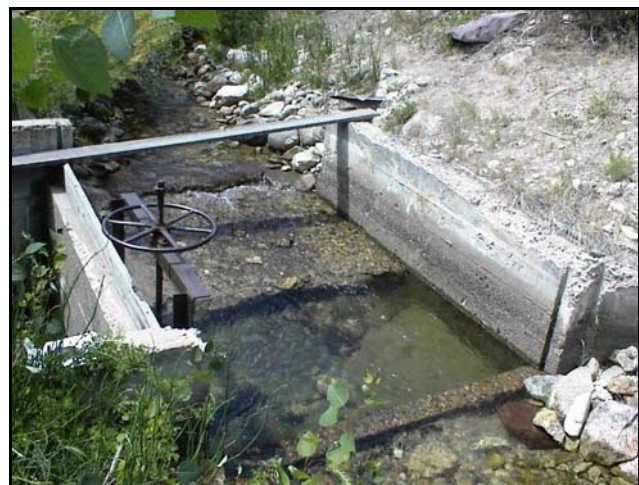
Figure 5.17 Sediment Trap on Gaylor Warnock Ditch.

- A sediment trap/release located downstream of the steepened reach has an ineffective slide gate which does not appear fully operable. At the time of the field inventory, a significant portion of the flows being diverted was lost below the gate (Figure 5.17).

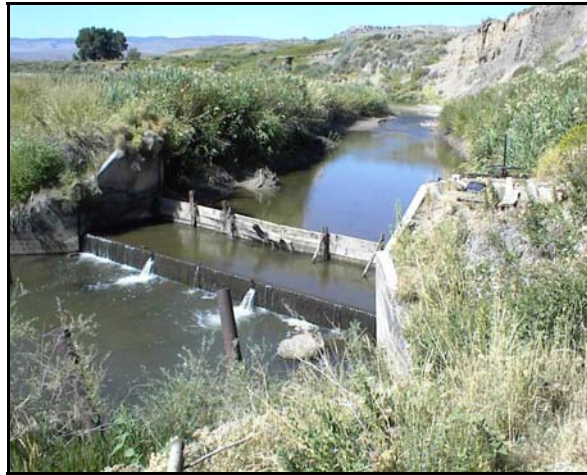
- The Lyons Ditch diversion structure spans the width of the Little Popo Agie River (Figure 5.19). It lies upstream of a reach that has been channelized in the past. The structure serves as a grade control for the river and has, at least partially, arrested degradation associated with channel response to the realignment project.

Figure 5.19 Lyons Ditch Diversion Structure on Little Popo Agie River.

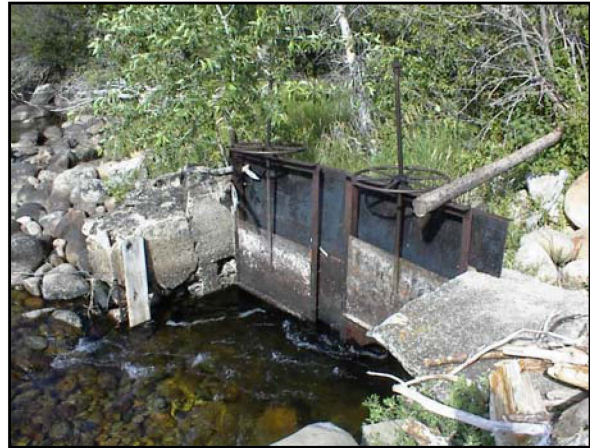
- Much of the existing infrastructure is aged and deteriorating. The diversion and headgate structures on the Middle Popo Agie River are in poor condition and are in need of replacement (Figure 5.22). Concrete in both structures is spalling and deteriorated. Gates are in poor condition and cannot be closed.

Figure 5.22 Nicol-Table Mountain Ditch Diversion Structure.

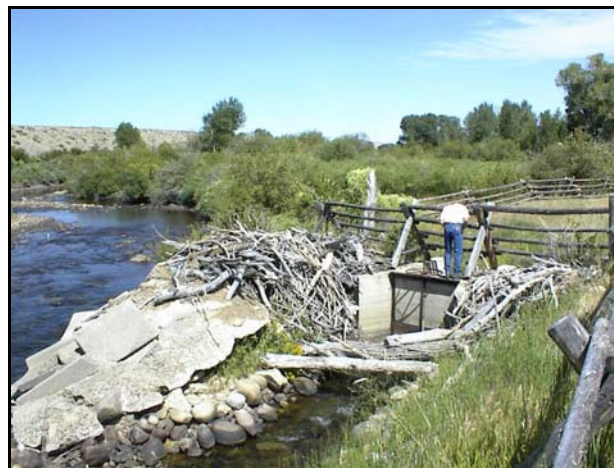
- Diversion from the North Popo Agie River is facilitated by a concrete structure. The structure is in poor condition and appears to require frequent maintenance (Figure 5.26). The ditch headgate is located immediately adjacent to this structure. It is in fair condition and appears operable.
- Several deteriorated structures were observed in the upstream reach of the ditch. These structures appeared to be abandoned.

Figure 5.26 North Fork Ditch Headgate and Diversion Structure.

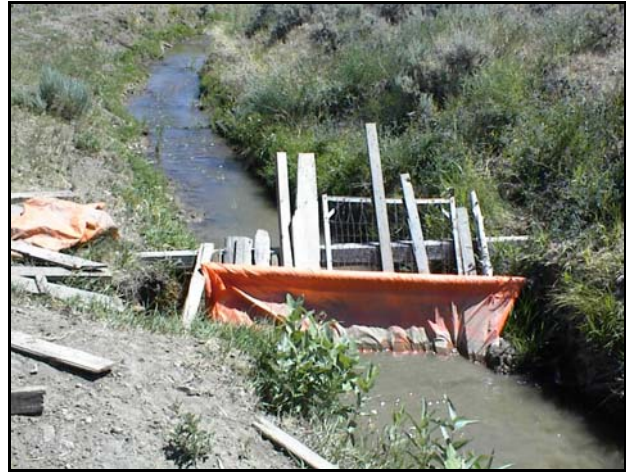
- No measurement structures were observed in the ditch system, including the ditch headgate and farm turnouts.
- Farm turnouts were generally in poor condition, consisting of deteriorated concrete check structures or wood/tarpaulin structures (Figure 5.27).
- Most of the ditch appears to be stable and non-erosive. However, a steep reach near the tail end of the ditch (GPS location 60-61) is degraded and erosive.

Figure 5.27 Turnout Structure on North Fork Ditch.
